Survey of damages, assessment of seismic behavior and interventions to the listed building of Vasileos Georgiou 27, Thessalonikis

MSc Student: Xofi Maria

ATHENS 2011

SURVEY OF DAMAGES, ASSESSMENT OF SEISMIC BEHAVIOUR AND INTERVENTIONS TO THE LISTED
BUILDING OF VASILEOS GEORGIU 27- FORMER 12TH PRIMARY SCHOOL THESSALONIKIS

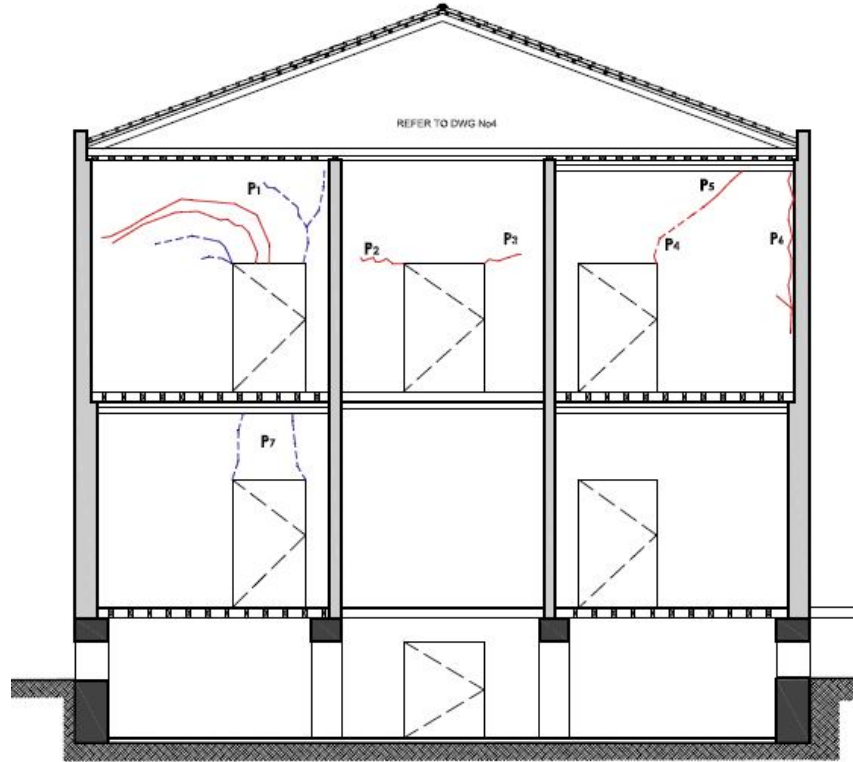
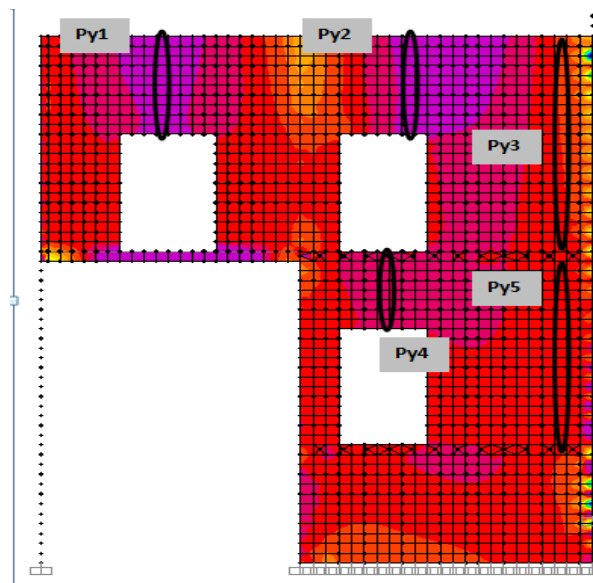
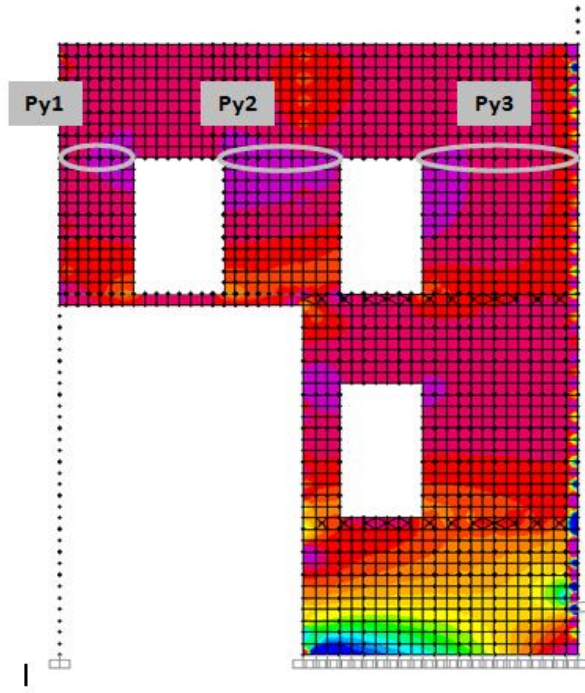
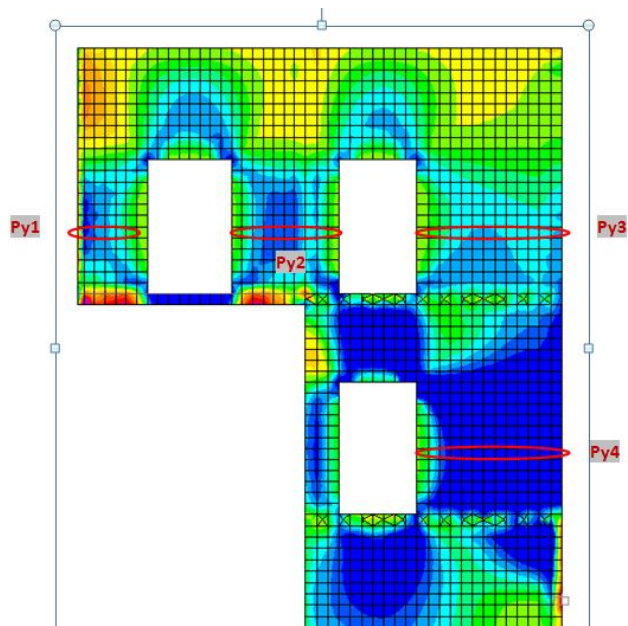
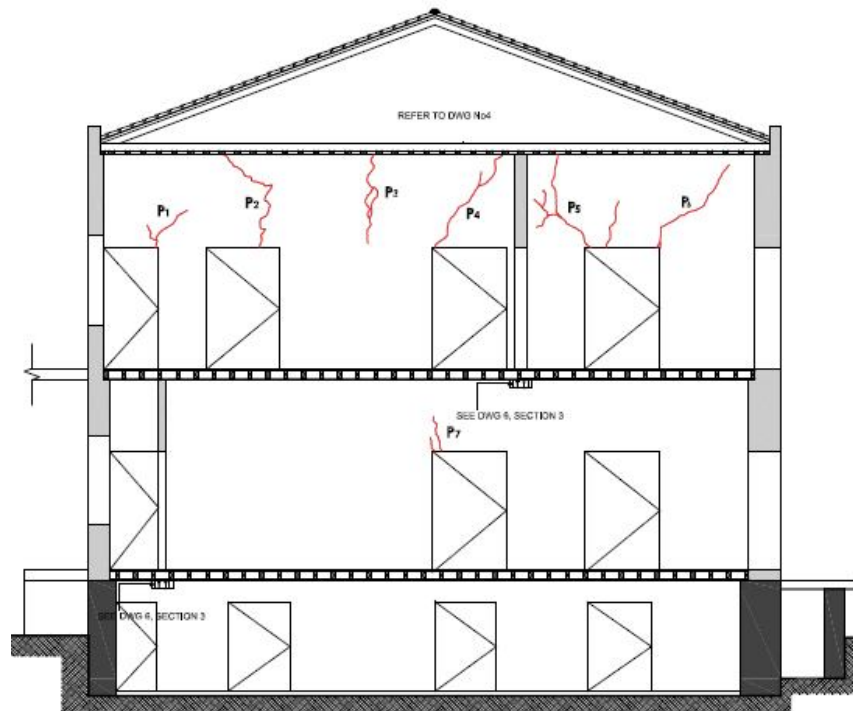
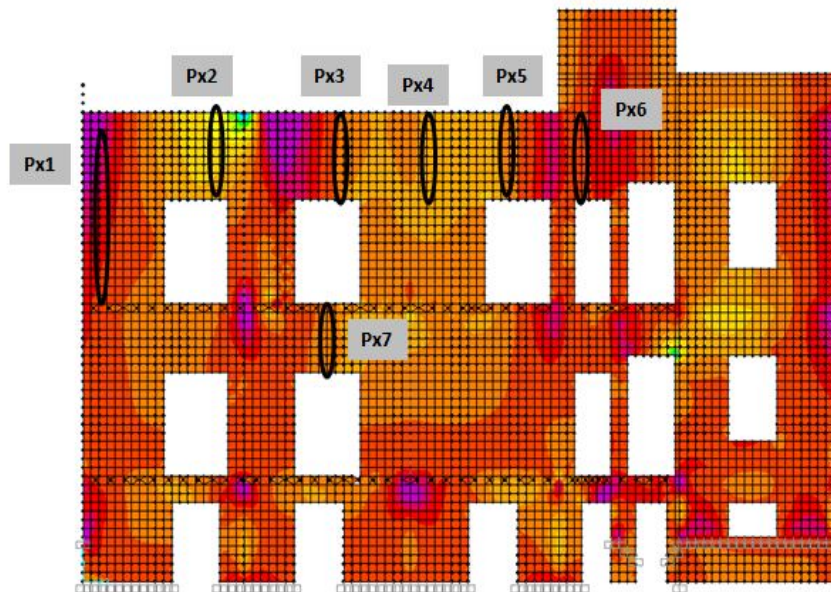
- The presence of vertical cracks at the junction point of wall O2-O3 with the perimeter wall of west elevation (Photo... and Section dwg.2b), and also at the meeting/ intersection point of wall O9-O10 with the perimeter wall of east elevation are both of special interest (Section dwg.5a). Particularly, on the second case, the crack width is about 5-6mm showing an insufficient connection with the perimeter wall interface.

- At present time, all apparent cracks in brickwork masonry walls are mainly at 1st floor level. The majority are oblique flexural and shear cracks located above openings and starting from the corner points of doors or windows towards the ceiling. It can be said that this kind of cracking is common on structures having fairly strong piers and weak lintels given the lack of horizontal ties above the openings. Hence, even under the influence of a mild seismic loading cracking will develop at the weaker areas above the openings.

The sections and images below represent the relation of the damages with the shear and out of plane bending moments respectively.
