Photographic Record

Former 12th Primary School

Vas.Georgiou 27 & Mpizaniou St.

M.Xofi - 2011

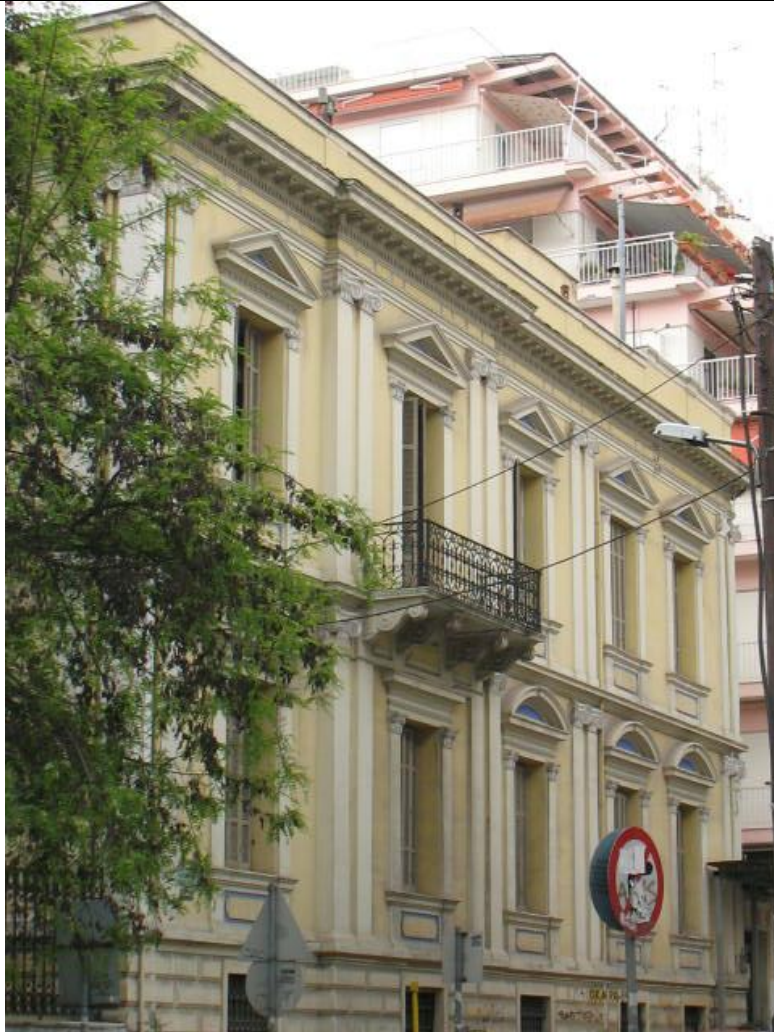
Ph.1- East elevation along Mpizaniou Street from S/E corner.

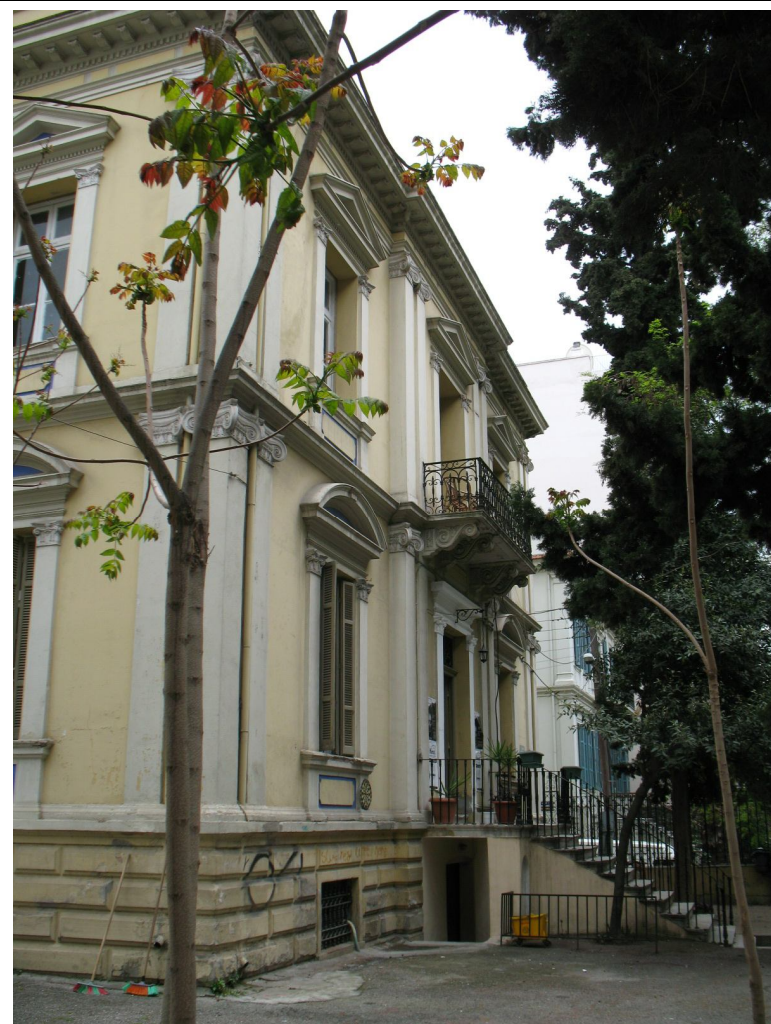
Ph.2 – S/W corner view showing the entrance to the basement below the main staircase entrance to the upper ground level.

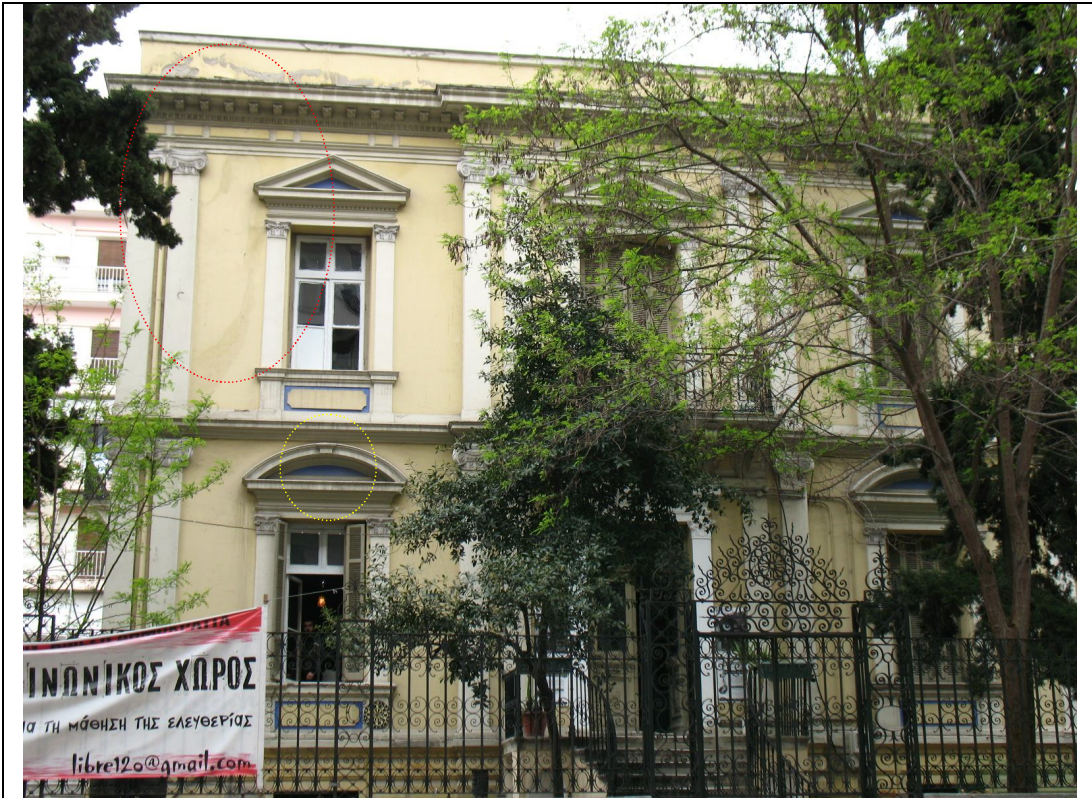
Description: Ph.3 – Main south view along Vasileos Georgiou Street.

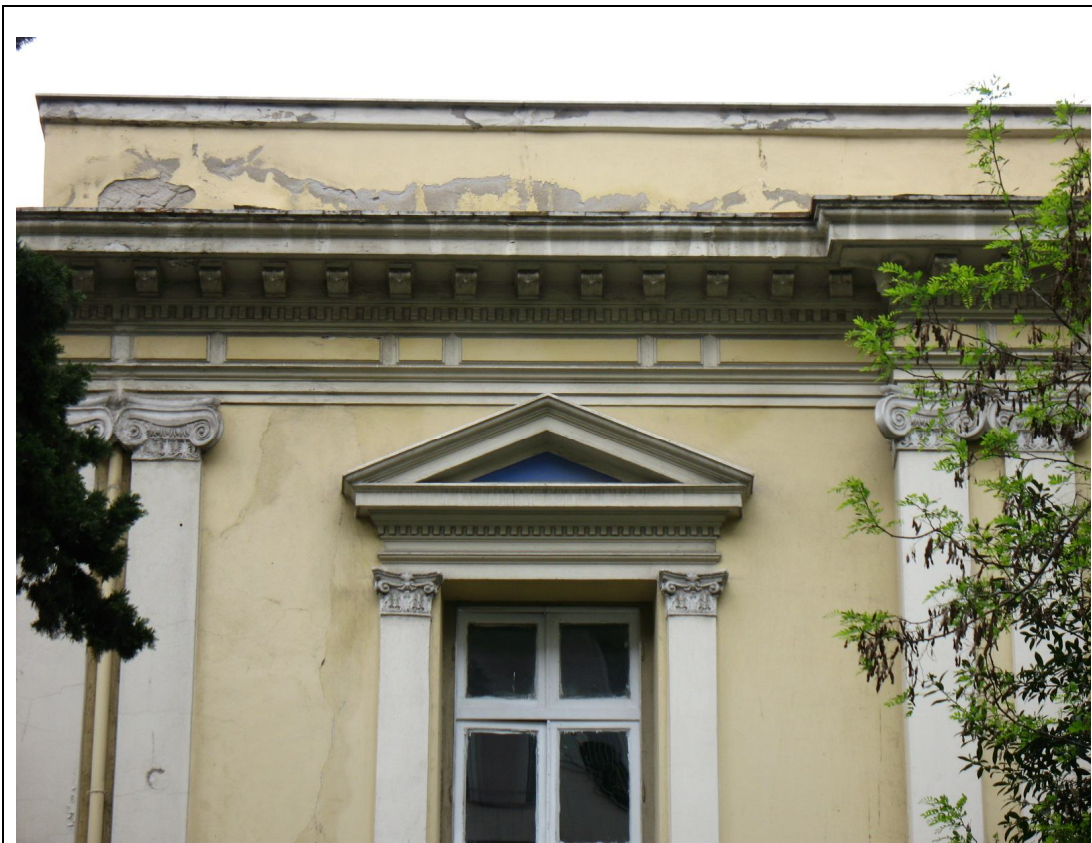
Description: Ph.4 – Detail of Photo 3 showing the disintegration of plaster along the parapet due to weathering conditions.

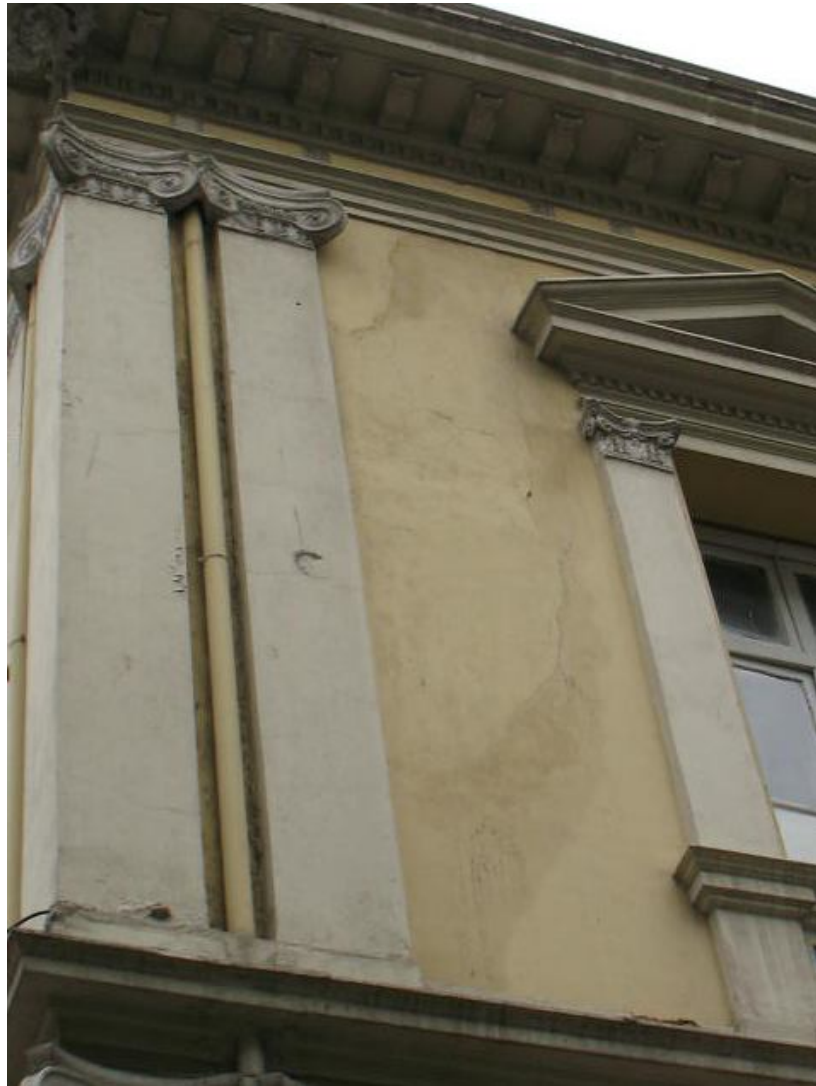
Ph.5 – Detail of Photo 4 showing fine vertical cracking and dampness along the wall height.

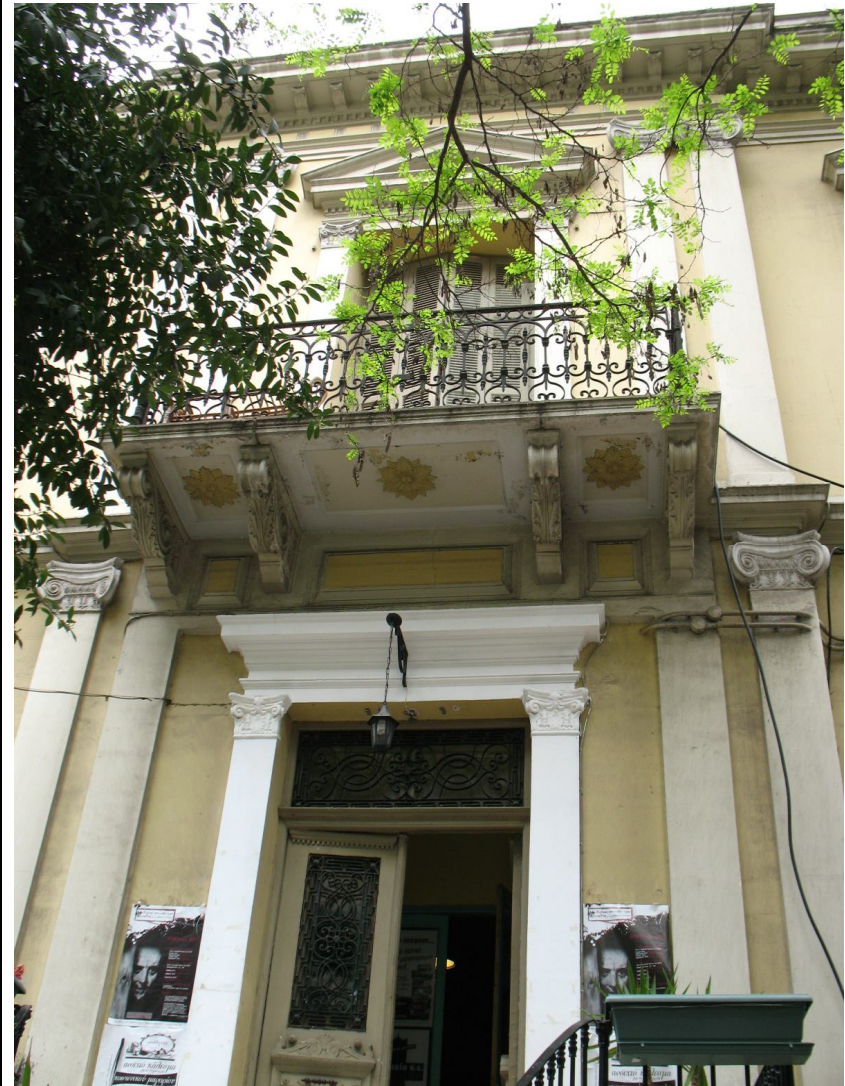
Ph.6- Main front entrance from south elevation of Vas. Georgiou St. The four cantilever supports of the balcony are shown together with the three marble slabs.

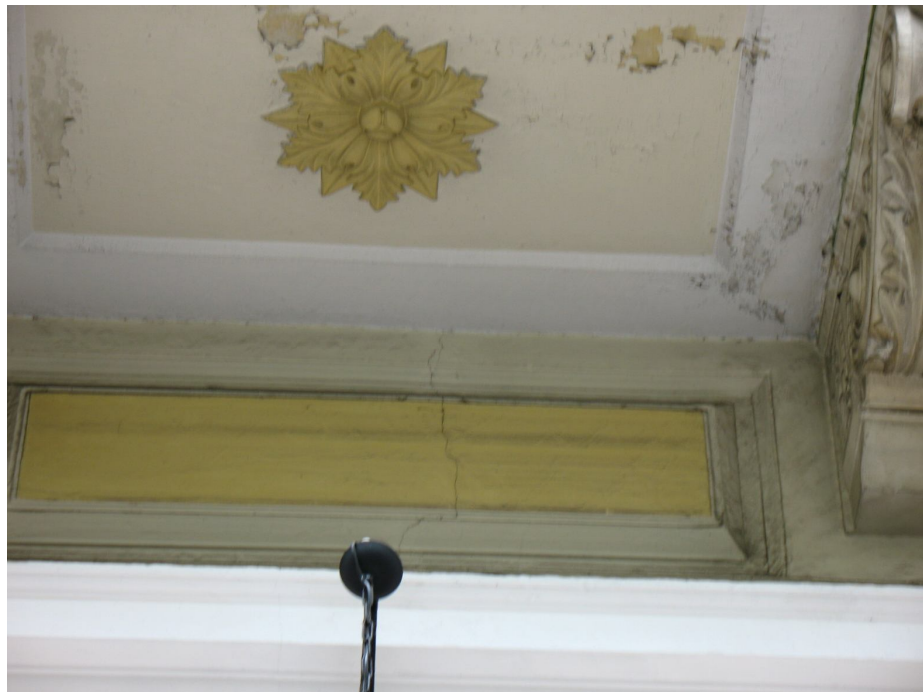
Description: Ph.7a- Detail of ph.7, showing the vertical crack below the balcony.

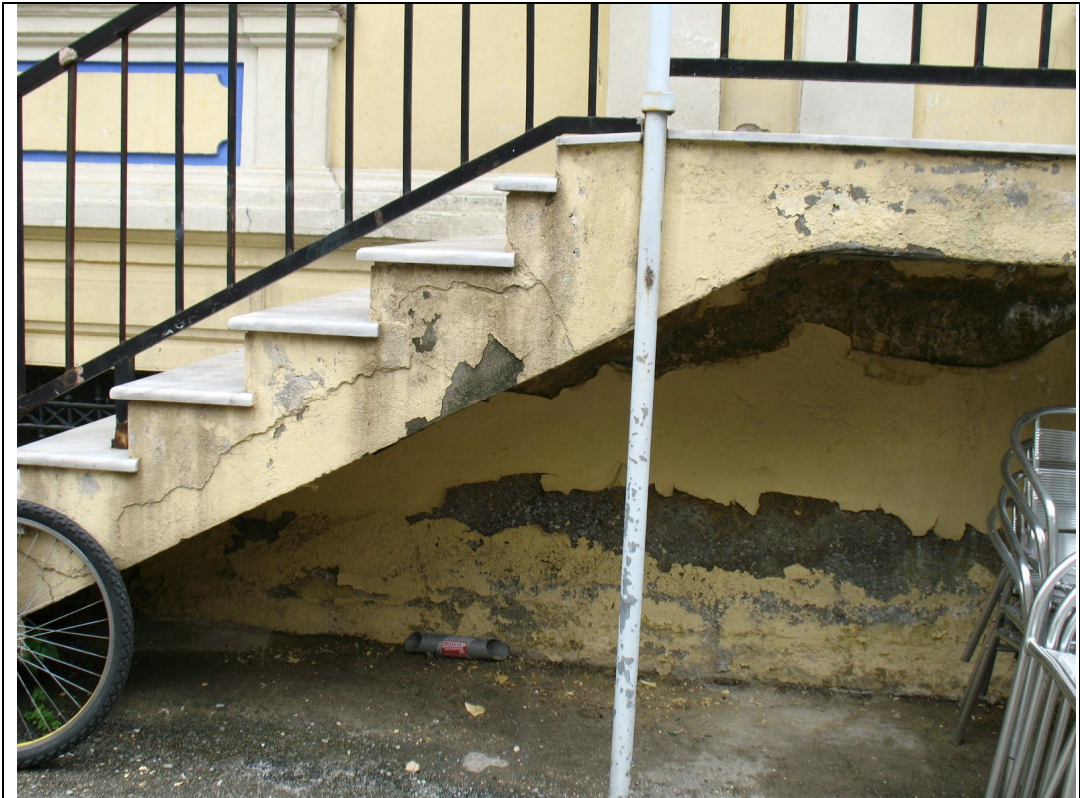
Ph.11- Detail of ph.10a showing the disintegration of plaster due to weathering.

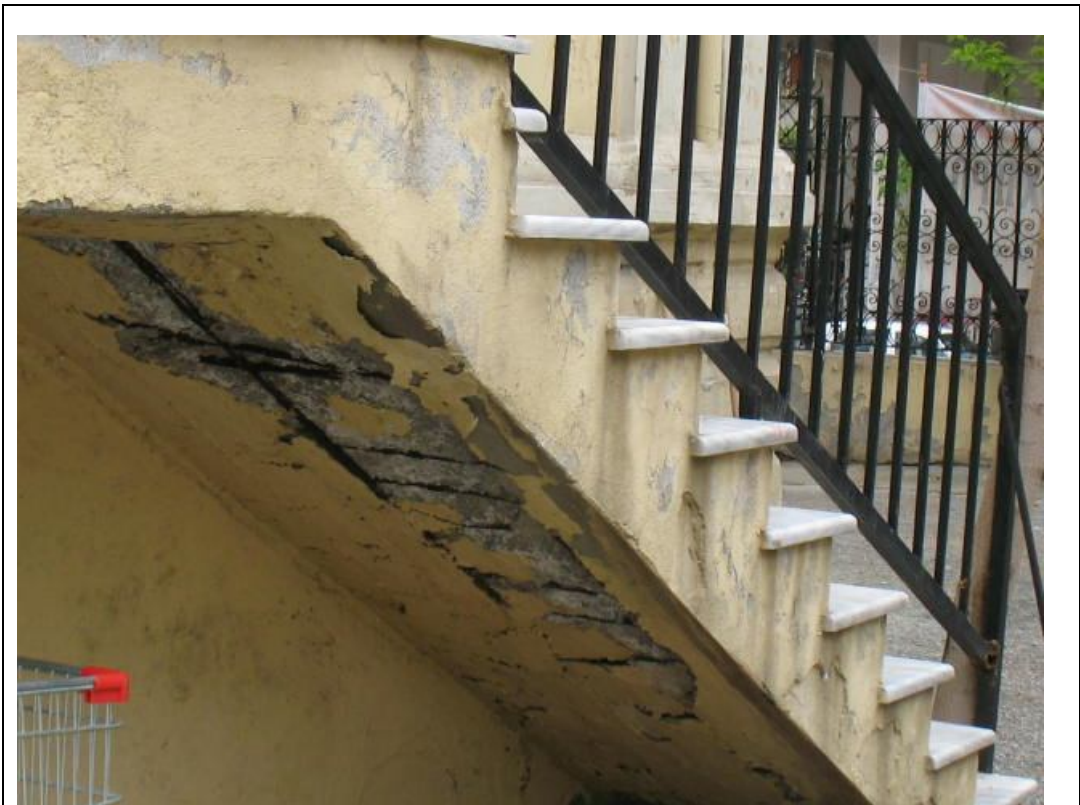
Ph.11a- Detail of ph.10b showing the disintegration of plaster due to weathering and the reveal of reinforcement of the concrete staircase.

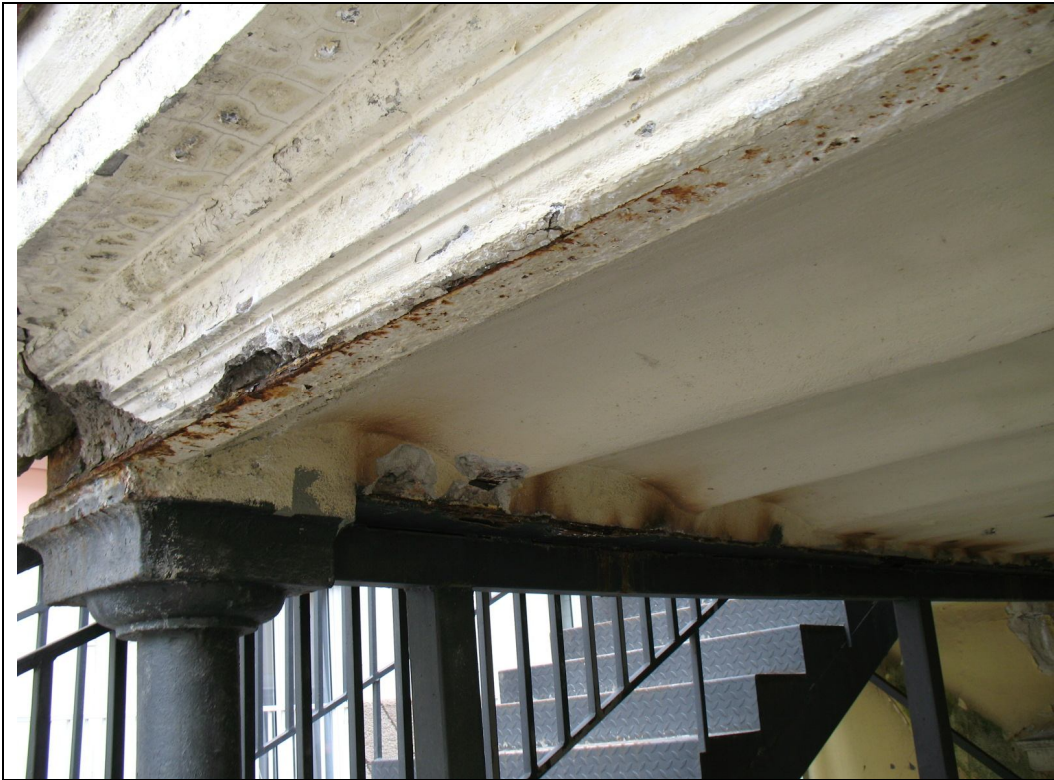
Ph.14- Detail of the support of the terrace with the original corroded edge steel beams I200 being supported on the Ø120 CHS post together with the recent SHS steel members supporting the existing frame.

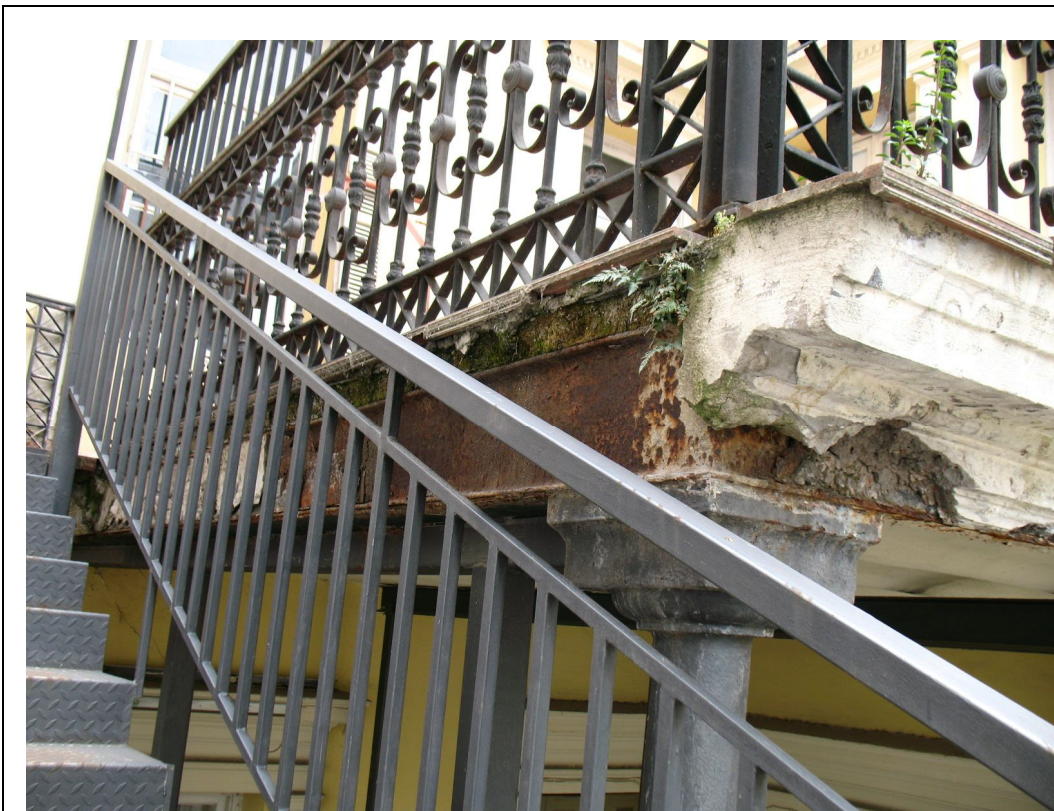
Ph.15- Detail of the terrace and the corrosion of the existing edge steel beams from the steel staircase.

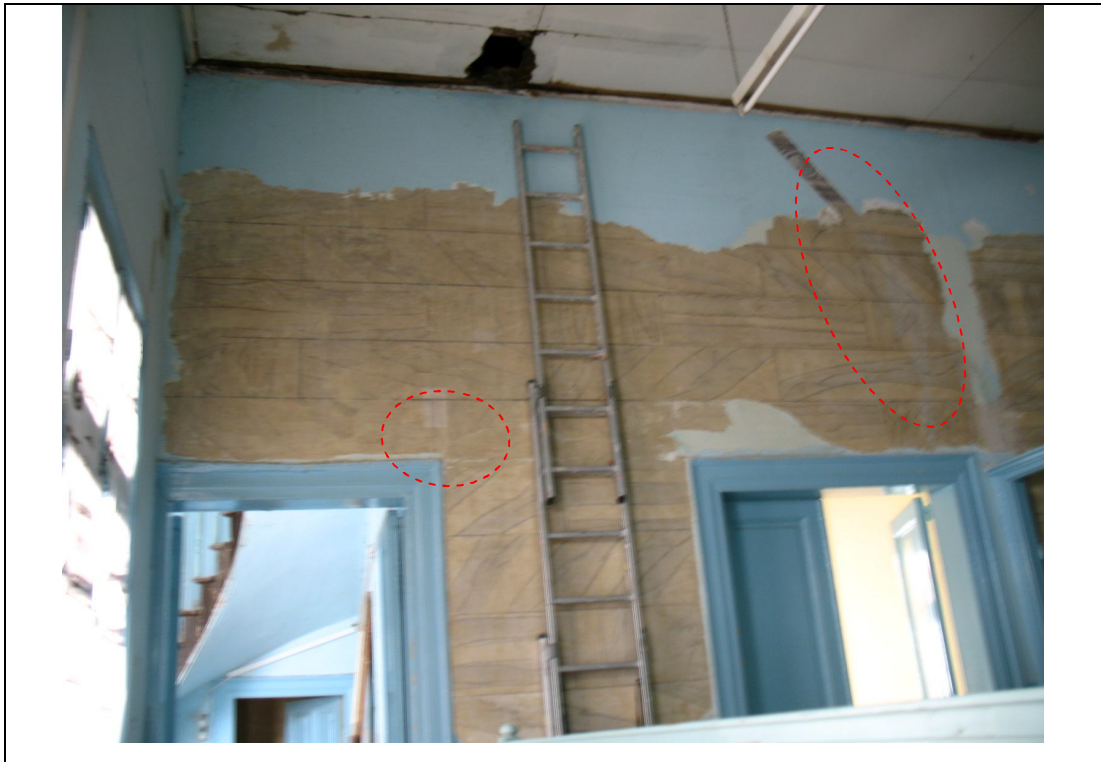
Description: Ph.23a- Front view of the wall of ph.23 (room O1) with cracks above openings.

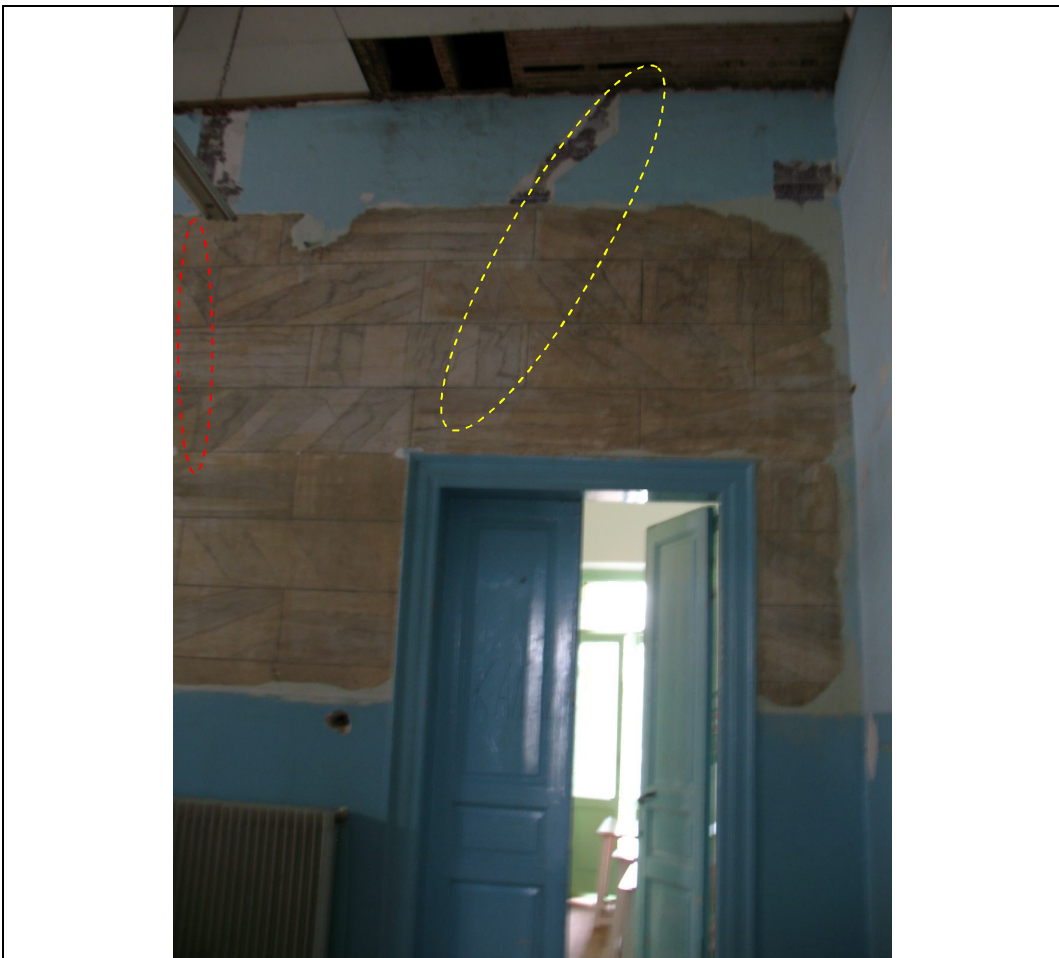
Description: Ph.23b- The right hand side of the wall from ph.23a showing the door entrance at room O6 and the cracks above door opening.

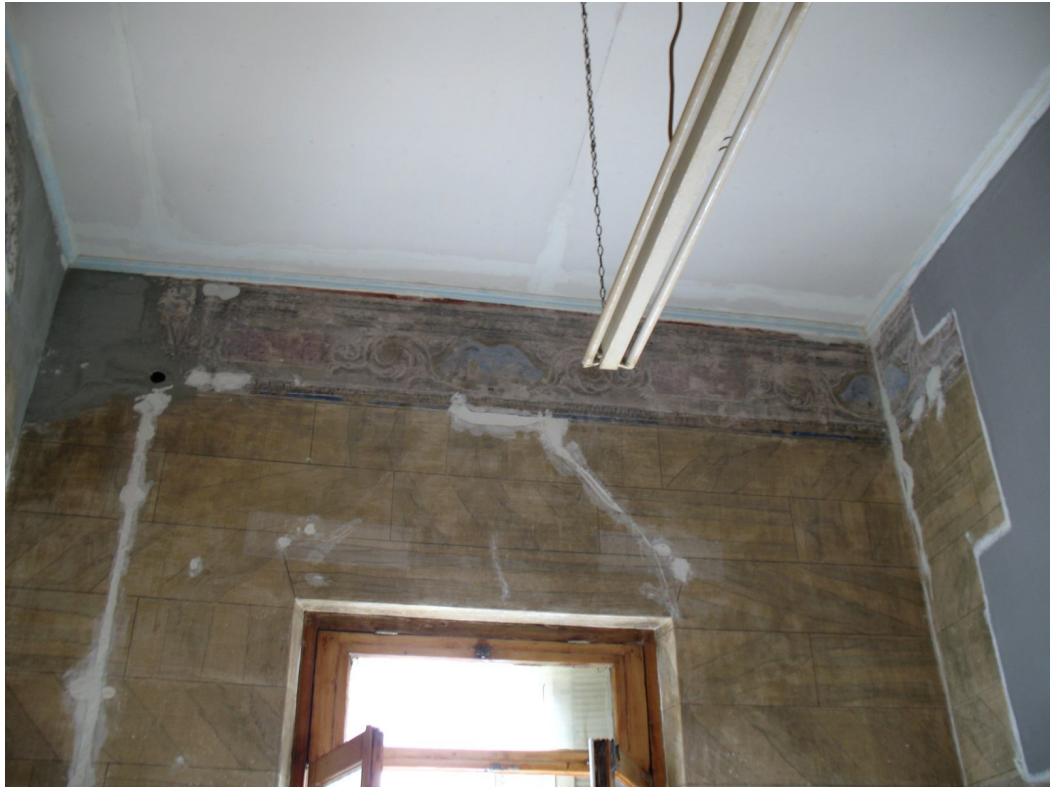
Ph.26 – View of the door exit to the balcony at south elevation from room O1α showing the crack above the opening and the reveal of the original wall decoration/ mosaic.

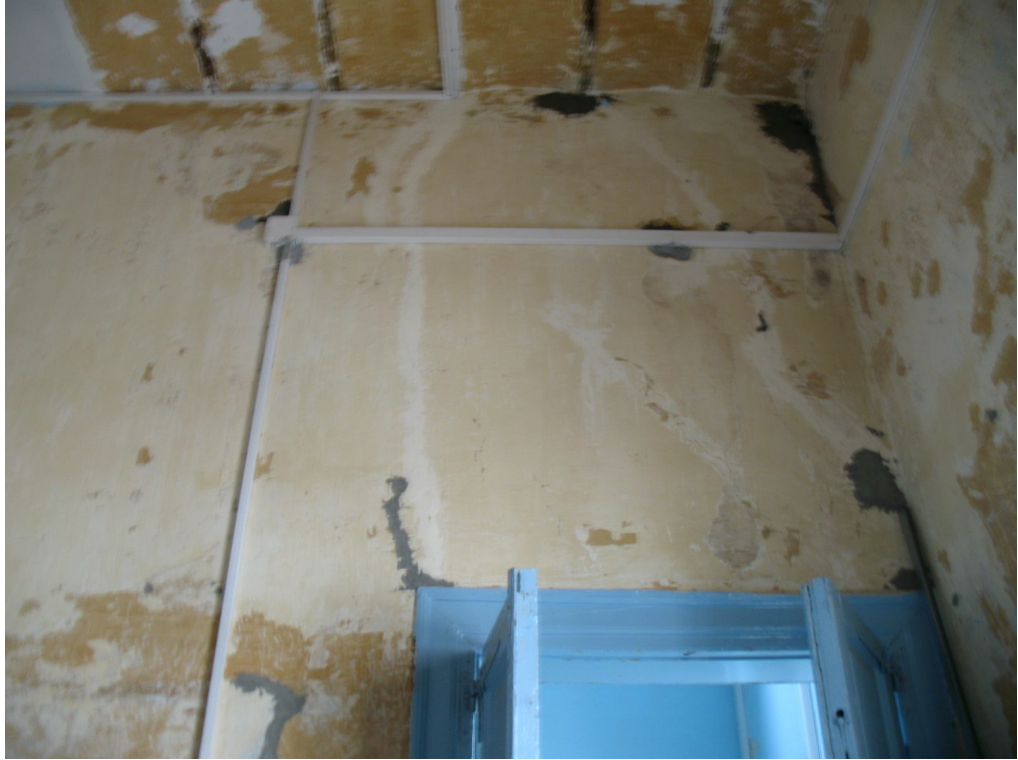
Ph.30– View of the wall section above the door of room O10 with oblique or vertical fine cracks.

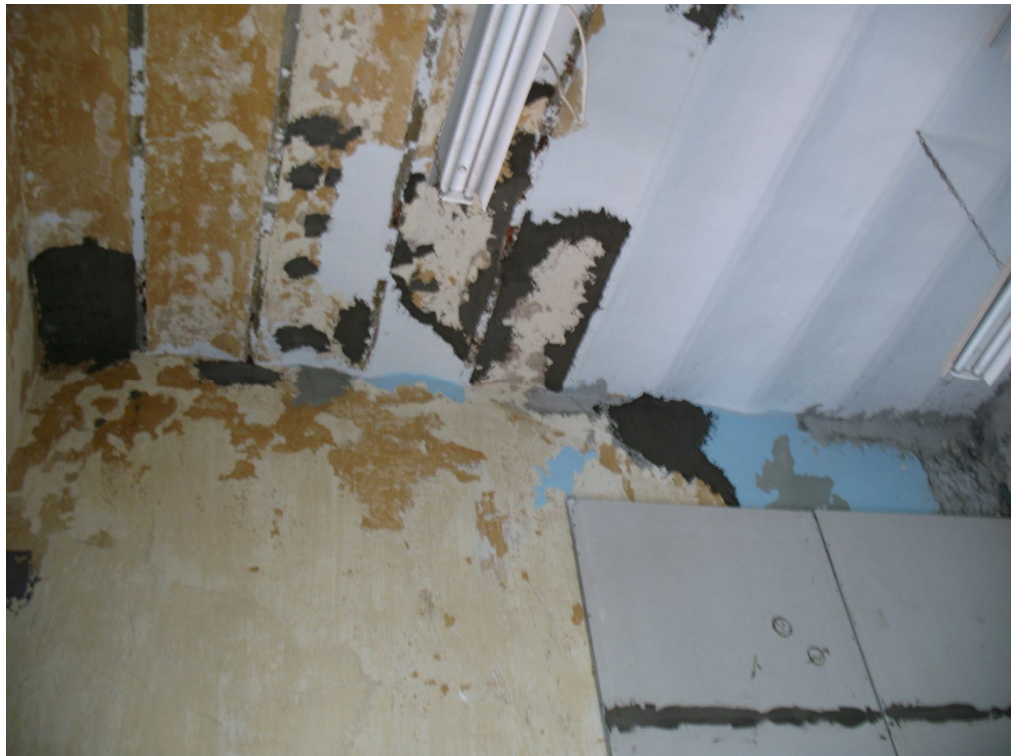
Ph.31– Disintegration of plaster due to weathering both at ceiling and walls.

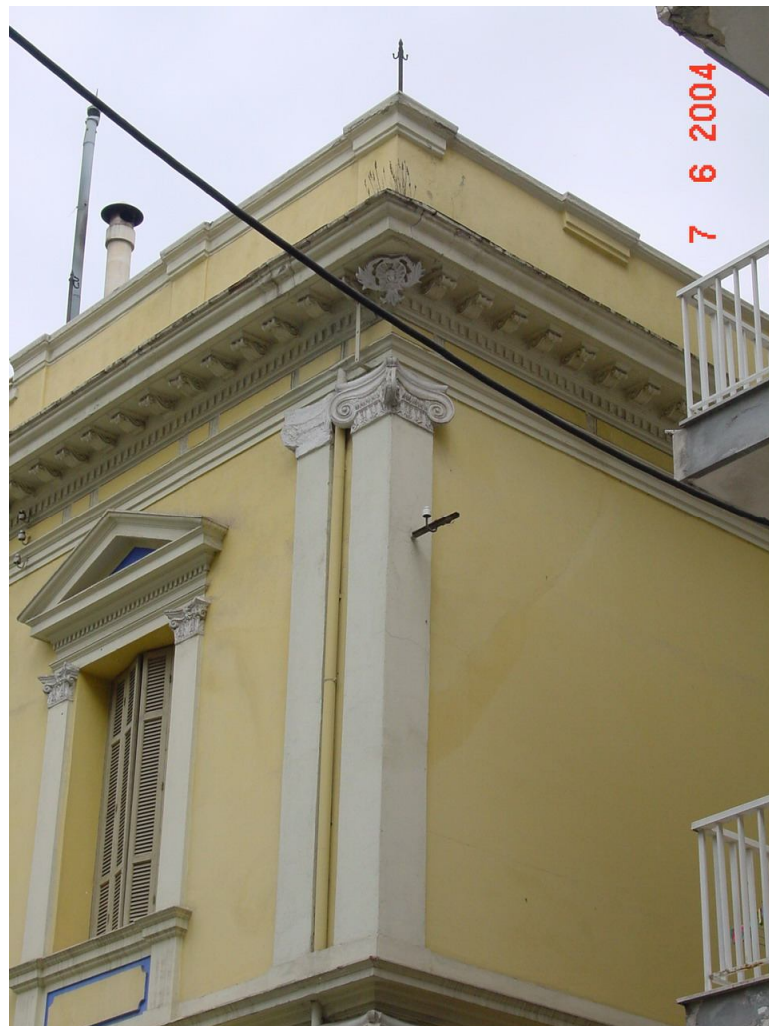
Ph.50 – External view of the NE corner of room O10. The oblique crack of the fireplace area is obvious.

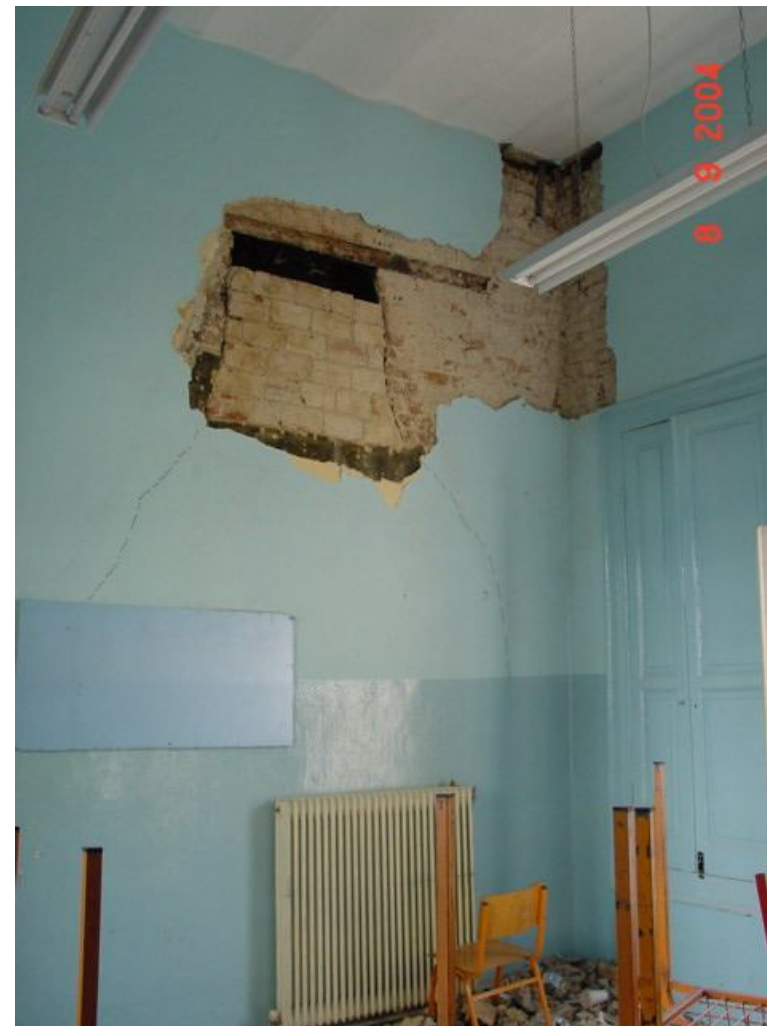
Ph.51 – View of the room O10 is showing the oblique cracks due to the later stage infill section of the old kitchen fireplace with the steel beam I140 acting as a lintel at the top.

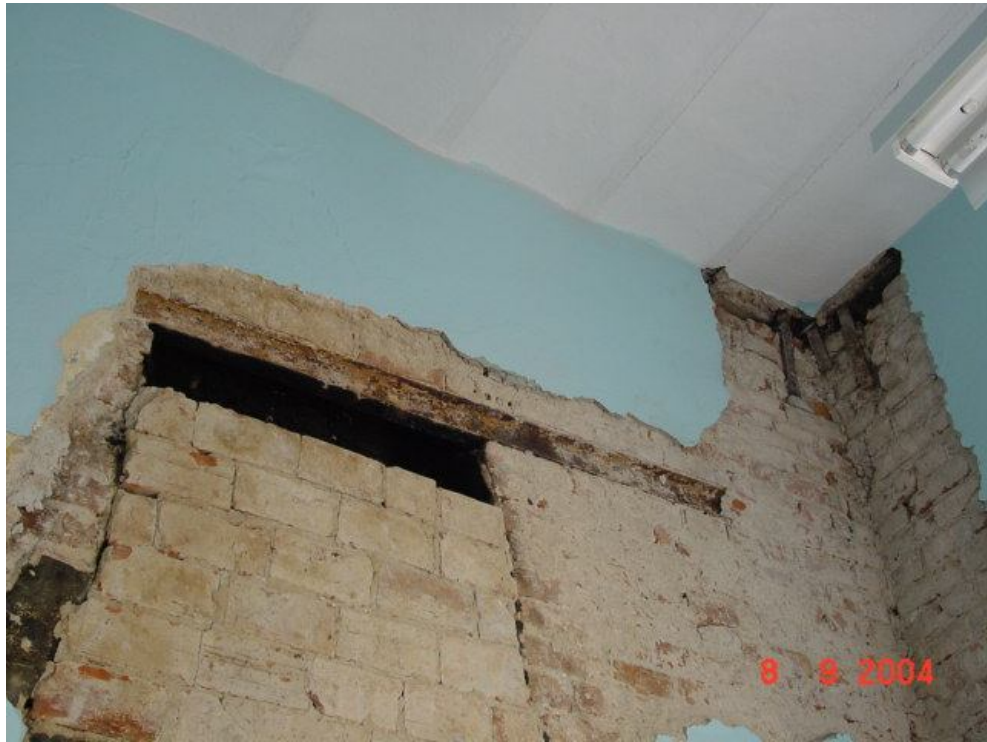
Ph.52- Detail of ph.51 showing the discontinuous built of the fireplace infill by bricks.

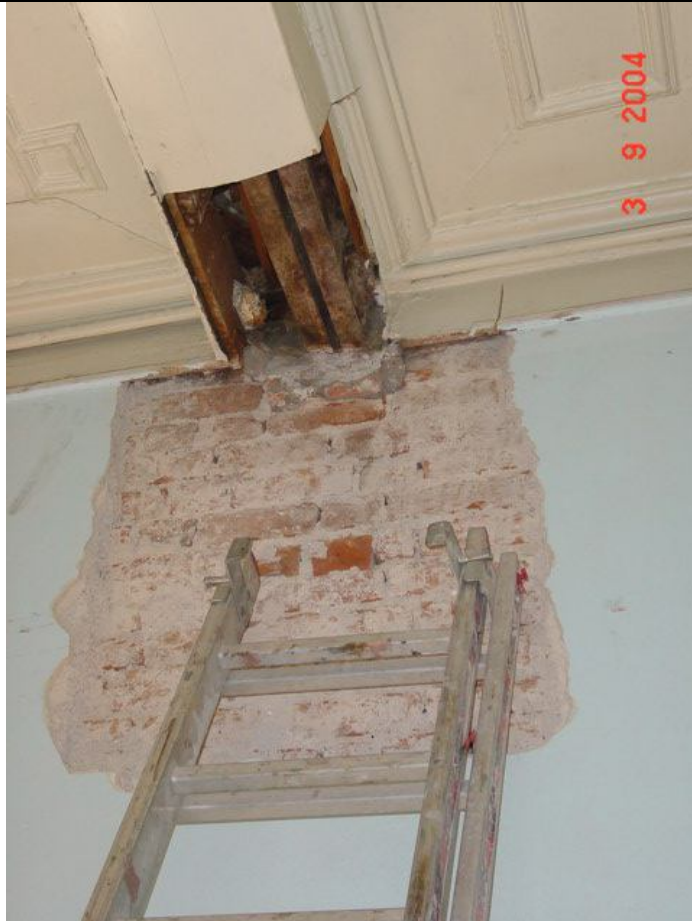
Description: Ph.66- Detail of Ph.65 showing the surface corrosion of the double steel beams I140 that support the timber beam above which then act as a line of support for the timber floor beams at room O6-O7.

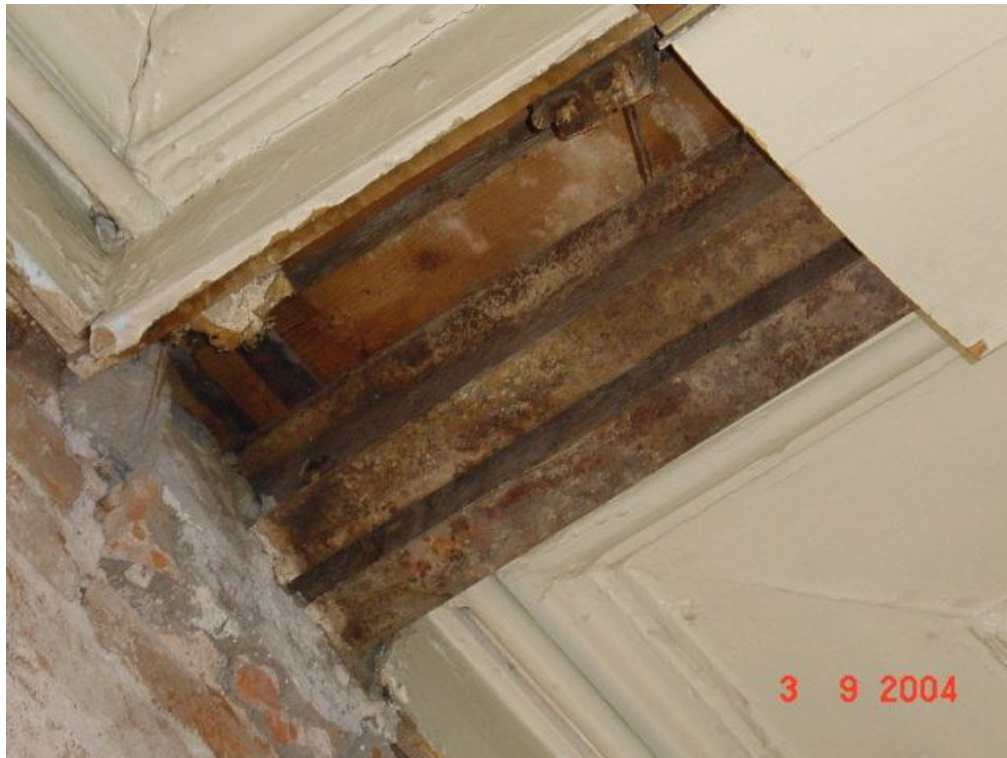
Description: Ph.67- Better detail of photo 66.
