NATIONAL TECHNICAL UNIVERSITY OF ATHENS

## **DIPLOMA THESIS**

Analysis of Non Accidental Structural Failures and  
Machinery Failures on Large Tankers  
(studied period 1990-2011, independently of year of built)

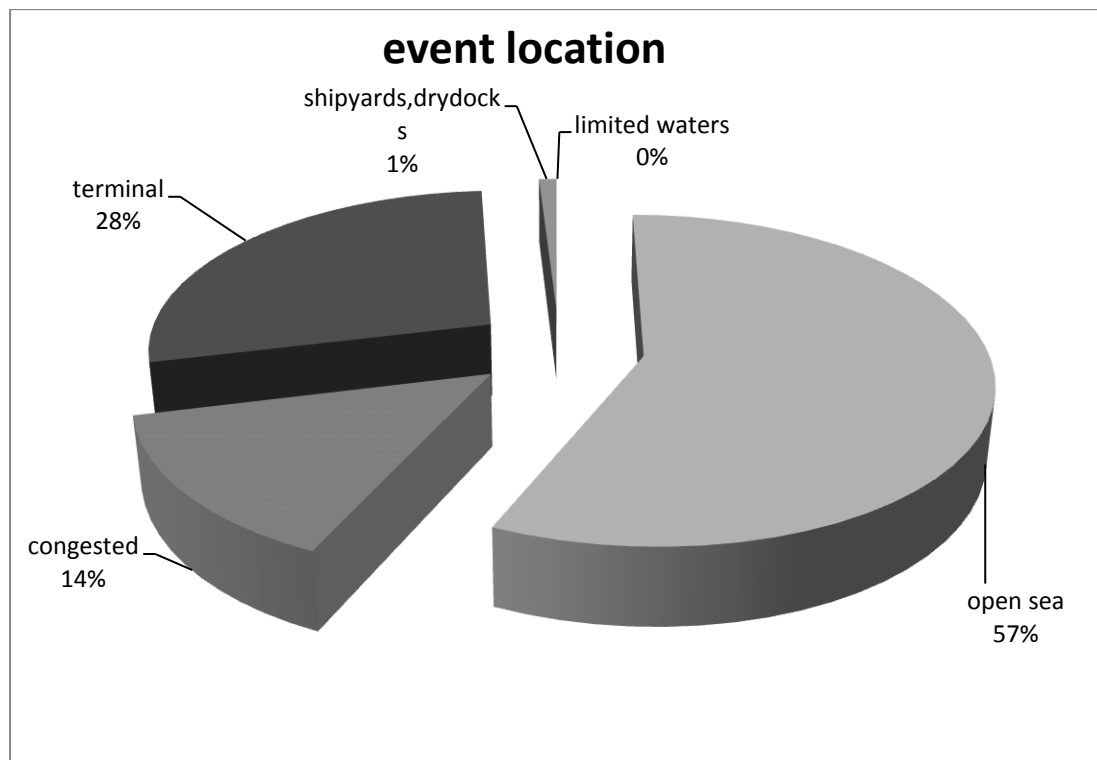
**Figure 4.5.** Event location. Unknown cases excluded.

A great percentage of NASF took place in terminal waters, where the ships in theory operate at a low speed and are mostly protected by extreme weather conditions. This can be attributed mainly to loading mistakes (ship overloaded or false loaded).

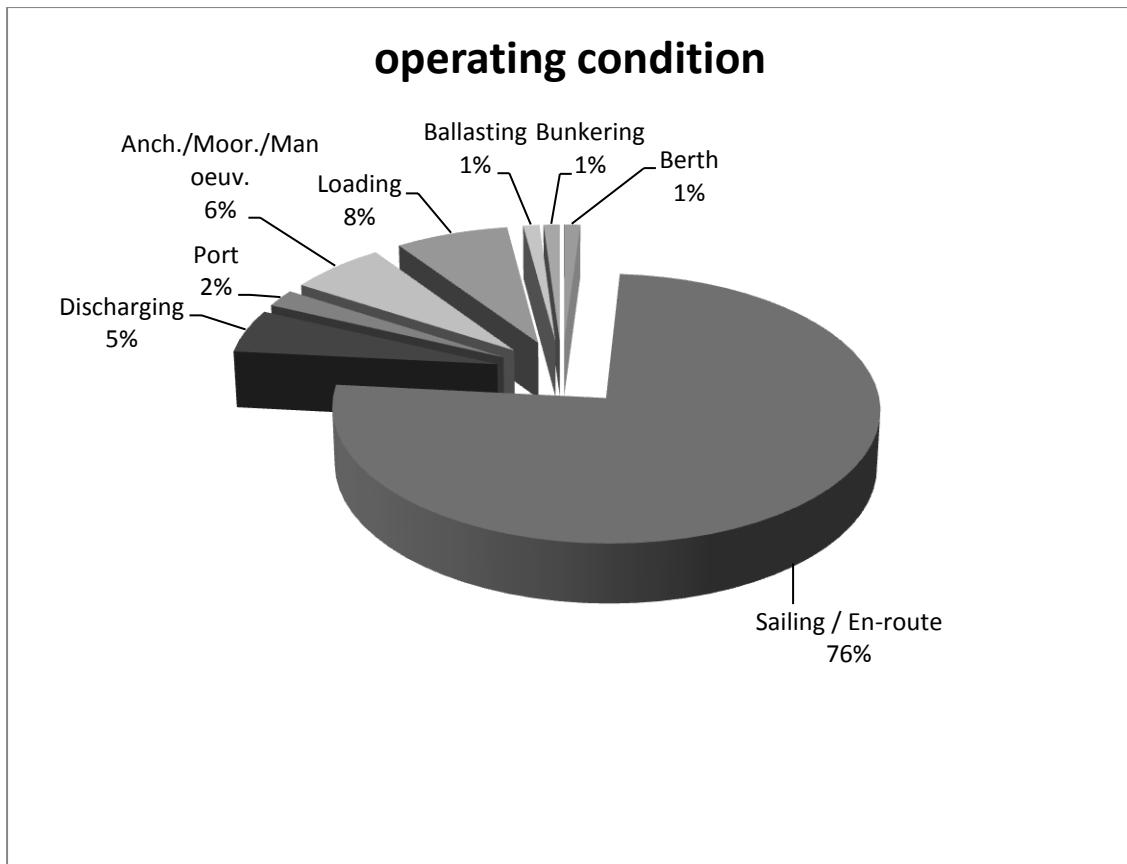
**Figure 4.6.** Operating condition. Unknown cases excluded.

With respect to operating condition, 36% of the cases are unknown. Apart from operating condition “sailing/en route”, which is greatly represented in this category, the other ones, that stand apart, are operating conditions “loading” and “discharging”. That seems reasonable, as loading mistakes could occur during loading/unloading processes. Possible loading mistakes during those procedures could lead to overstressing of the hull.

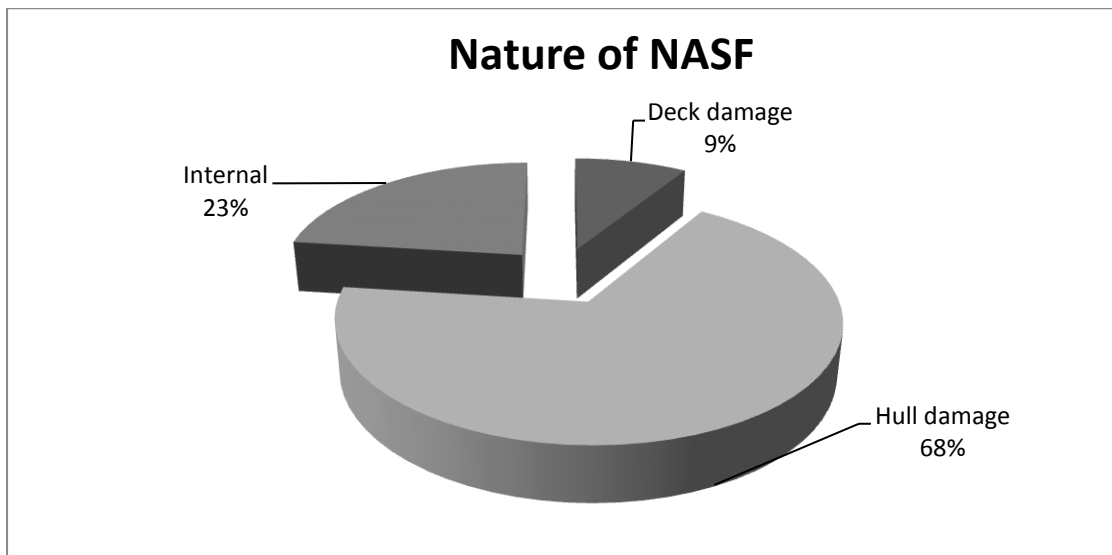
**Figure 4.14.** Nature of NASF. Ship's part damaged. Unknown cases excluded.

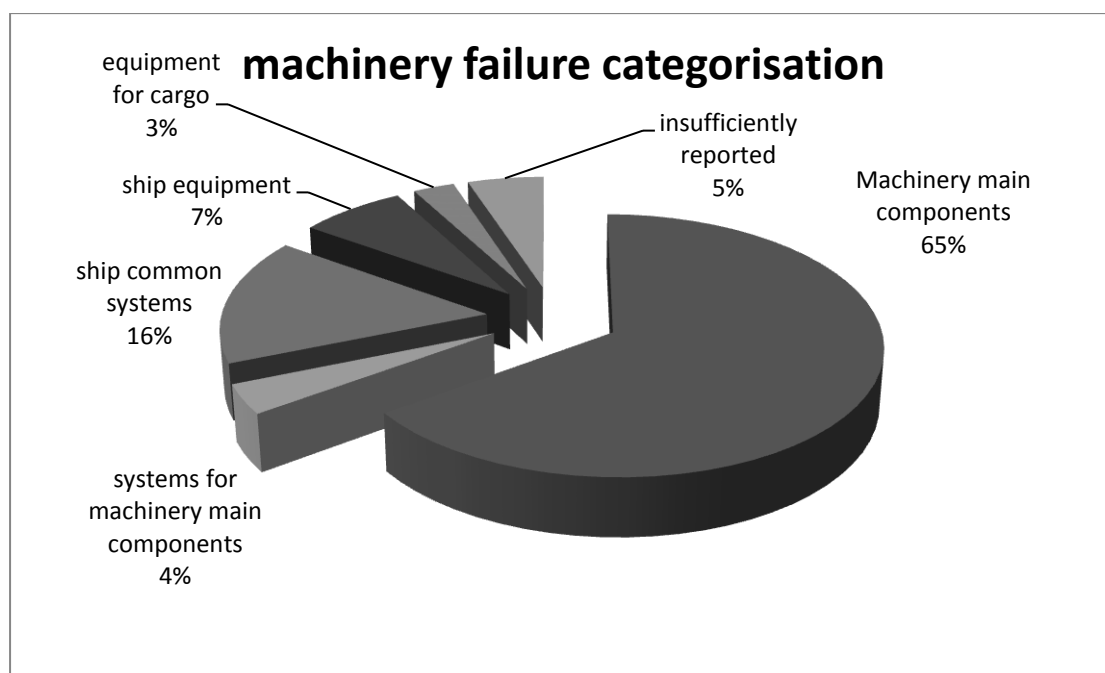
**Figure 5.16.** Main machinery failure categories. Distribution by machinery system, that failed.
