National Technical University of Athens (NTUA)
Faculty of civil engineering

**DAMAGE ASSESSEMENT AND REHABILITATION OF
HISTORIC TRADITIONAL STRUCTURES**

Doctoral thesis

Athens 2015

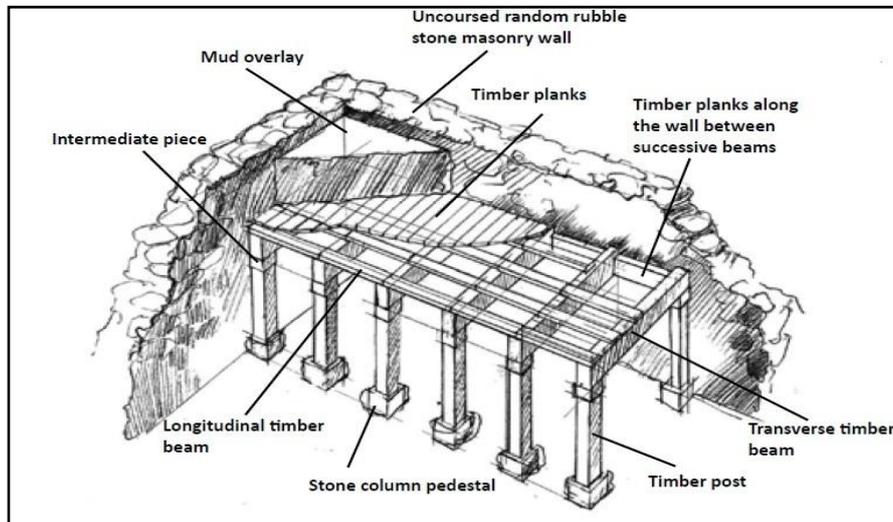
Figure 1.4: typical stone masonry building with exterior stone masonry walls and an interior timber frame (Bothara and Brzev 2011).

renovations over the course of their lives. Typically, stone masonry houses are built by owners themselves or by local builders without any formal training. The quality of construction in urban areas is generally superior to that found in rural areas. In some cases, a dual gravity load-bearing system is used (see Fig. 1.4).

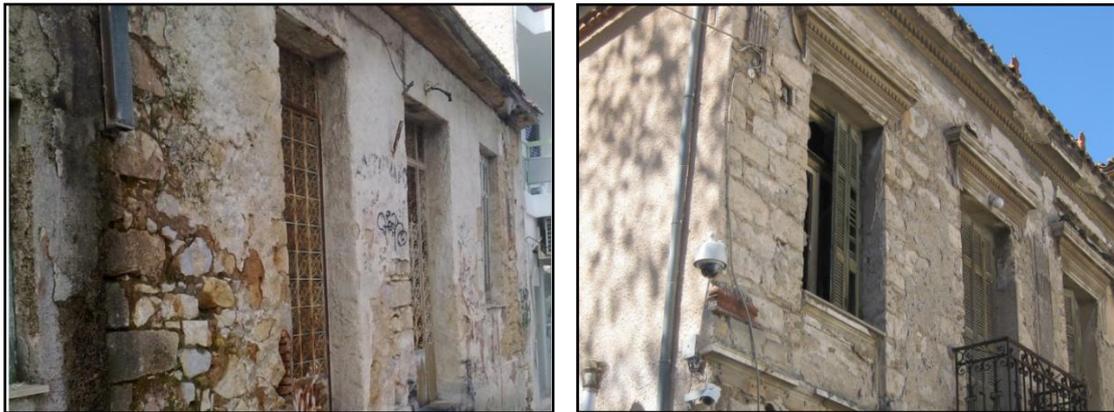
Figure 1.14 Poor and good connections in wall corners

The quality of the materials and their arrangement in the corners is even more important for buildings with multi-leaf walls, considering that for these cases the quality of the masonry is lower in some cases due to the smaller dimensions and poor mechanical properties of the stone units. In some cases we find mixed use of limestone and marble in the walls' intersections and this is one of construction defects in some buildings, as shown in Fig. 1.14, leading to failure in some cases.

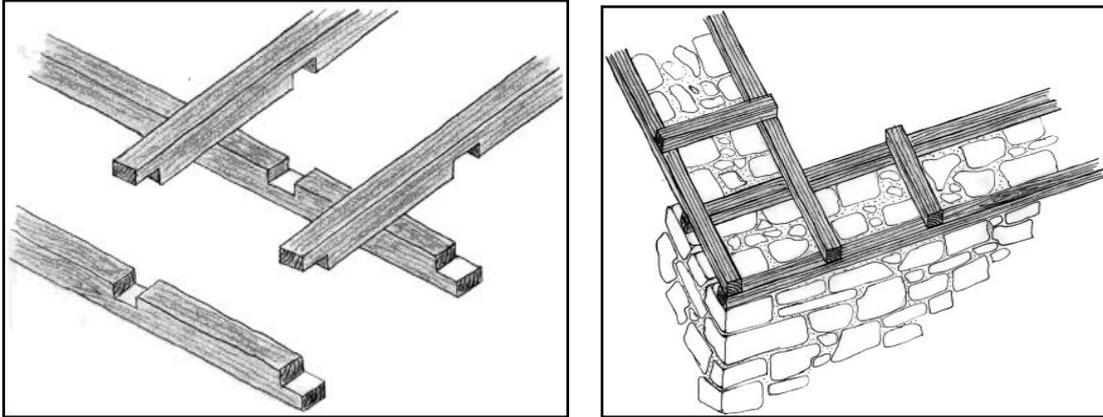
Figure 1.16 Timber ties technique between floors and at floor levels in some buildings (Vintzileou 2011)

At intermediate levels, the connection among longitudinal timber pieces is ensured by means of diagonally placed stiffening elements. At floor levels, timber ties (located within the thickness of masonry) are connected to the timber beams of the floors. Timber pavements fixed onto the floor beams ensure a diaphragm action of the floors, thus forcing the walls to deform jointly in case of an earthquake. The concern of the constructors about the seismic behavior of the tower is also demonstrated by the fact that floor beams are positioned along the x- or along the y-direction every other floor. In this manner, a uniform behavior of the construction is sought, independently of the predominant direction of the seismic motion.

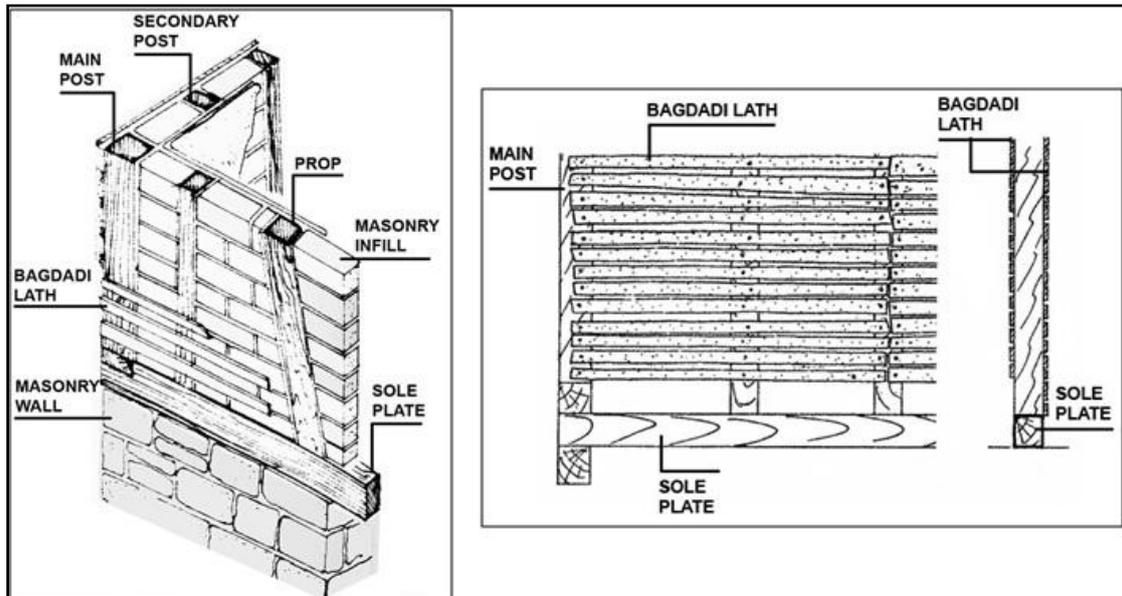
Figure 1.18 Masonry infill timber-framed system and Baġdadi lath system

Also, timber framed construction with a brick filling material were used between the 15th and the 18th century. Buildings were constructed using this system, but, after the 18th century, there was a decrease in the quality of work and walls with brick filling began to be plastered over as shown in Fig. 1.18. The filling of timber skeletons with masonry material continued to the end of 18th Century.

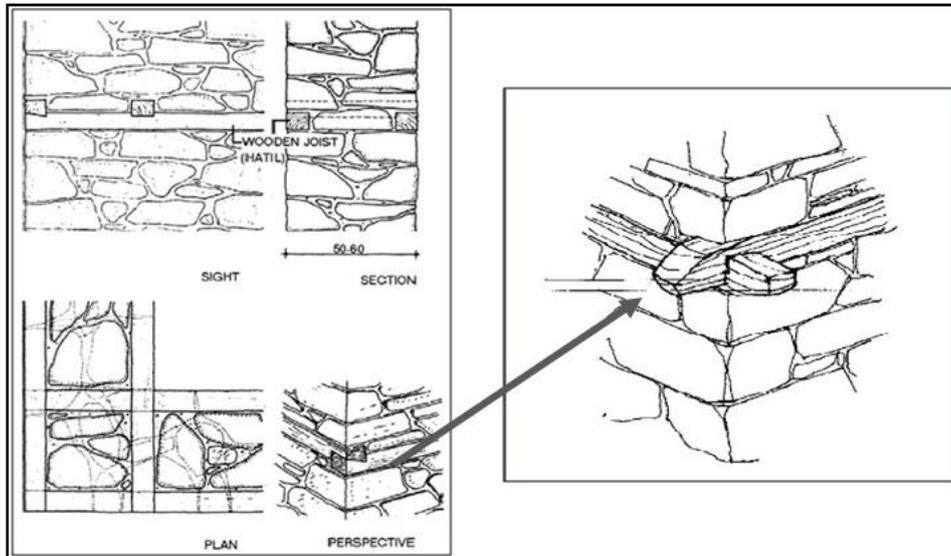
Figure 1.19 Rubble Stone walls with wooden joists

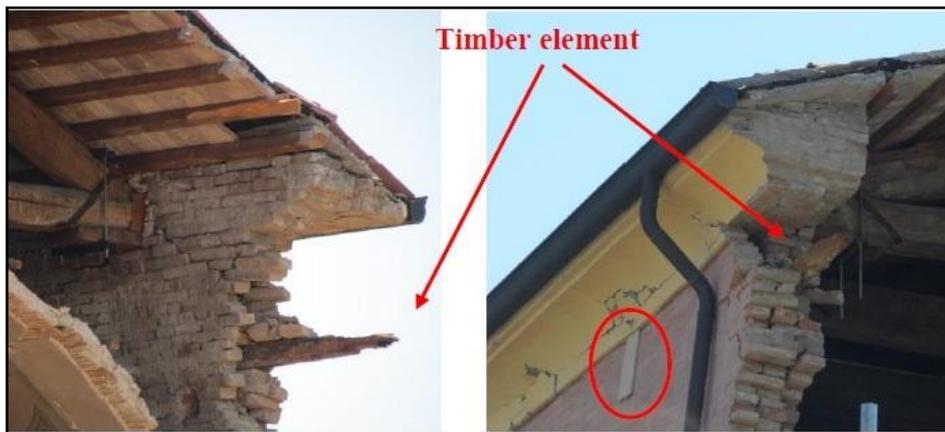
Figure 1.21 Timber elements inside the brick walls

In some cases of brick structures (in churches) with the triple header masonry bonding timber element was found inside the triple header masonry lateral walls in the anchorage region of the tie rods with the purpose of enhancing their efficiency as shown in [Figs. 1.120-1.22](#)

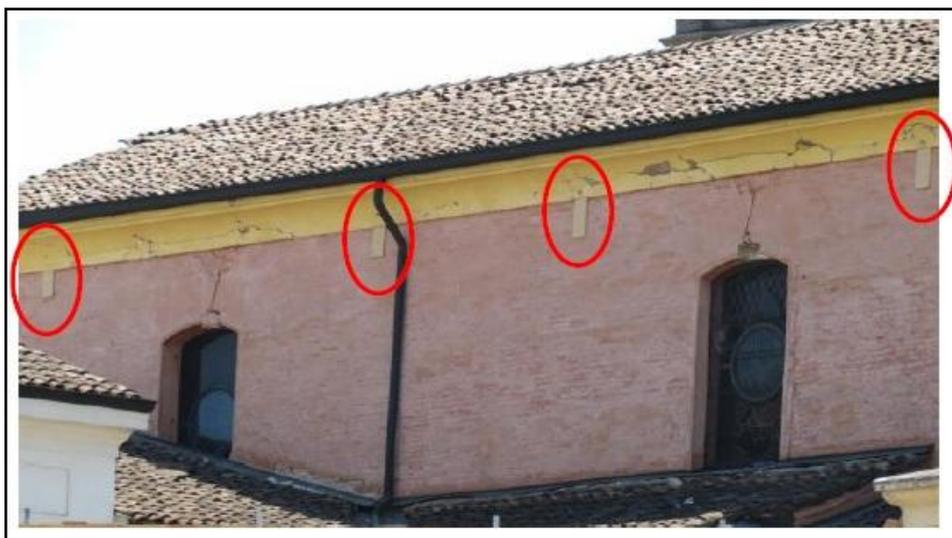
Figure 1.22 exterior views showing the tie timber element rods

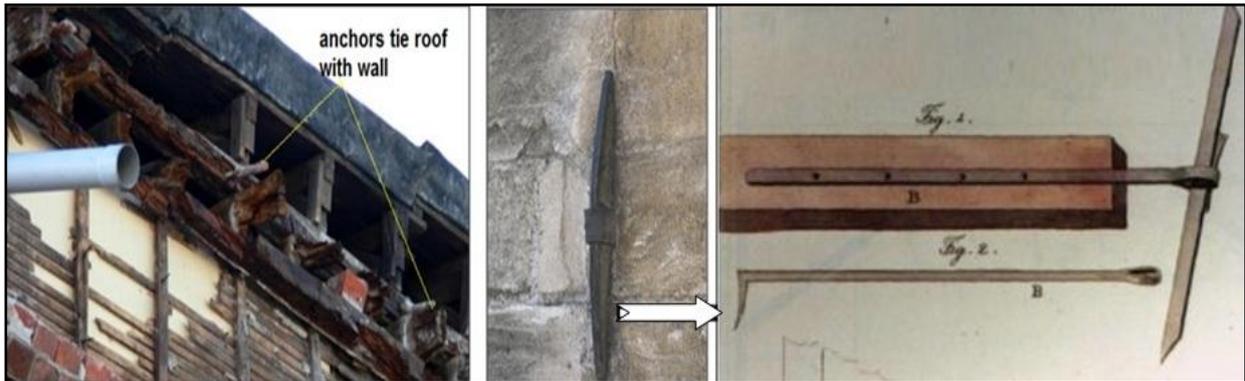
Figure 1.24 Steel anchors tie roof with wall

In historic traditional masonry, steel was used to connect floors with walls in order to achieve good structural performance under seismic excitation. The builders, in this period used a steel T bar or anchor bars in order to connect the floor with walls (see Figs. 1.24 and 1.25). This connection technique was used in different types of historic buildings, such as mosques, churches, houses, etc.

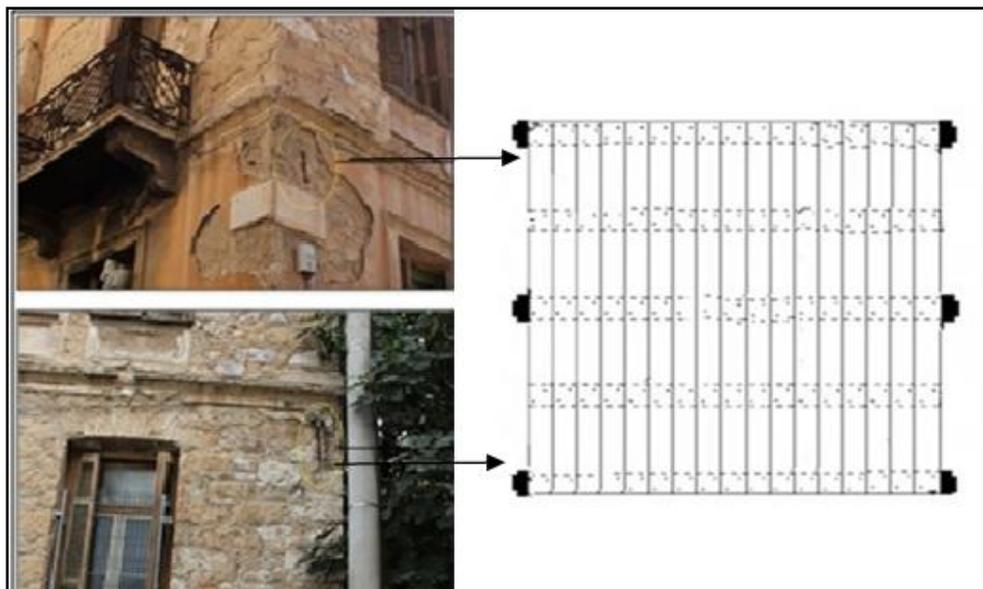
Figure1.27 Three steel ties positioning, plan

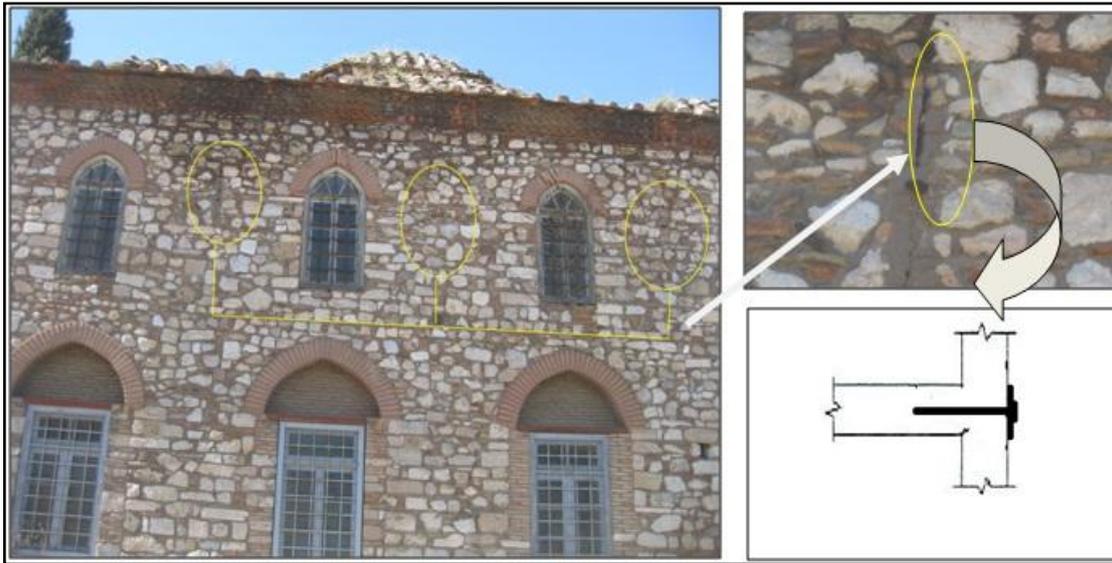
Figure 1.28 Positioning of three steel ties in historic traditional building (Alfatihia Mosque)

On the one hand, in buildings where large numbers of people meet, such as religious buildings (mosques, churches, and governmental buildings), the builder has been found to use more than two or three steel bar ties or steel anchor bars on all sides of the building, as shown in Fig.1.27 and Fig. 1.28. On the other hand, in pottery art mosque, anchor steel bars were used for connecting the column capital which supported arches in order to sustain the thrust of arches as shown in Figs.1.29 and 1.30.

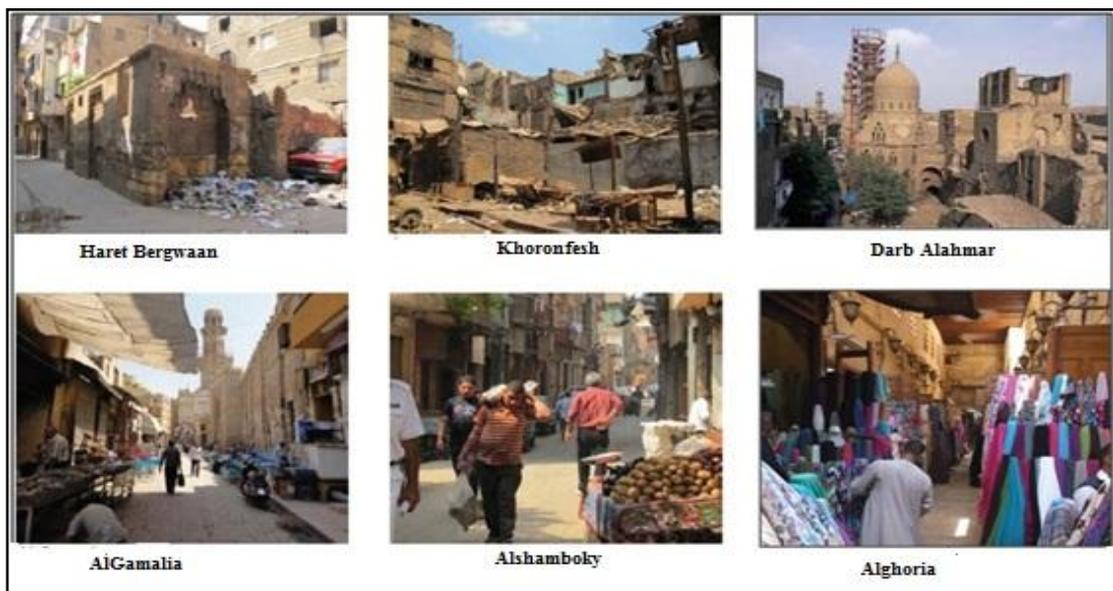
Figure 1.35 Deterioration phenomena of historic Traditional masonry building in Cairo (UNESCO 2012)

- continued deterioration of monuments and historic structures especially houses due to the misuse of inhabitants in these historic traditional houses
- the consequence of 1992 earthquake and a lack of public investment and regular upkeep of city infrastructures
- the absence of essential community facilities and services (Siravo 2002)
- The hard attack of environmental factors (groundwater, humidity, etc.)

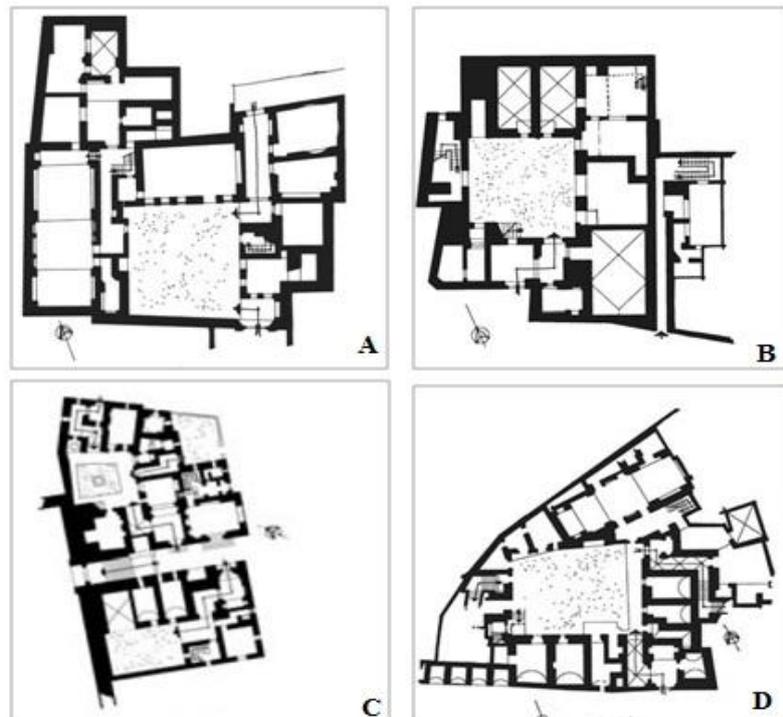
Figure 1.40 plan of the courtyard typologies in historic traditional houses in Cairo where
 A- Gamal Eddin Al Zahabi, Ottoman period,
 B-Zeinab Khatoun, Mamluk period,
 C-Alkiritlia house Mamluk period
 D-AlHarrawi house Mamluk period

Courtyards in traditional houses in Cairo were typically three types (see Fig. 1.40). This prototype evolved from the original traditional Islamic house to the 19th century model, and was later influenced by the Turkish and European styles (see Fig. 1.40B). This type continued to exist until the transformation of the late 19th / early 20th century, when it became obsolete and was replaced by the new Western prototypes. Houses with side courtyard may be observed to be the same as those of central courtyard (see Figs 1.40A & 1.40D).

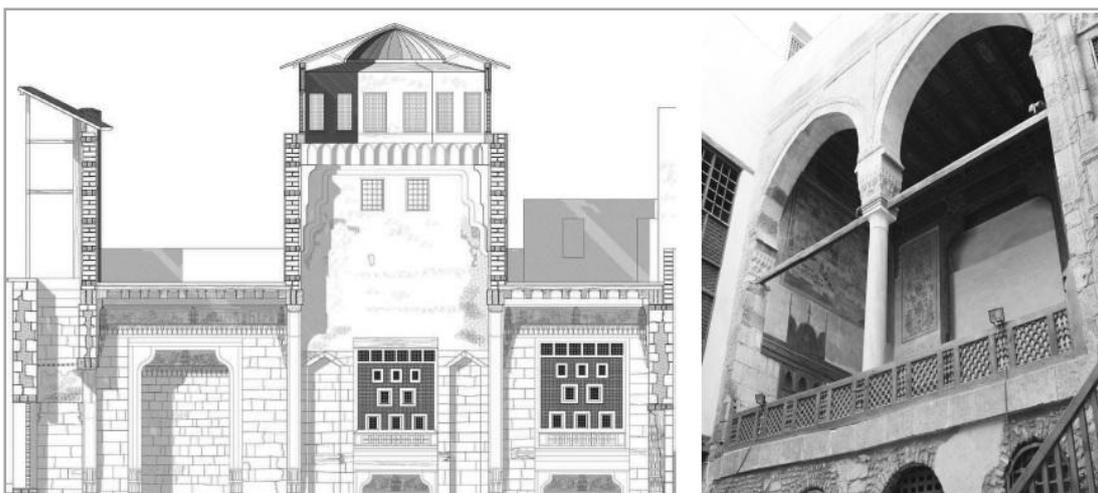
Figure 1.42: Drawing sections of Qa'a and of Malqaf (left) and Maq'ad (right); (Ficarelli 2008)

On the top stands a lantern, in the purpose of the ventilation and the lighting of qa'a. Often, in the centre of the durqa'a, there is a fountain that has an aesthetic role and above all it contributes to cool the air of the room mixing air and water to increase the humidity.

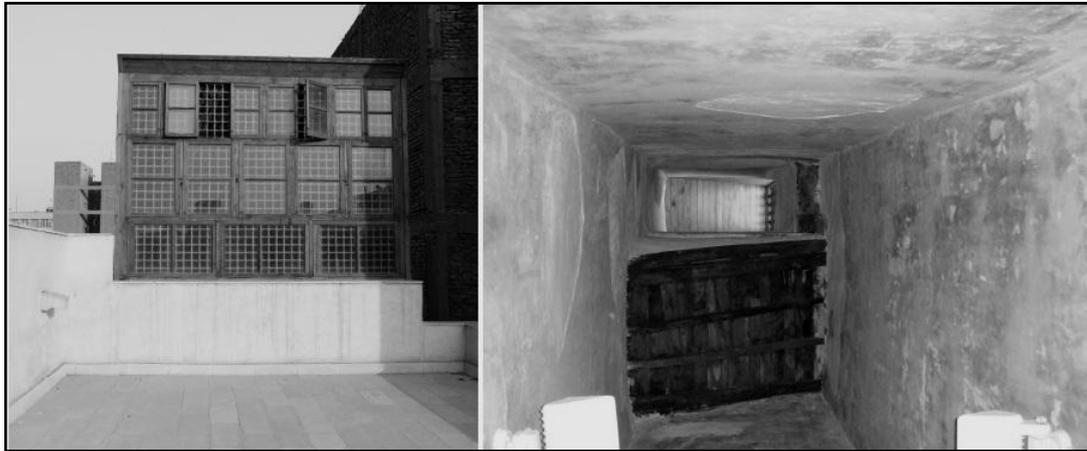
Figure 1.48 Show Malqaf from outside and inside (Ficarelli 2008)

For the correct functioning of this component it is necessary to have a system to close and to filter. The *malqaf* channels inside the prevailing current of air from the north to adjust the flow and the admission in *qa'a* through a series of different openings. The air directed to the central part of *qa'a* is further cooled by a fountain on the floor of *durqa'a*; when the air becomes warmer it tends to rise upward, coming out

through the high central tower of the room, the *shukhsheikha*. On the top of this one there is a lantern hexagonal, octagonal or circular with openings on the sides: this device expedites the flow of air upward and facilitates the expulsion of the hot air from the tower toward the outside (Ficarelli 2009).

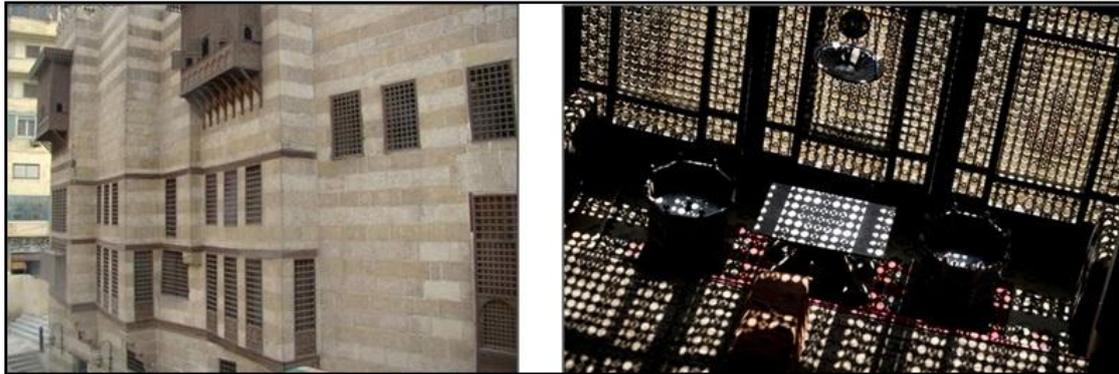
Figure 1.50 *Mashrabiya* from outside and inside view

The mashrabiya is a window element that automatically activates a convective cycle moving air masses from the zone of high to that of low pressure. This phenomenon naturally ventilates small streets and makes incredibly fresh the courtyards of the houses. In the afternoon, when the courtyard begins to warm up, the

system works contrarily: the air comes back in courtyard from the secondary roads creating a perfect balance between the two areas, in the evening. In the seventeenth century the opening becomes the window in the wall screened by a grate in carved wood, flat or rounded, which will be called “mashrabiya” (Ficarelli 2009).

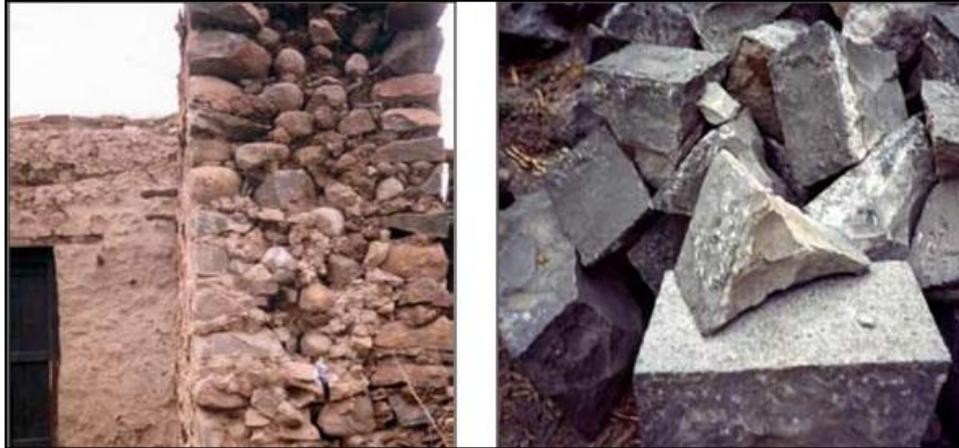
Figure 1.52 Round stone boulders used for traditional stone masonry and semi-dressed stones ready for wall construction (Bothara and Brzev 2011)

Stones used for this type of construction are irregular shape, including small or medium-size river stones, smooth stone boulders with rounded edges, or stones from quarries. Sometimes, these round stones are usually laid in mud or lime mortar. The walls consist of two Wythes and the space between the Wythes is filled with mud, small stones and pieces of rubble. Wall thickness is usually of the order of 600 mm,

but it can be excessively large up to 2 m. In many instances, the exterior walls in the building are constructed first and the interior walls are constructed later without any connection. Rooms in these buildings are generally small and there are few small wall openings (if any) (World Housing Encyclopedia No 16).

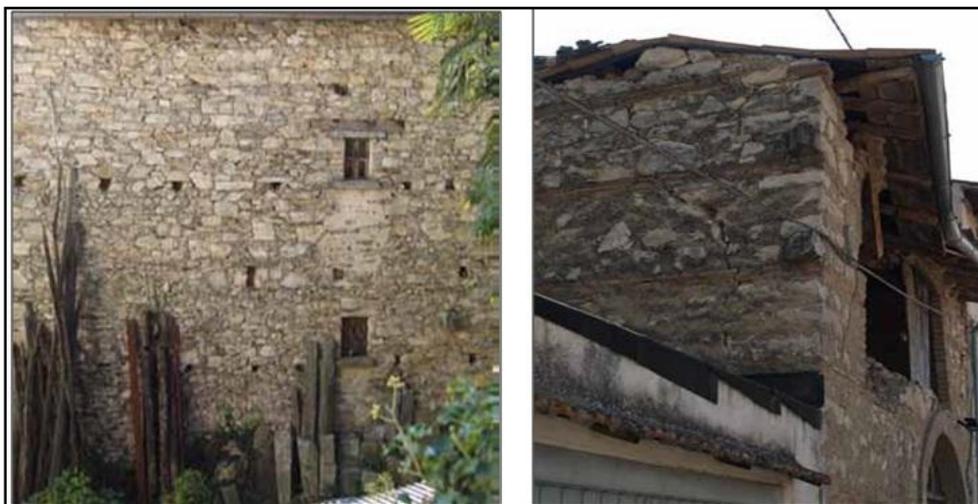
Figure 1.53 Un-coursed semi-dressed stone masonry walls (Bothara and Brzev 2011)

Fig. 1.53 show examples of un-coursed semi-dressed stone masonry, in some regions of the world, timber or brick bands are used to enhance the wall stability in both un-coursed random rubble and semi-dressed masonry.

This construction type is similar to random rubble stone masonry in that there are two external wall Wythes and an interior filled with rubble. However, in the case of semi-dressed stone masonry, the exterior Wythes are dressed. As a result, the construction has a better appearance, although its seismic performance may not be significantly improved.

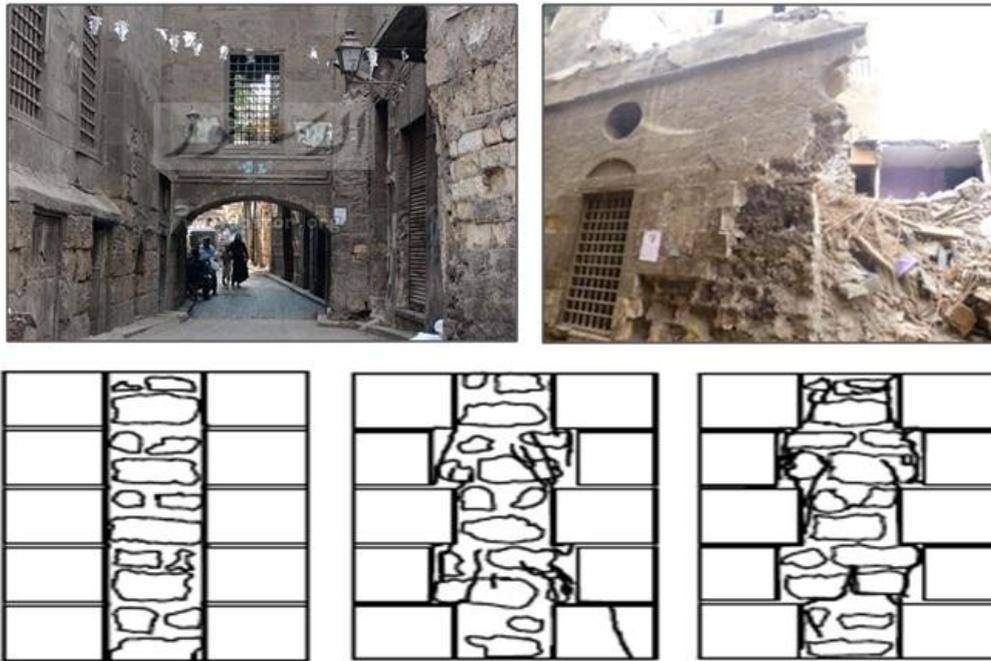
Figure 1.55 The three leaves walls in historic traditional masonry buildings

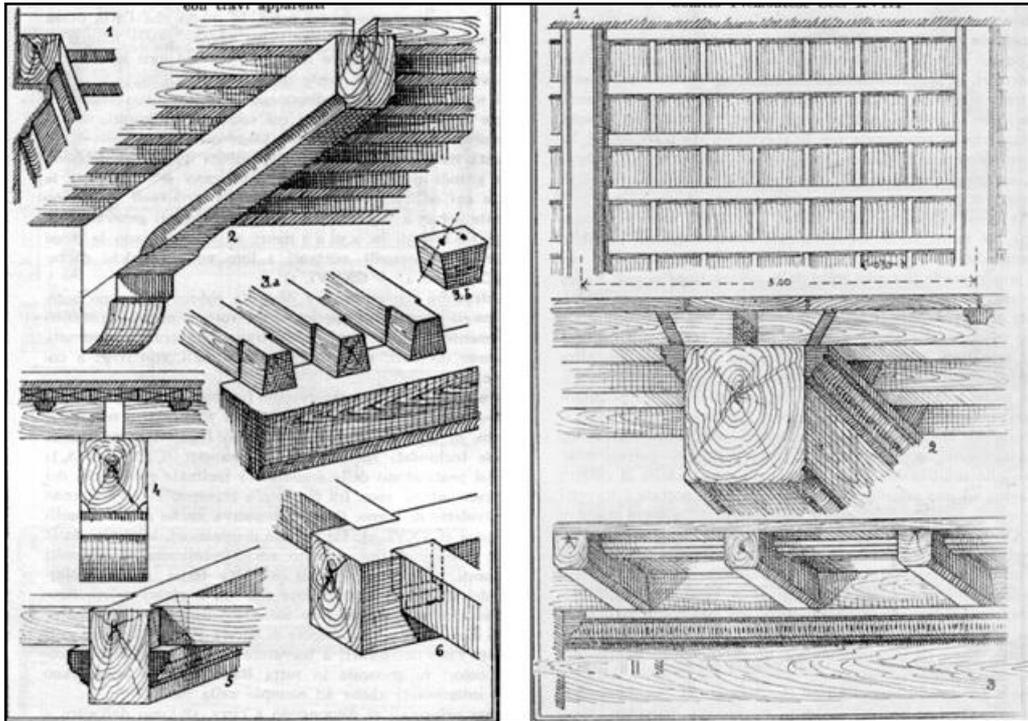
Figure 1.57 Double timber frame floor

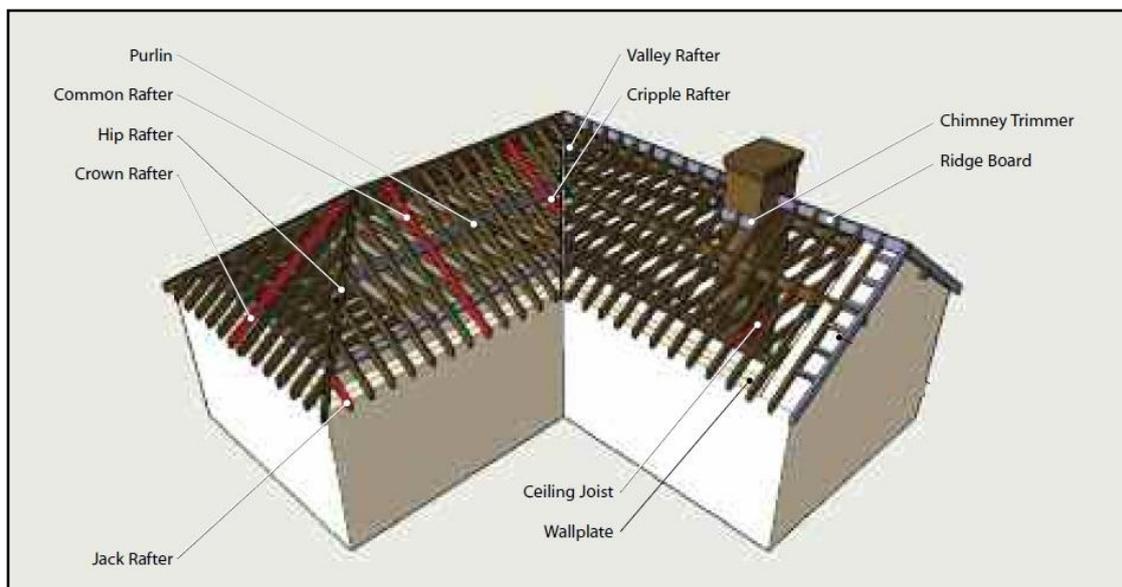
Figure 1.58 Terms used to describe the elements of the roof (Donnelly 2010)

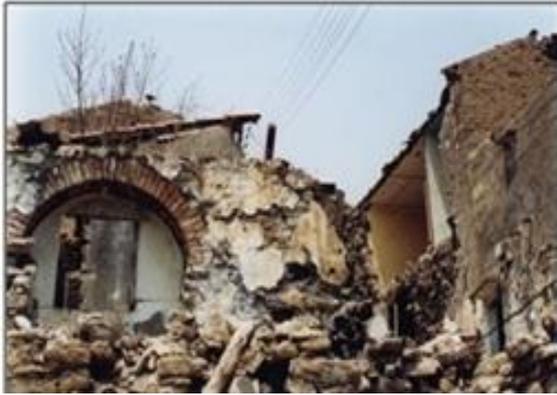
Figure 2.5 Total collapse of construction

- 1- Total collapse of the traditional building as shown in Fig. 2.5
- 2- The destruction and collapse of load bearing walls
- 3- The deep fissuring in the load bearing walls
- 4- Vertical or shear cracks to the walls as shown in Fig. 2.6
- 5- The collapse of internal walls
- 6- The destruction of floors
- 7- The destruction of roofs as well as stairs

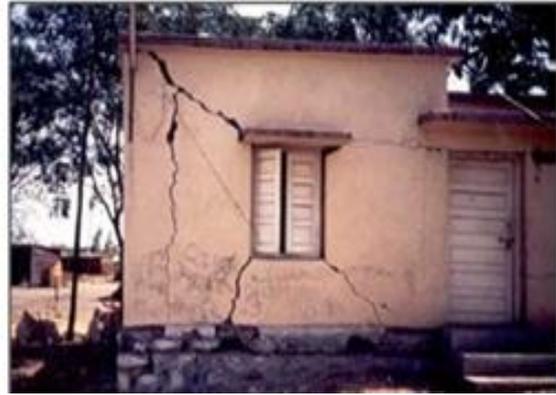
Figure 2.6 Typical wall cracking (Abdessemed 2003)

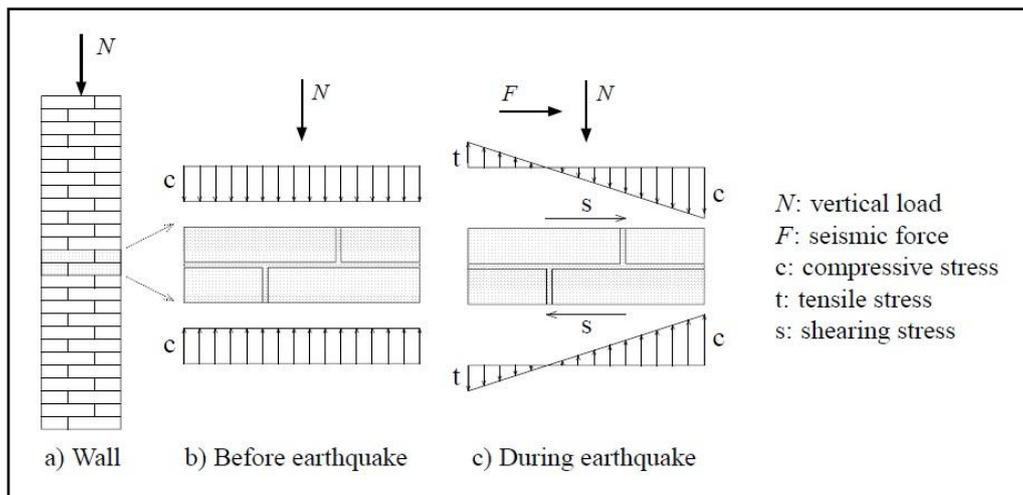
Figure 2.7 Stress condition in a wall element (Bothara and Brzev 2011)

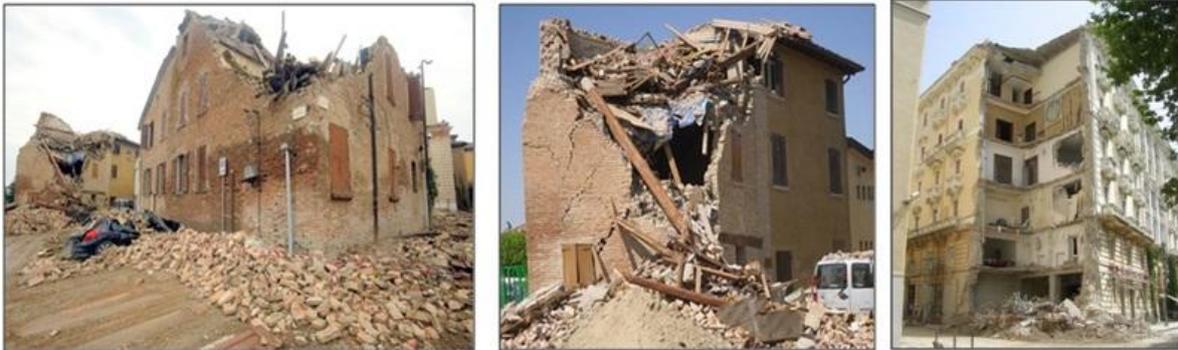
Figure 2.8 Out-of-plane corner mechanisms of masonry building units located in the historical center of San Felice sul Panaro and Salerno building (Branco M., 2011, Augenti, N. 2007)

Therefore, in some historic traditional masonry, it has been observed that the collapse of the façade occurred due to the lack of connection between floors and walls or between walls themselves or detachment of the external layer of the wall due to

the absence of good multi-layer connection and the collapse of the corner due to the excessive nearness of corner to the openings (see Fig. 2.8) (Abdessemed-Foufa 2003).

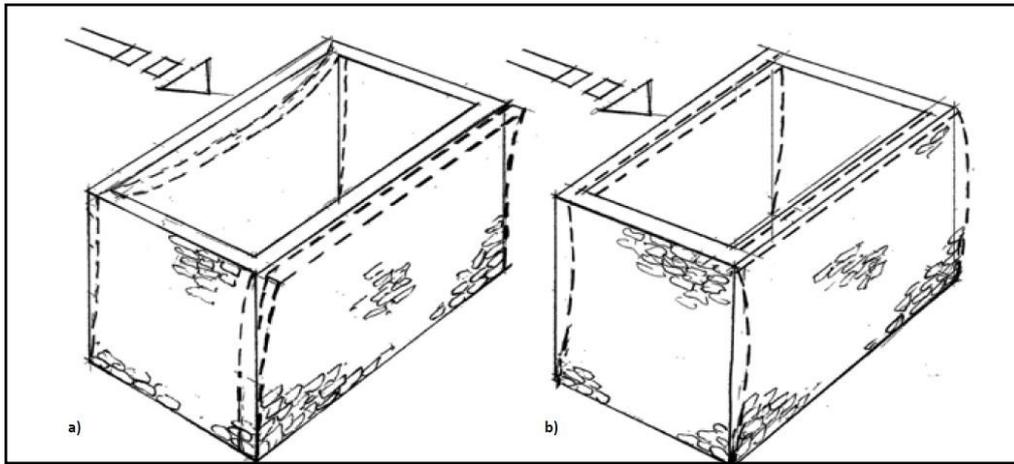
Figure 2.11 Masonry building during earthquake shaking: a) loosely connected walls without slab at the roof level, b) a building with well connected walls and a roof slab (Bruneau 1994)

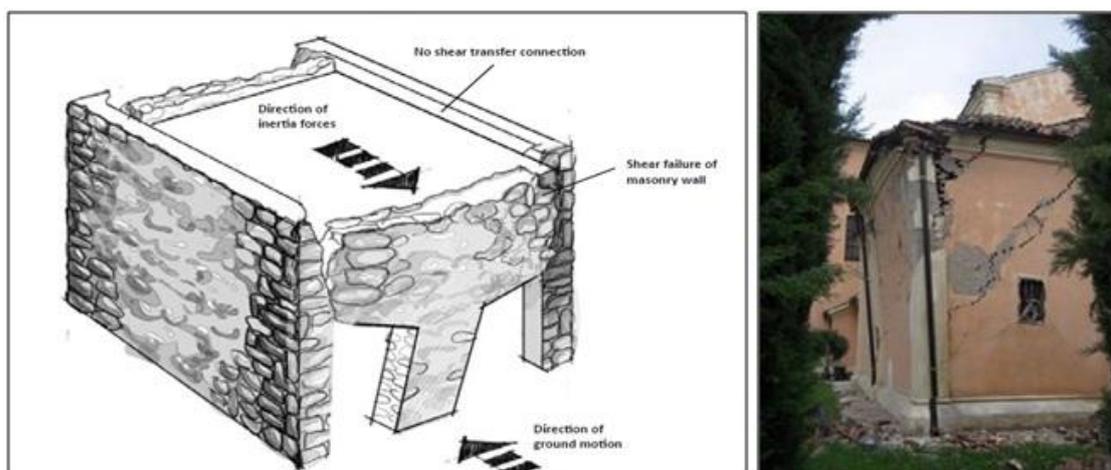
Figure 2.13 Inadequate wall-to-roof anchorages (Bothara and Brzev 2013)

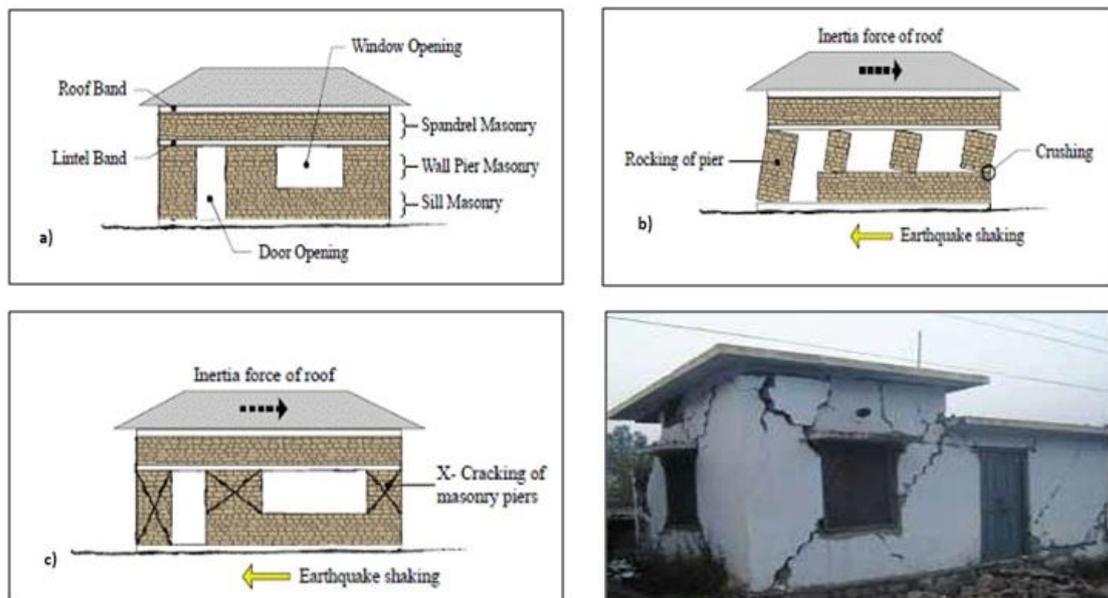
Figure 2.14 In-plane damage of stone masonry walls: a) typical wall with openings; b) rocking failure, and c) diagonal shear cracking (Bothara. and Brzev 2011)

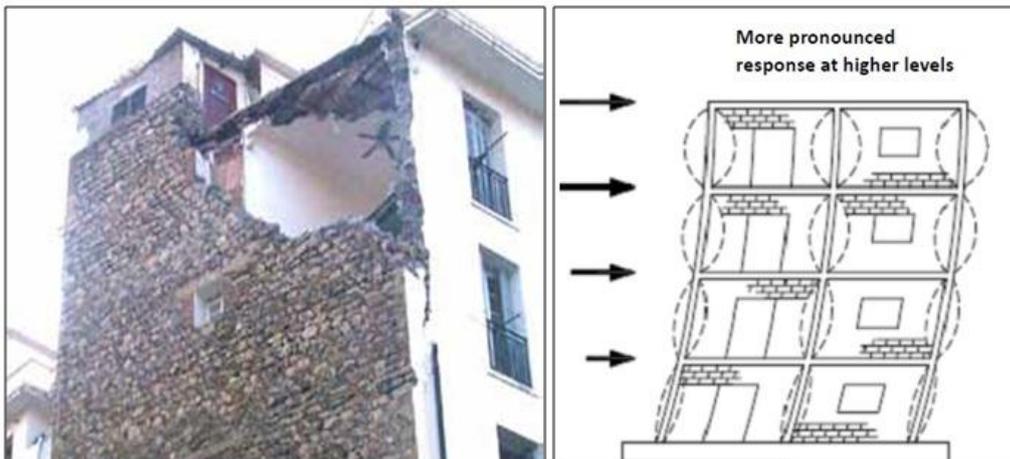
Figure 2.15 Example of Out-of-plane collapse of a wall with tie beams, and roof hammering the masonry walls (Binda et al 2006)

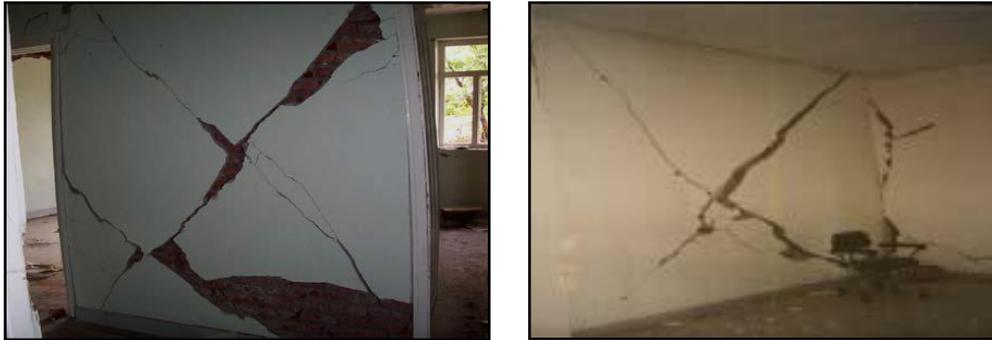
Figure 2.18 The form of double-diagonal shear cracks (Boen 2001)

The length of the load-bearing walls is the most important factor for masonry building damage occurring during earthquakes. Excessive bending and shear may produce in-plane failures, depending on the aspect ratio of the unreinforced masonry elements. Many masonry buildings have suffered very significant wall damage in the form of double-diagonal shear cracks (X cracks), as shown in Fig. 2.18 (Boen 2001).

Although, this cracking seldom causes total collapse, it may become unstable leading to collapse when a full X crack occurs during an earthquake (Doğangün 2008). On the other hand, the accurate assessment of lateral load capacity of URM walls is difficult because of the complex in stone/brick-mortar interaction. Also during an earthquake different modes of failure of load bearing walls in masonry buildings are possible as shown in Fig.2.19 (Decanini et al 2004).

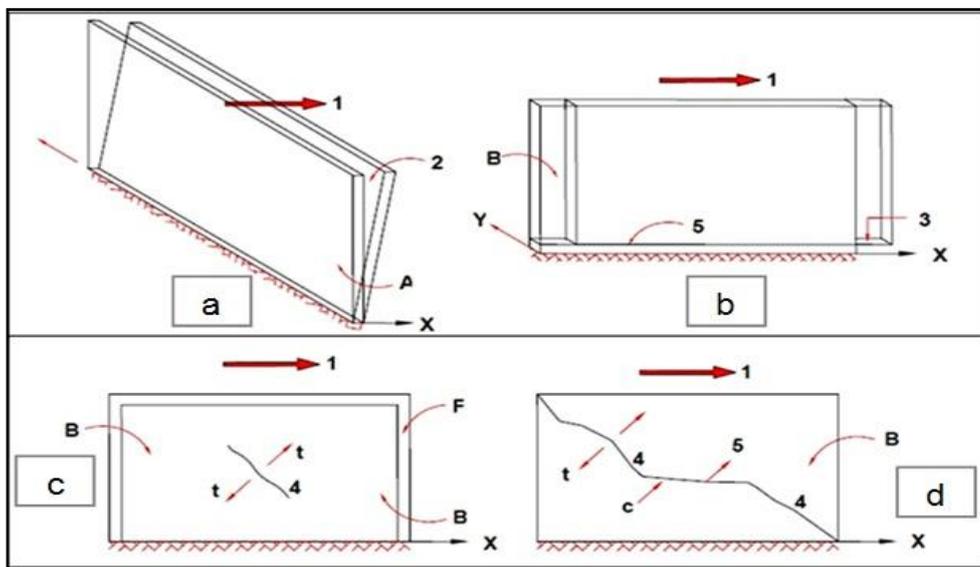
Figure 2.22 (a) Perpendicular force at upper end of wall A (b) Unreinforced wall B with small length to width ratio (c) Wall B with moderate length to width ratio (d) Wall B with long length to width ratio (Boen 2001)

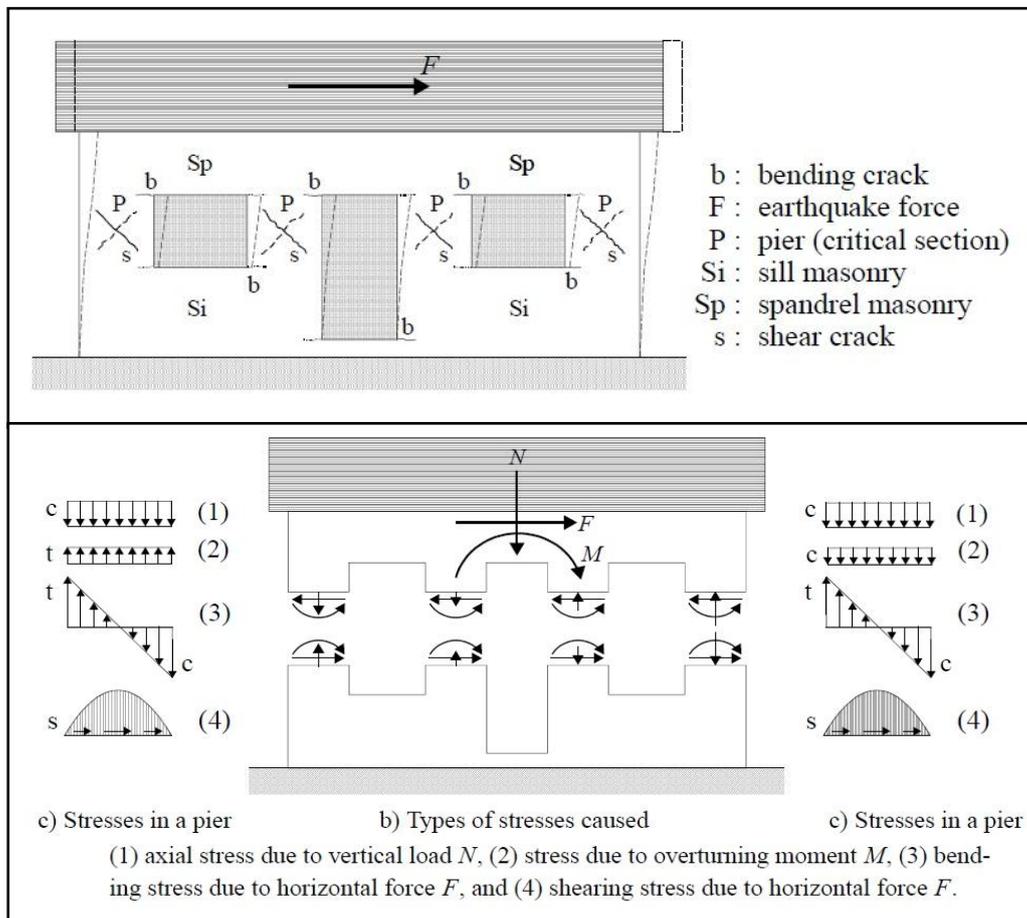
Figure 2.25- Deformation, cracks and stresses of a shear wall with openings (Boen 2001)

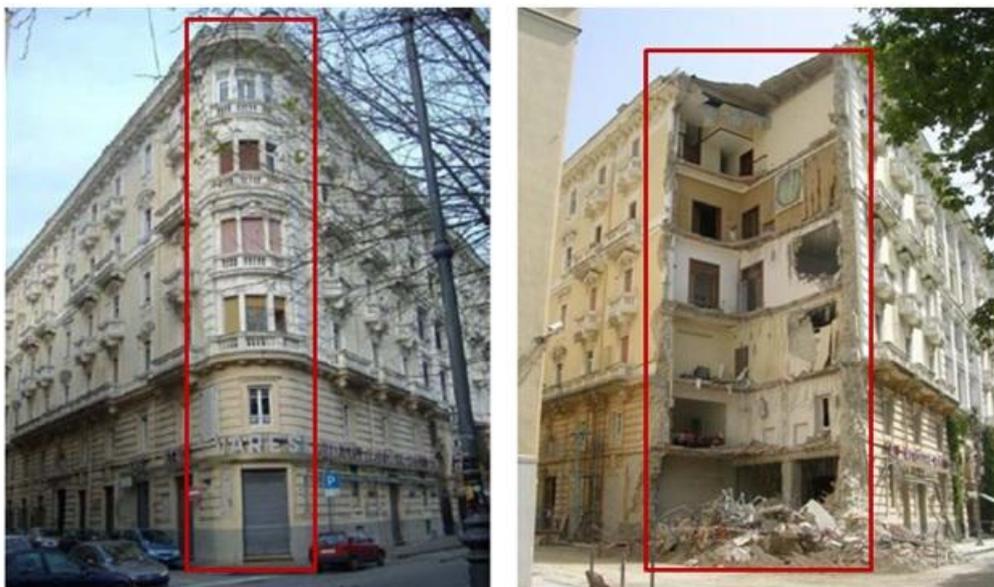
Figure 2.26 Salerno building before (left) and after (right) the partial collapse

On the other hand, historic traditional buildings usually undergo to many types of conversion such as making new openings for ventilation or removing a column or pillar or even a wall from the building (Barry 2001). As a result of such modifications the buildings are susceptible to serious damage to architectural aspects such as sweeping and bulging of facades resulting from the removal of orthogonal walls or large openings in these walls see Fig. 2.26 (Mills 1998).

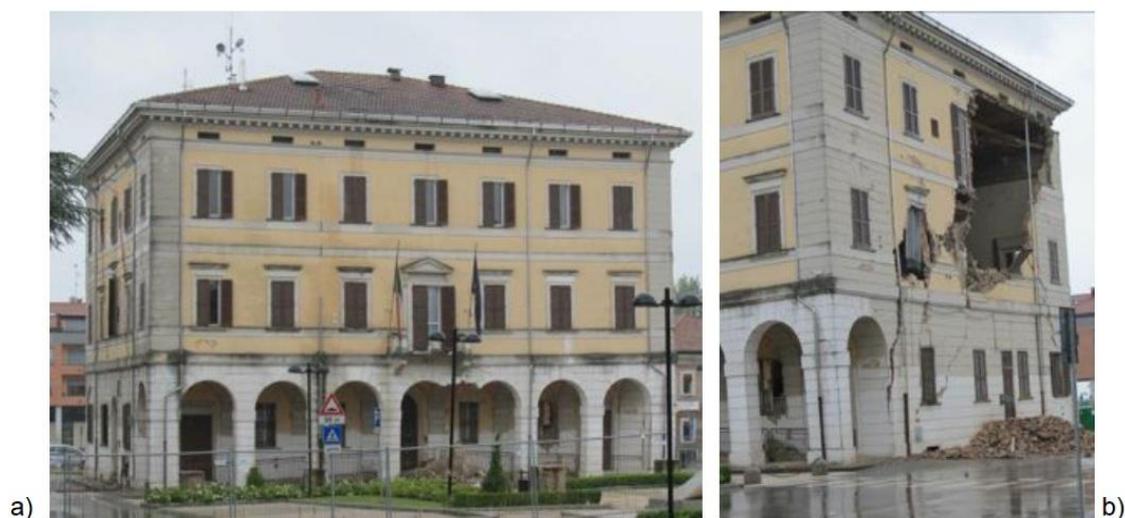
Figure 2.27 Sant Agostino, Town hall (Decanini L et al 2012)

Load-bearing walls of masonry buildings must be arranged in plan, as much as possible, regularly and symmetrically in respect of the two main axes. Some masonry buildings were built with different kinds of masonry units (stone, solid brick and hollow clay tiles) at the different storeys; in these cases, the lateral rigidities of each storey differ, and such differences in stiffness and loads increase the risk of failure (ICOMOS 2003). Figs 2.27 on the right side, the cracks have induced the collapse of the façade wall corresponding to a large hall having openings taller than those on the parallel opposite side (Fig. 27b).

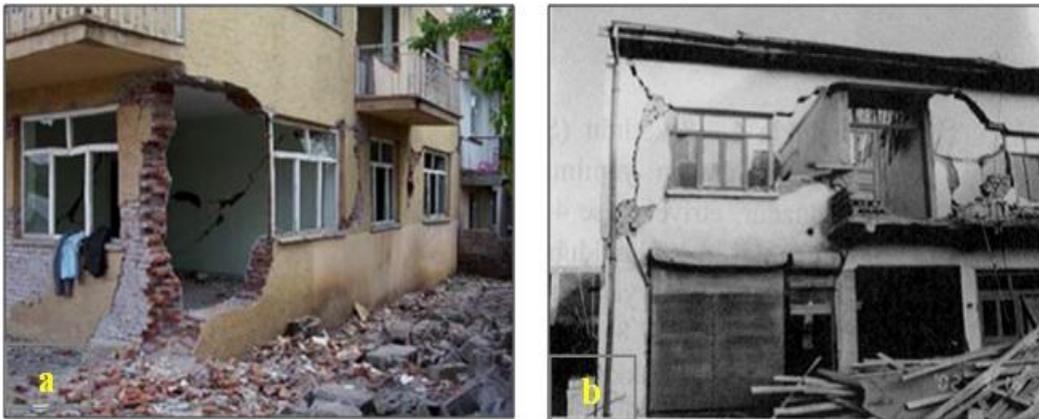
Figure 2.28- Collapse of a corner and vertical cracks near the corner for masonry buildings (Doğangün A. et al., 2008)

Vertical confining elements should be located at the end of the load-bearing walls, at both sides of the doors and windows opening. Fig. 2.28 shows two damaged masonry buildings due to the lack of vertical confining elements, the side of load-bearing wall next to joint space failed and the door opening was extremely narrowed around the middle of the door height as shown in Fig. 2.28, as a result or due to the lack of vertical confining element there is X cracking in this wall (Doğangün et al 2008).

Failure can be the formation of vertical cracks at the corners of an unconfined masonry building in which the wall begins to form a hinge from the swaying. Failures and cracks at the corners occurred because of the insufficient connections between the walls and floors, as shown in Fig. 2.28. As seen in Fig. 2.28a, failure occurred in the bearing wall between the window and the corner (Doğangün et al 2008).

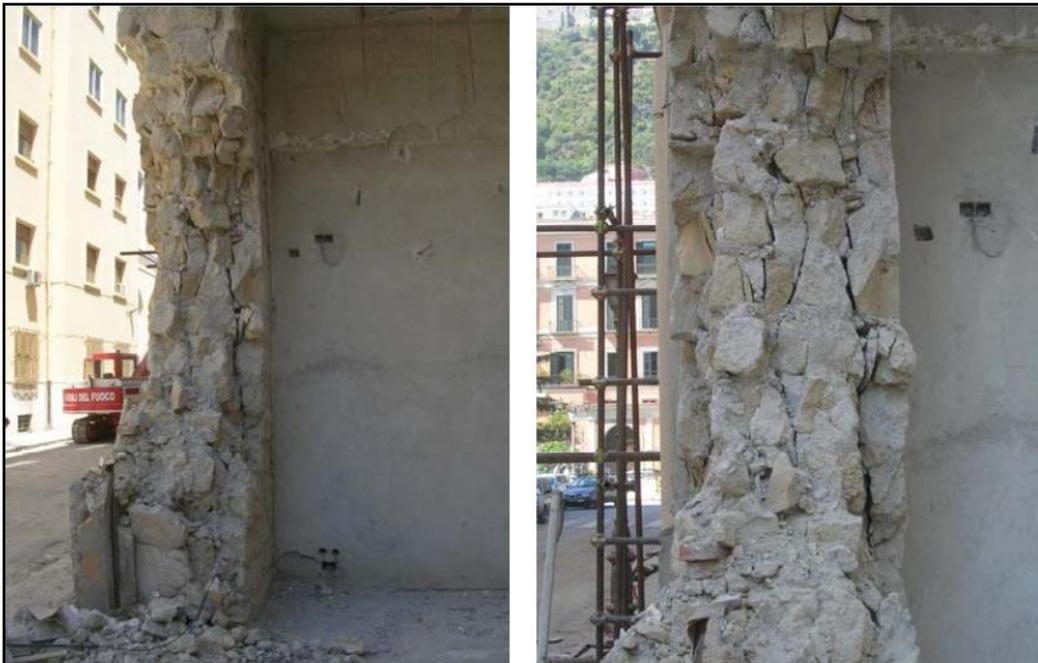
Figure 2.32 The use of poor building materials and poor mortar bond (Augenti, N. 2008)
