National Technical University of Athens (NTUA)
Faculty of civil engineering

**DAMAGE ASSESSEMENT AND REHABILITATION OF
HISTORIC TRADITIONAL STRUCTURES**

Doctoral thesis

Athens 2015

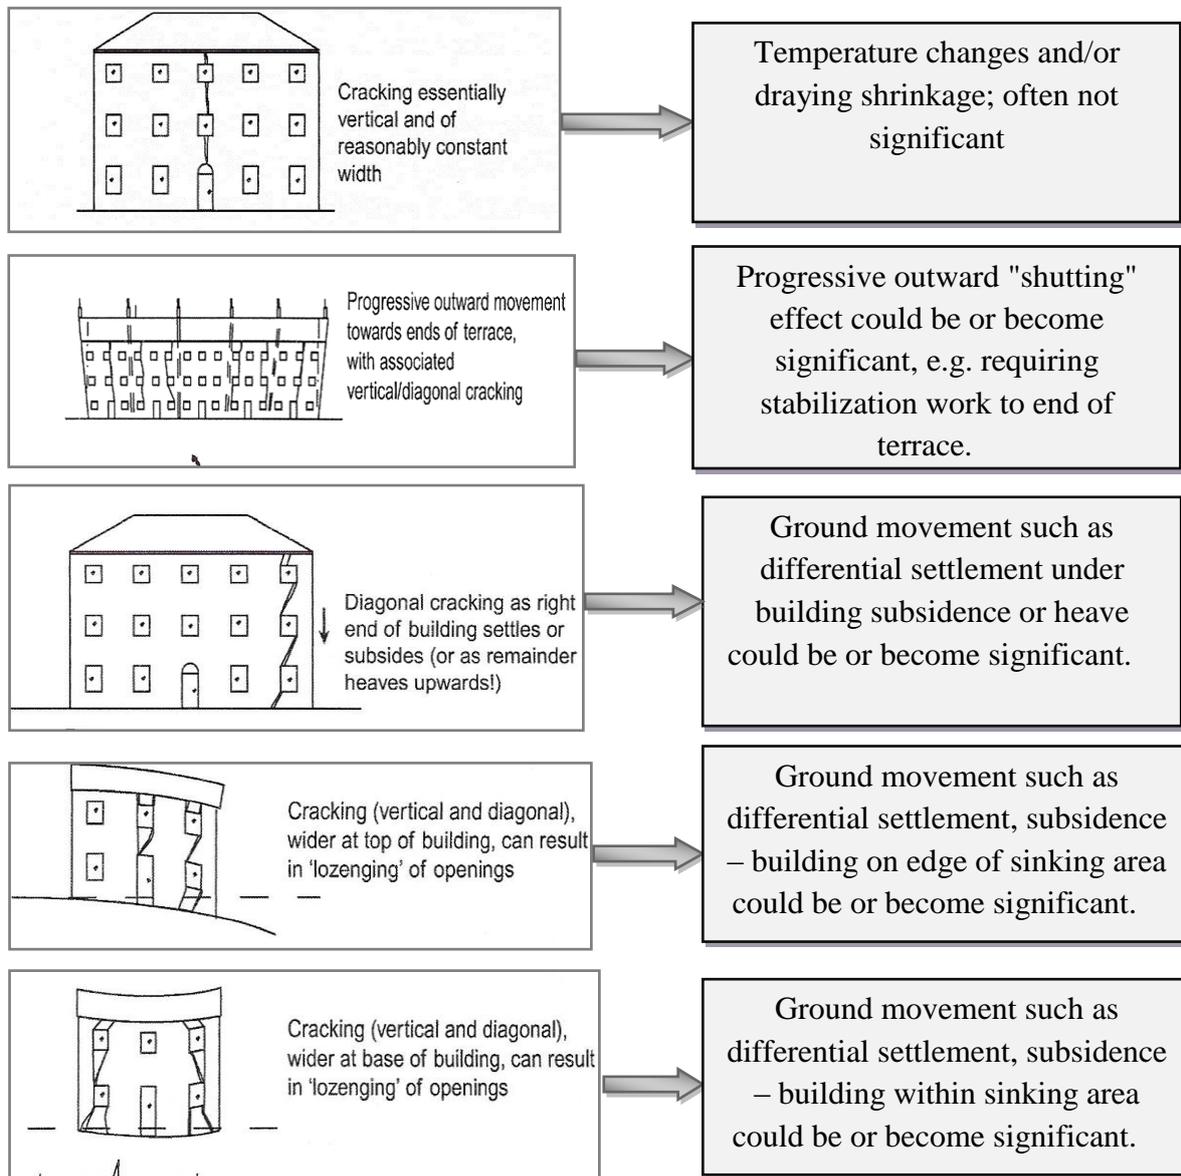
Figure 2.33- typical crack patterns in masonry walls

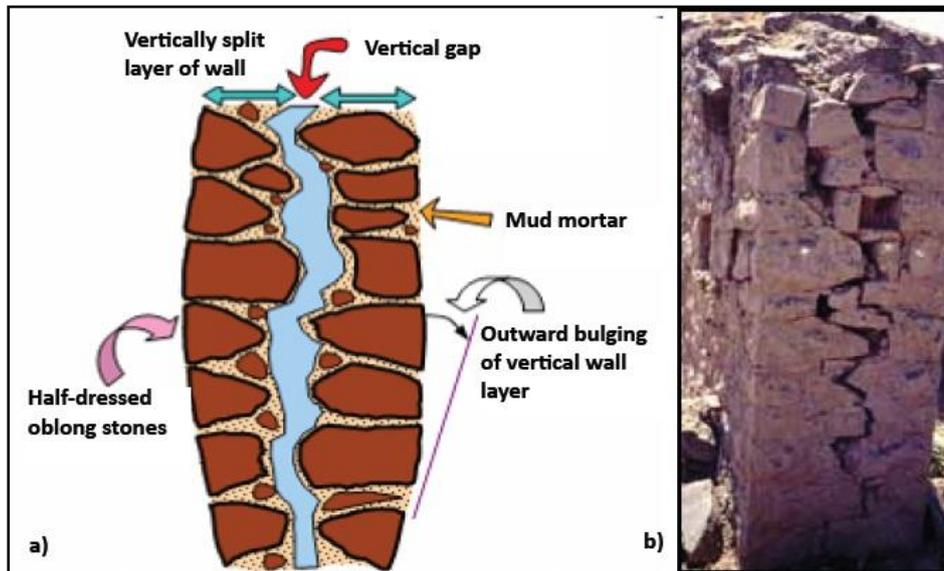
Figure 2.37- Delamination of stone masonry walls: a) delamination in progress and b) delamination of wall wythes due to earthquake

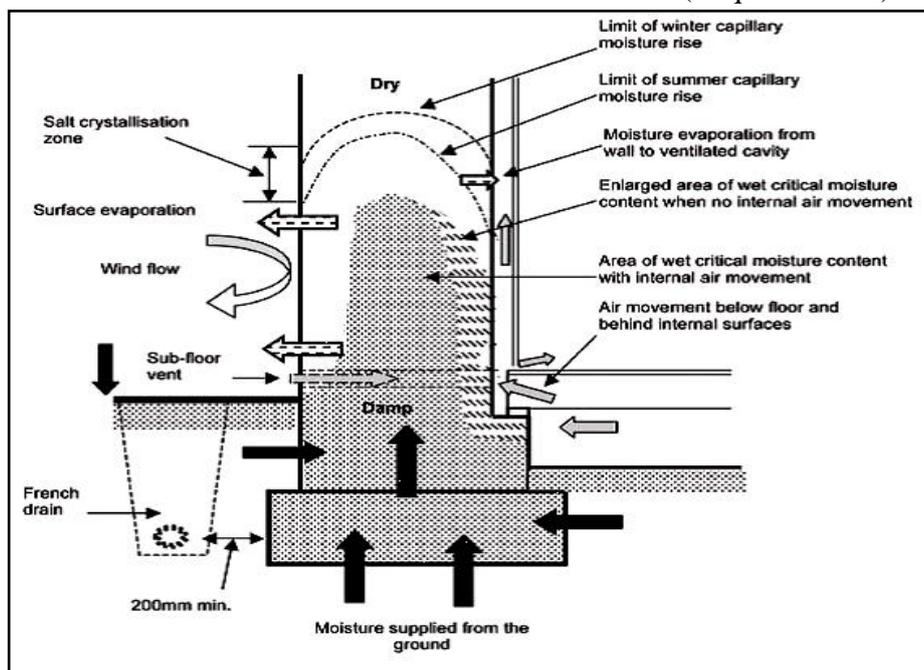
Figure 2.39- Representation of the effects of air movement on the critical moisture content of a porous masonry wall (Urquhart 2007)

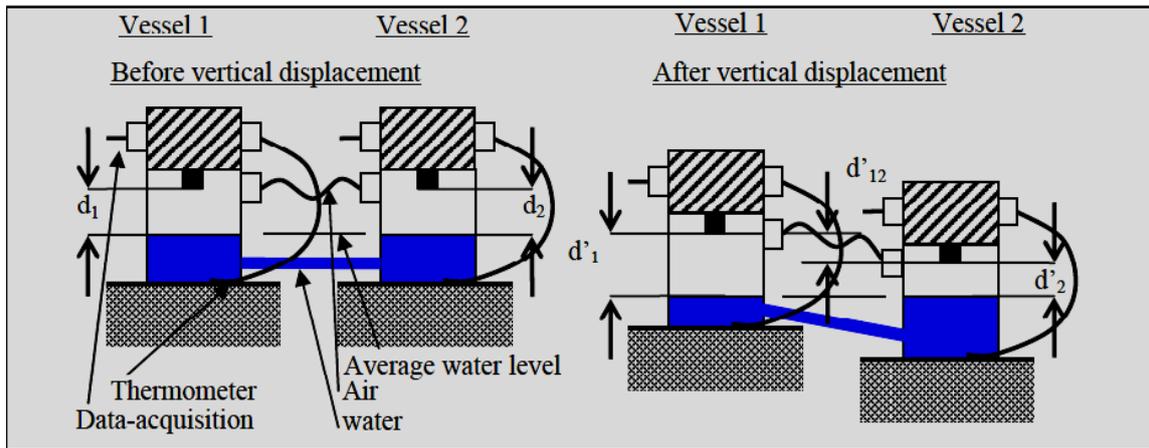
Figure 3.3: Hydrostatic leveling system – measuring principle (After Lombillo et al. 2009)

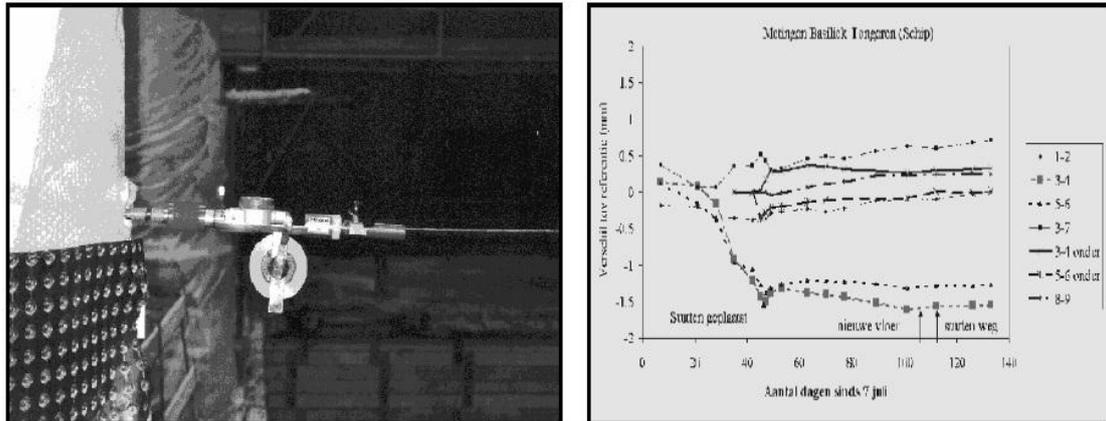
Figure 3.5 Invar wire measurements at the Church of Saint Mary at Tangerine (Brownjohn et al. 1992)

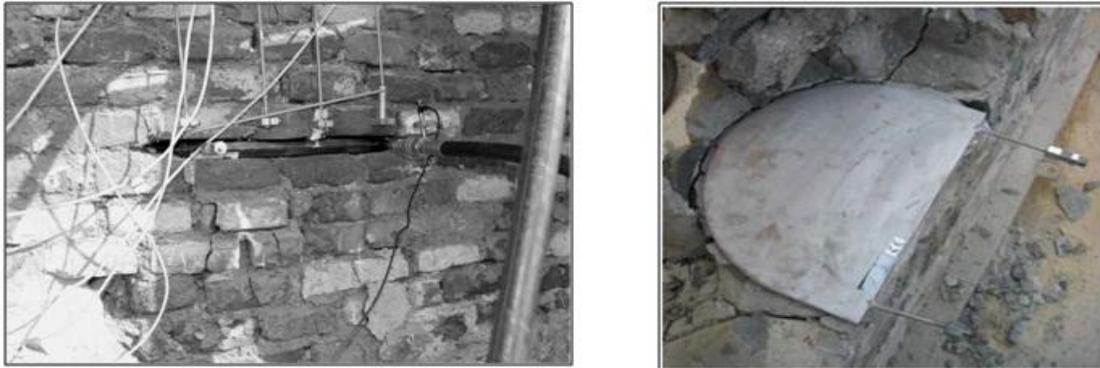
Figure 3.6 Placing the flat jack in the masonry wall and Relation between the contact area of the flat jack and the real area of the realized cut (Timchenko 2000).

single flat-jack test is carried out by introducing a thin flat-jack into the mortar layer. After the test is completed, the flat-jack can easily be removed and the mortar layer restored to its original condition (Timchenko 2000).

The thickness of the flat-jack is determined by its specific function: An ideal flat-jack will completely fill the slot in the mortar joint (see Figs. 3.6 & 3.7). The reference field of displacements is first determined by measuring distances between gauge points fixed to the surface of the masonry (distances d_i in Fig. 3.8b). Then, a slot is cut in a plane normal to the direction of measured stresses. This allows deformations in a direction normal to the slot.

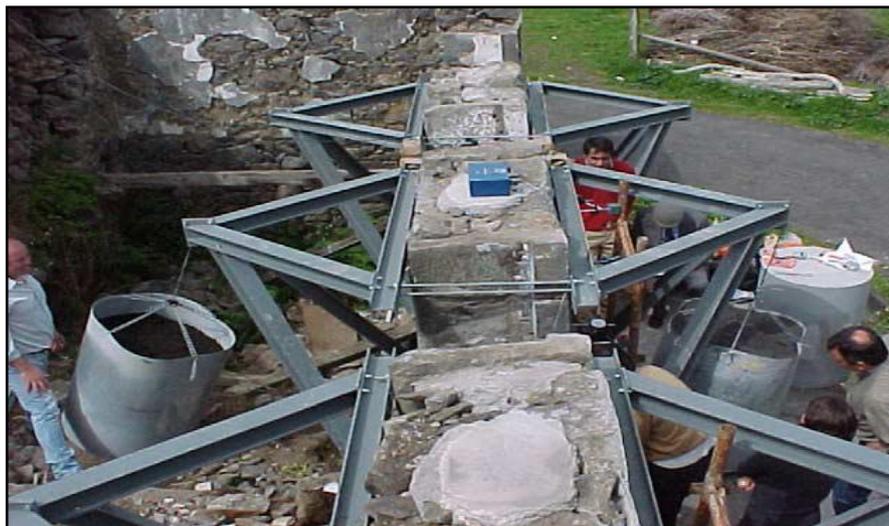
Figure 3.19 - General view of the experimental set-up used to perform the tests (after Costa and Arede 2006)

These instruments include mechanical dial gauges, suitable for the static loading stages and an accelerograph to obtain records of the dynamic response. Dial gauges are placed at the wall top-end, one pair and at the wall mid-height (also one pair). Note that the buckets are filled with sand and subjected to forced oscillation. The vibration recordings and the respective analyses are an indirect technique of estimating the mechanical elasticity properties of a given structure.

Therefore, several acceleration plots are obtained for each panel and for different load stages in the buckets upon the application of an impact on the panel. That signal is processed to estimate the predominant frequencies and damping, respectively, by selecting amplitude peaks of the signal (Costa and Arede 2006).

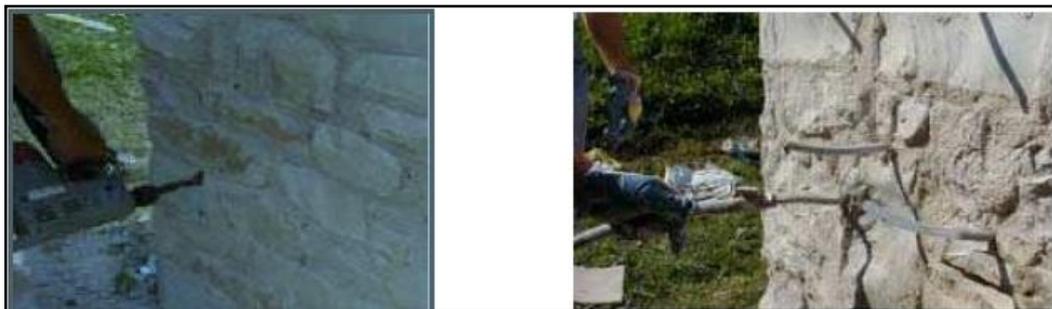
Figure 4.1 masonry wall injection techniques (Meireles and Bento 2013).

It is particularly indicated for the rehabilitation of the masonry that has internal cracks connected between them. This solution is based on the injection (in holes previously made with injection tubes and spread throughout the wall), of grout to the internal cracks. For the external cracks the coating should be removed previously and the injection tubes may also be used. Figs. 4.1 and 4.2 show the techniques of the grouting process.

This technique shows improves in the mechanical characteristics of masonry. It is more suited for stone masonry. To deliver a specific injection grout one must carry on in situ and laboratory tests to refine the grout (Meireles and Bento 2013).

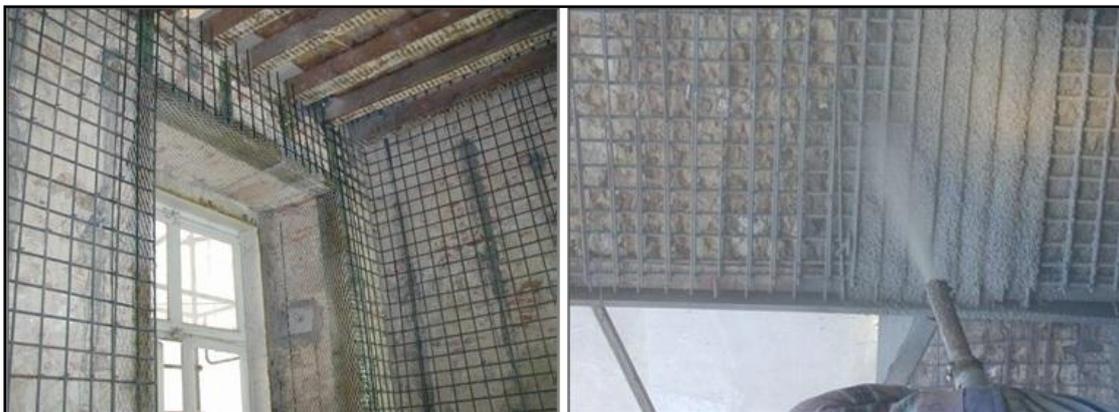
Figure 4.4 Masonry walls strengthening with steel mesh inside the building (Rashadul 2008).

This comprises thin layers of cement coatings less than 10 mm with a mesh of steel or glass fibre or plastic meshes, on masonry walls. The coating increases the wall strength and ductility. It can be placed outside or inside or both, depending on the most accessible areas. To enable the behavior of both elements (existing and new) to work together one places steel connectors on the wall.

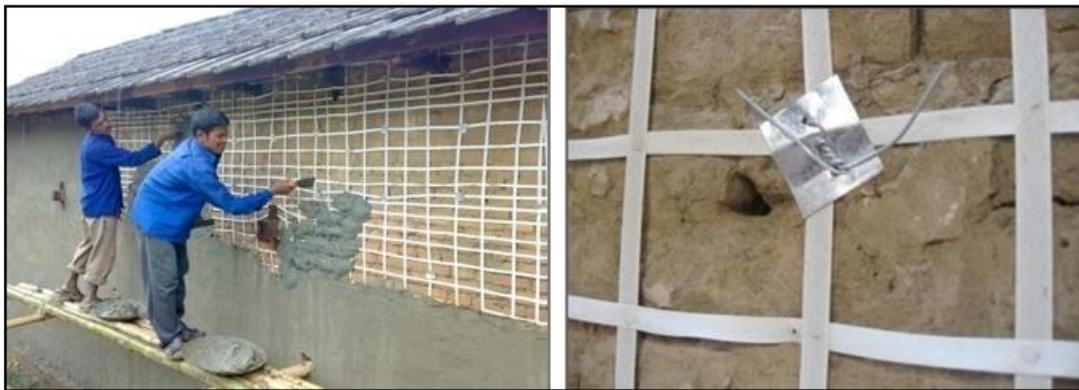
Figure 4.5 Implementation of PP band method of retrofitting and anchorage throughout the wall (Mayorka and Meguro 2008)

Polypropylene meshing uses common polypropylene packaging straps (PP bands) to form a mesh, which is used to encase masonry walls (see Fig. 4.5), preventing collapse during earthquakes. PP bands are used for packaging all over the world and are therefore cheap and readily available while the retrofitting technique itself is

A PP band mesh provides enough seismic resistance to safeguard limited and controlled cracking of the retrofitted structures. Under extremely strong ground motions, they are expected to prevent or delay the collapse, thus, increasing the rates of survival. This method is good for one storey buildings and can be used for a maximum of two storeys. To protect the polypropylene from ultra violet rays, mud plaster is used on the outside, providing adequate cover to ensure the durability of the material (Shrestha et al 2012).

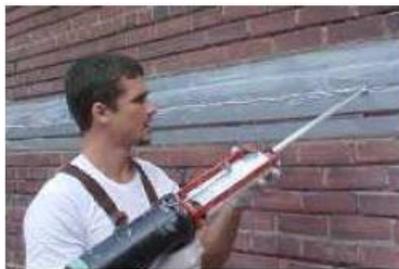
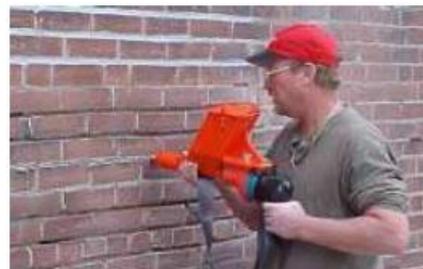
Figure 4.6 Guns for Installation of Embedding Paste (Rashadul 2008)

a) Air Powered Gun

b) Electric Powered Gun

Depending on the kind of embedding material, cementitious-based or epoxy-based, a mortar gun can be used for tuck pointing or an epoxy gun can be used. The guns can be hand, air or electric powered, being the latter two, the most efficient in terms of efficiency. Fig. 4.6a illustrates the application of an epoxy-based paste using an air powered gun. Fig. 4.6b shows the application of a cementitious-based paste with an electric powered gun (Rashadul 2008)

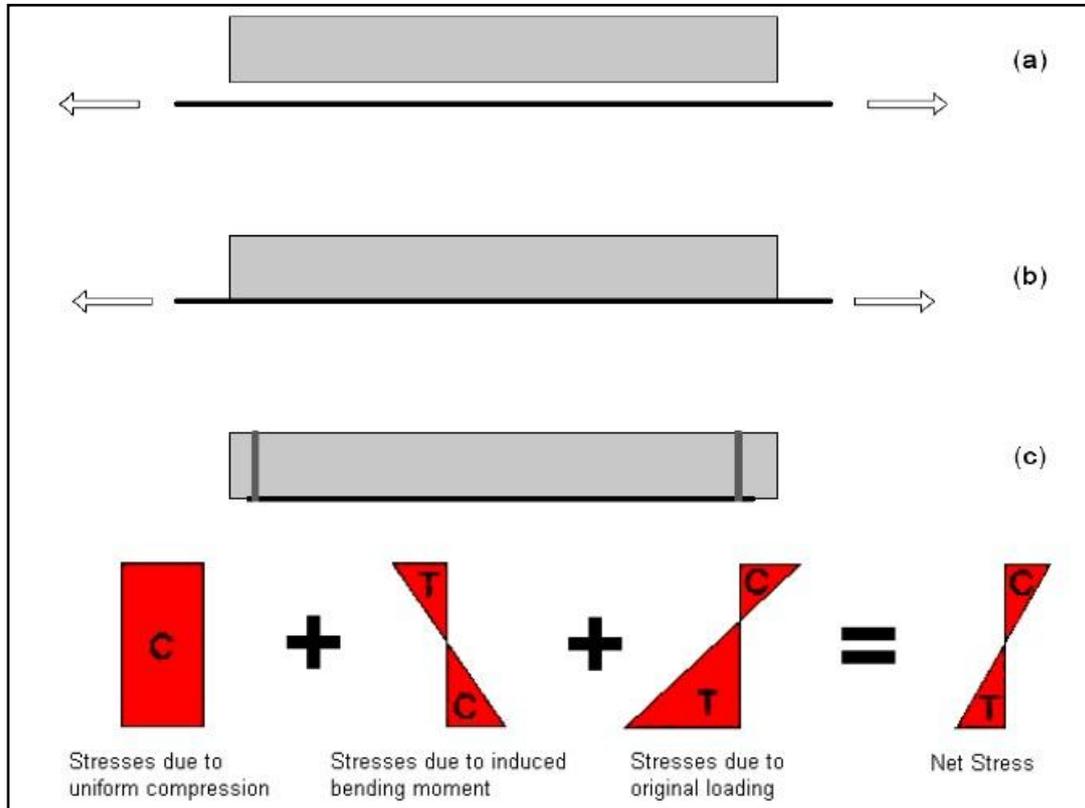
Figure 4.10: Strengthening with Prestressed FRP: (a) prestressing (b) bonding (c) end anchorage and release and finally the stress reduction (Rashadul 2008).

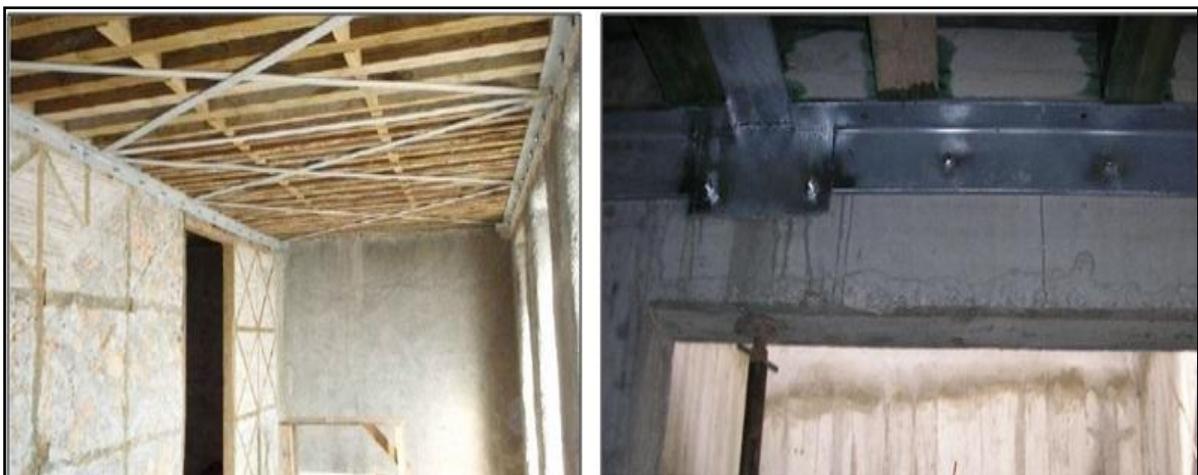
Figure 4.14 In plan stiffening with metallic diagonal and L shaped steel plates as connection reinforcement between walls and floor.

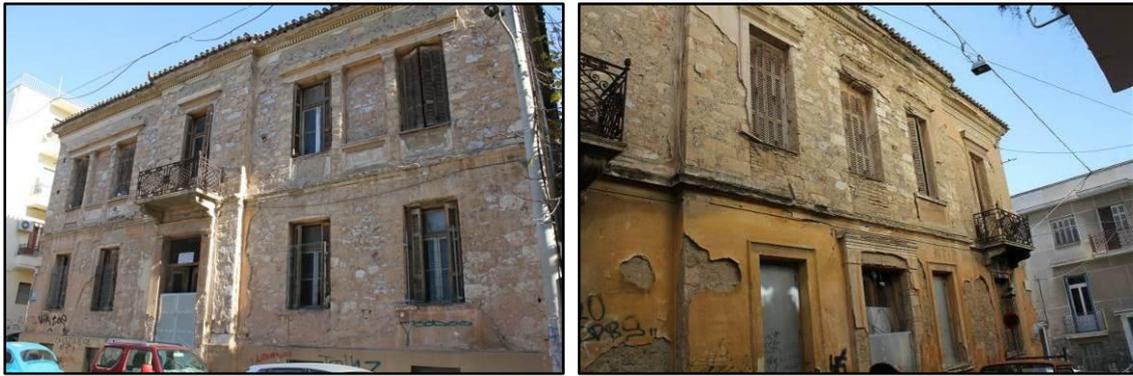
Figure 5.4: The Aktaiou building: façade in Aktaiou Street (left) and northern face in Lykomidon Street (right)

The Aktaiou building, which was built in the early 1900’s, is considered to represent the structural and architectural trends prevailing in Athens this period. Over the years, this house (see Fig. 5.4) has suffered significant damage due to various causes, such as seismic excitation, lack of maintenance, construction defects, neglect, environmental surrounding factors etc.; it is now being in the process of being rehabilitated and converted into a cultural centre.

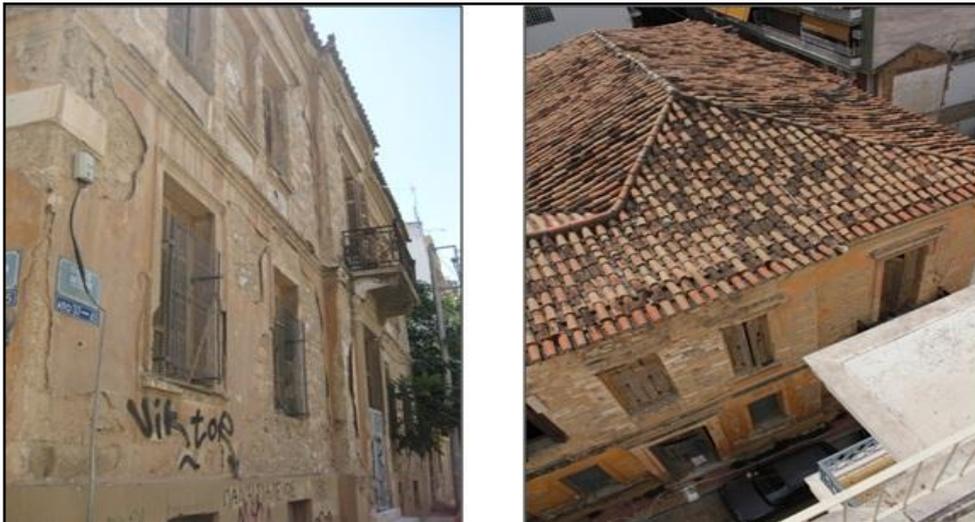
Figure 5.5: View of Aktaiou building house

Aktaiou building, which is a two-storey building with U shape in-plan geometry, is a typical urban Athenian house of its period. It was constructed with local materials, rubble (cobble) and ashlar natural masonry stones which may have had a polished, dressed or broached finish, the ashlar being the cheapest local material with good insulation properties for masonry structures. The building can be considered as a historic load-bearing masonry structure. It is an excellent example of residential architecture initially influenced by the urban architecture of the late 18th and early 19th century. It comprises basement, ground floor, and first floor. The building has a gable roof formed by wooden trusses and covered by terracotta tiles.

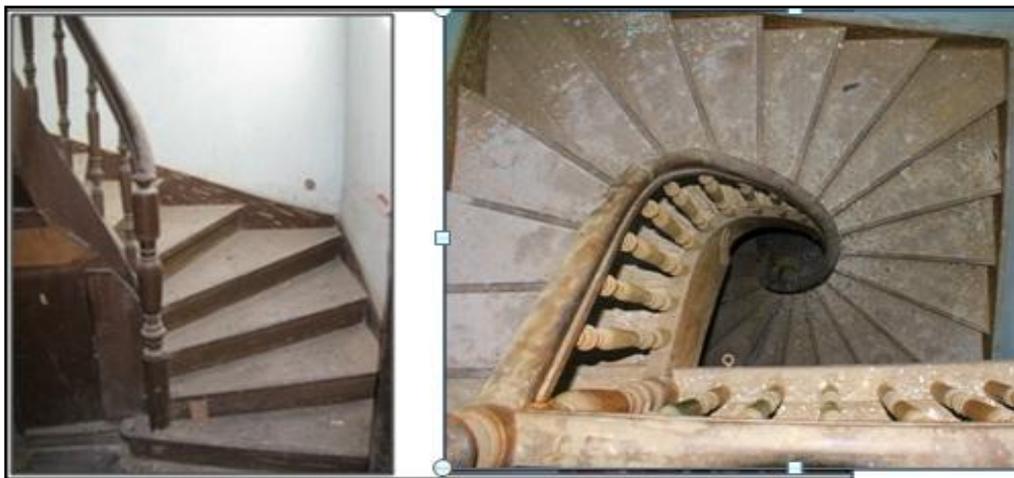
Figure 5.8 The building wooden staircase

One can reach the first floor by the wooden staircase shown in Fig. 5.8. The first floor comprises ten main rooms and some smaller rooms used as rest rooms and storage areas. Some of the rooms overlook Aktaiou Street and the remainder Lykomidon Street. All the first floor rooms are almost equal in size with wooden floors and walls covered with frescoes as shown in Fig. 5.9. The first floor can also be reached by secondary staircase when entering the building from the entrance in Lykomidon Street.

The stair steps of the main entrance to the building are made of marble stones, whereas the internal staircase is made of timber (see Fig. 5.8). The balconies on the faces on the Aktaiou and Lykomidon streets are made of marble plates supported on sculptured marble cantilevers (see Fig. 5.32). The galleries looking in the open space forming between the building's central and wing parts essentially form extensions of

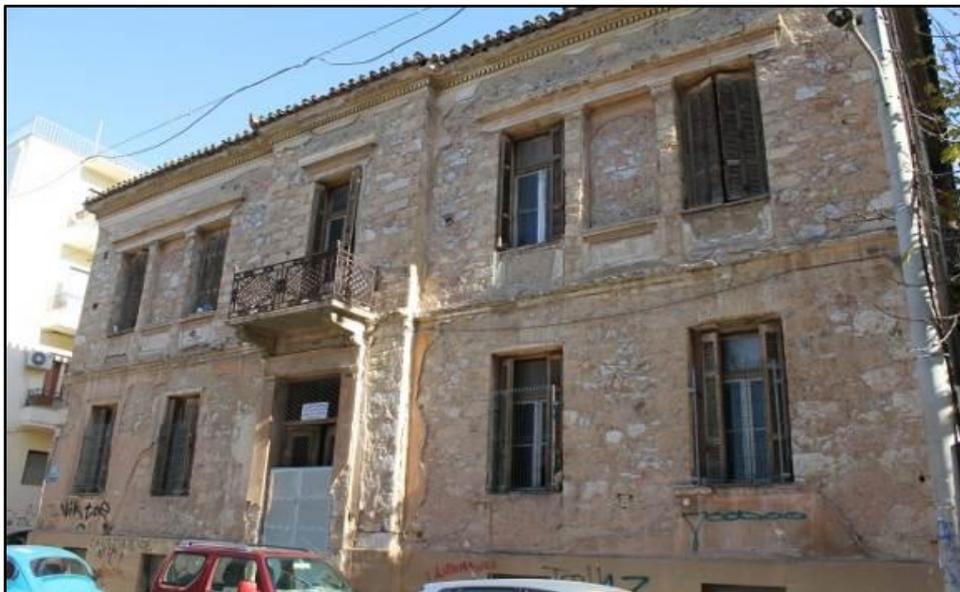
Figure 5.11: Aktaiou building facade (main façade) – Wall 1

The facade of the building lay in Aktaiou Street (wall 1), has a length of 18.40 m (see Figs 5.11 and 5.12); its left-hand side face (wall 2), which lies in Lykomidon street, has a length of 18.00 m (see Figs. 5.13 and 5.14), whereas its right-hand side face (wall 3) sees in an internal open space and has a length of 17.00 m. Wall 4 essentially forms the fence separating the building from the adjacent property.

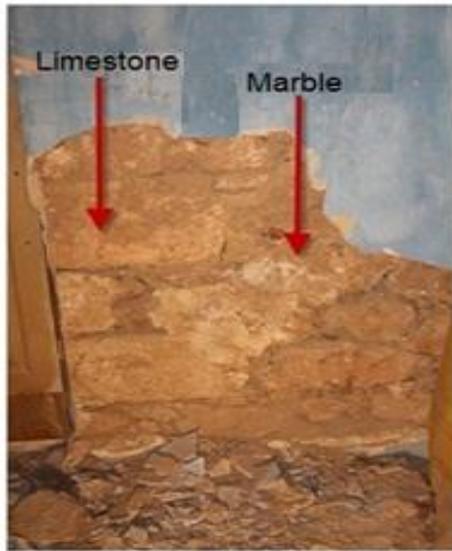
Figure 5.16: Wall masonry

- **Limestone** – semi-chiselled or chiselled stones used as corner stones or for strengthening the sides of wall openings (doors or windows) (see Figs 5.16 and 5.17)
- **Marble** – of irregular shape and varying sizes being one of the constituents of the parts of the masonry between wall openings and wall corners (see also Figs 5.16 and 5.17)

- **Volcanic stone** (lightweight stone) – encountered in the walls of the 1st floor in between limestone and marble stones , and
- **Mortar** (binding material) – containing a large quantity of sand and a significantly smaller quantity of lime

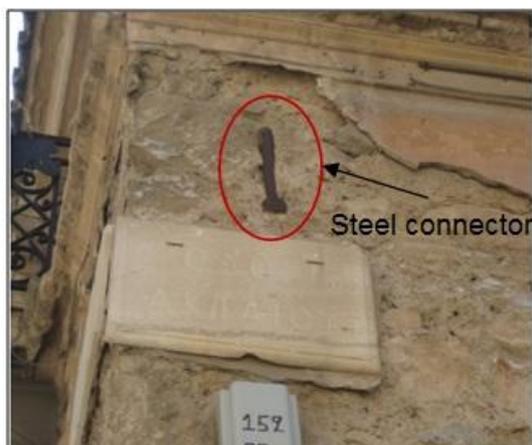
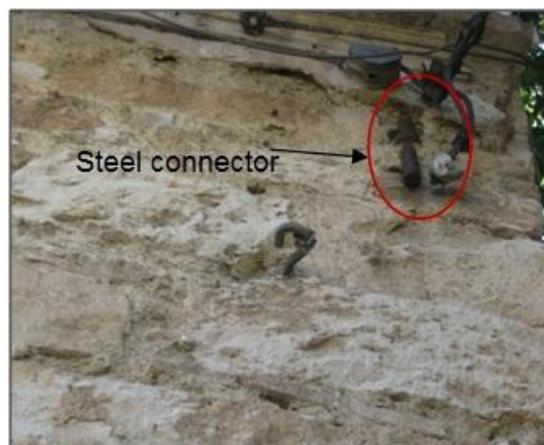
Figure 5.18: Steel connector tying orthogonal walls and roof

The connection between the main bearing walls was effected not only through the use of large pieces of limestone (corner stone's), but also through the use of steel connectors (short anchor elements) which improve the connection of walls orthogonal to each other (see Fig. 5.18).

This type of cracking is more pronounced (larger crack widths) at the 1st floor due to the lack of a bracing of the wall crowning. The presence of blind anchors across the wall width (see Fig. 5.18) may have contributed to this type of cracking.

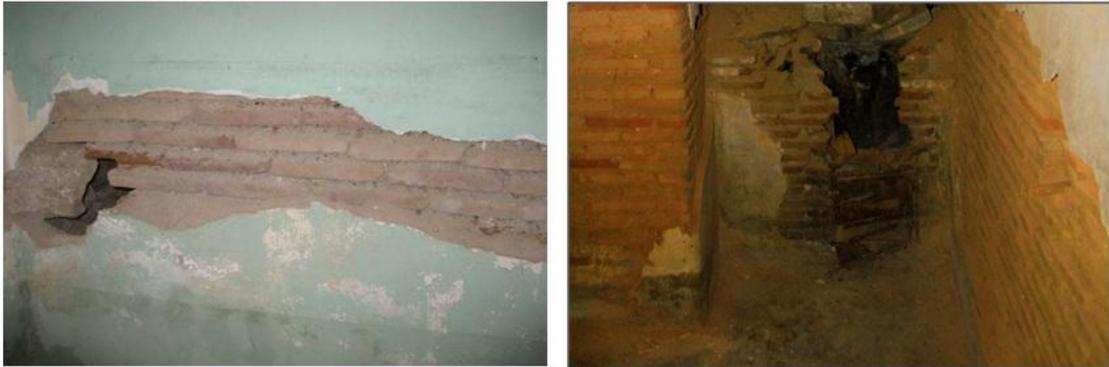
Figure 5.19: Partition walls

The partition walls (secondary walls) were made of 8 cm wide bricks as indicated in Fig. 5.19. The partition walls and room walls were built in one-leaf brick masonry, connected by a low-resistance mortar, and presented low structural properties.

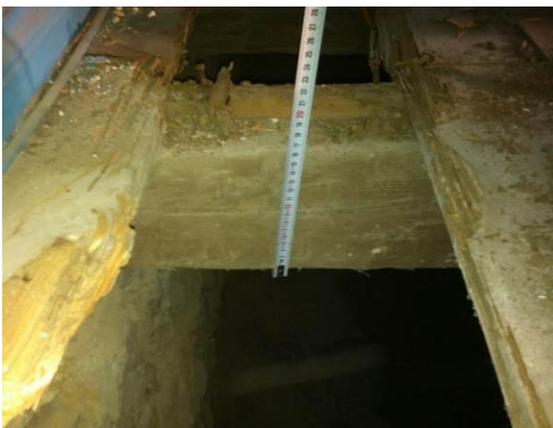
Figure 5.20: Beams of ground level floor

Both the ground level and the 1st storey floors were made of 17 cm high x 11 cm wide timber beams arranged in parallel at distances of 50 cm (see Figs 5.20 and 5.21), covered with 21 cm wide x 2.5 cm thick planks. The beams are simply supported within recesses formed in opposite walls (see Figs 5.22 to 5.23).

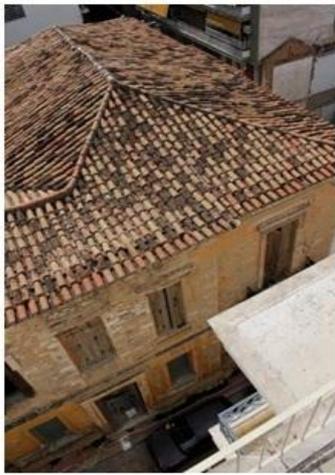
Figure 5.25: Central roof

The roof of the central part of the building (CB) is two-way supported and comprises single and double slope trusses, whereas the roof of the wing parts (W1 and W2) of the building are one-way supported and comprise double slope trusses (see Figs 5.25 and 5.26). The latter comprise one vertical and two inclined struts, a horizontal tie and two diagonal struts as indicated in Fig. 5.27. The inclined struts of the trusses support 2 cm thick purlins extending in parallel to the supporting walls, with the purlins being covered by planking which underlies the byzantine tiles.

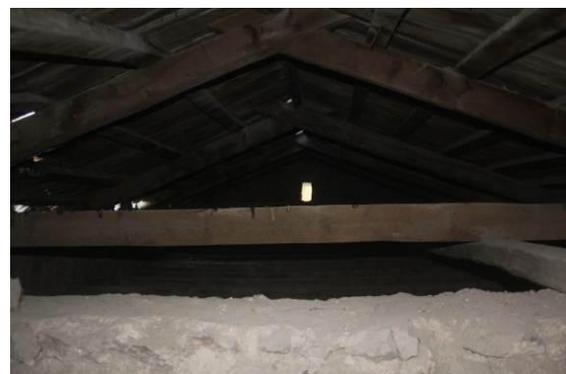
Figure 5.28: Truss of wing roof

The trusses of the wing roofs comprise inclined struts and horizontal tie only (see Fig. 5.28). Although carpenter connections were formed for the truss members, steel connectors were also used in certain cases (see Figs 5.29 and 5.30).

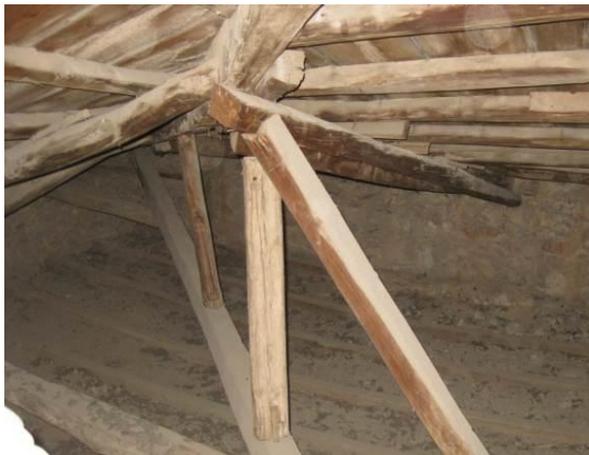
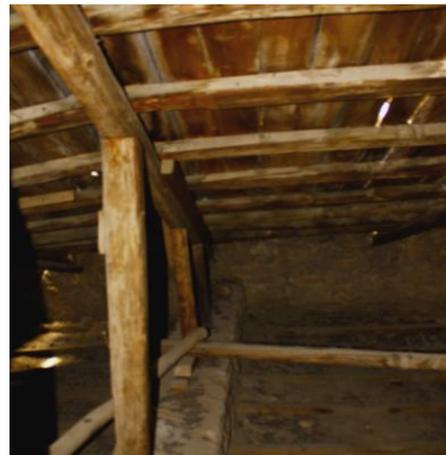
Figure 5.31: Single slope truss

The single-slope trusses comprise inclined and vertical struts supported either on the horizontal tie or on the upper side of wall 5 (see Fig. 5.31). The roof trusses have timber supports encased within the upper side of the walls forming the perimeter of the building' plan. It is interesting to note that the building walls are not braced.

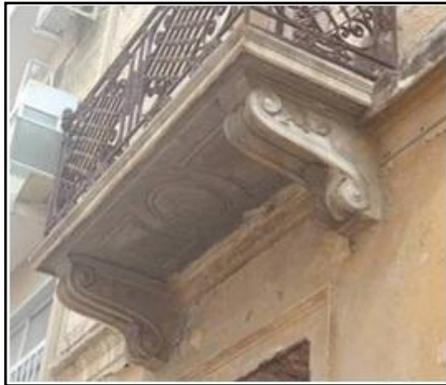
Figure 5.32: Typical balcony

In contrast with the collapsed timber beams supporting the galleries overlooking the interior open space (see Fig. 5.47), the marble balconies of the street facades suffered no damage.

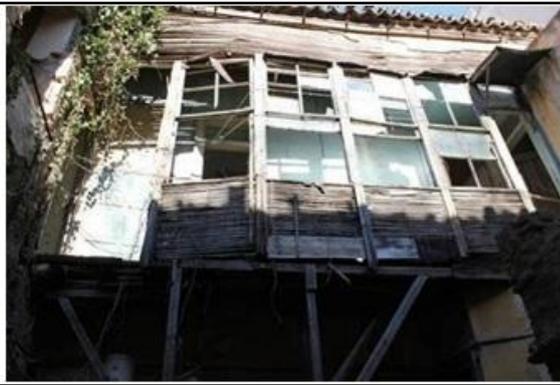
Figure 5.33: Typical gallery looking in the internal open space with temporary prop

the 1st floor and roof beams (see Fig. 5.33) and they are currently in a state of collapse (see Fig. 5.34).

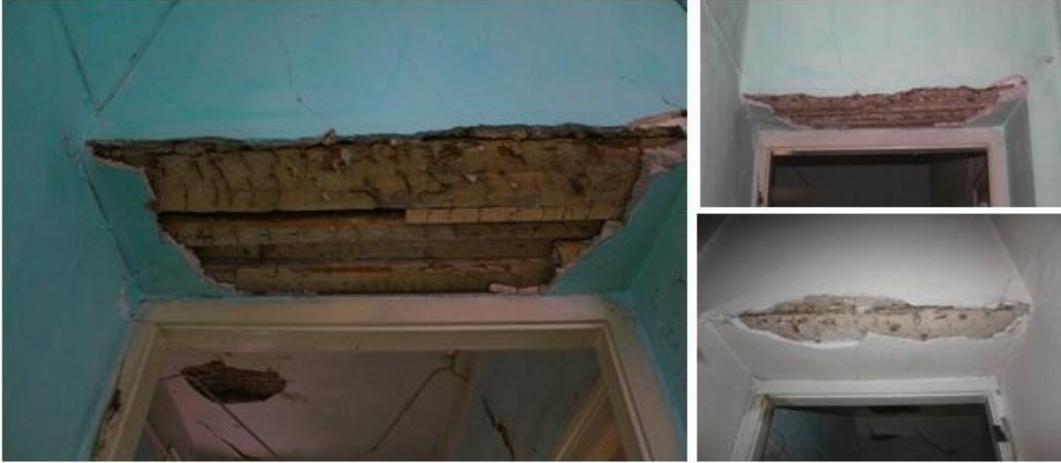
Figure 5.35: Typical lintel of internal opening

For the internal openings timber beams are used as lintels (see Fig. 5.35), whereas the lintels of the external openings are made of rubble and brickwork (see Fig. 5.36) and have an arch shape. The lintel of the main door to the internal open space has been provided with metal supports (see Fig. 5.37).

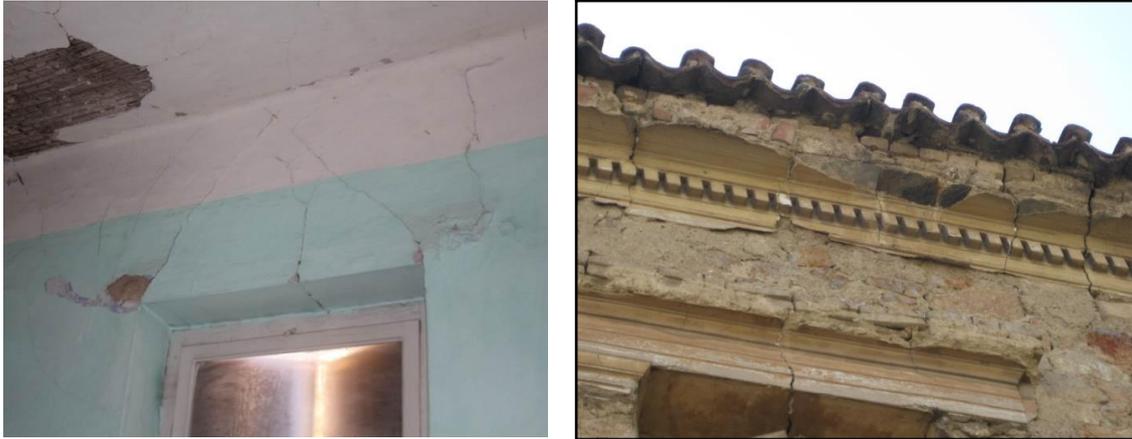
Figure 5.38: Lintel cracking (W1-in, 1st floor) and vertical cracking at both the top (W1-ex, 1st floor) of the building

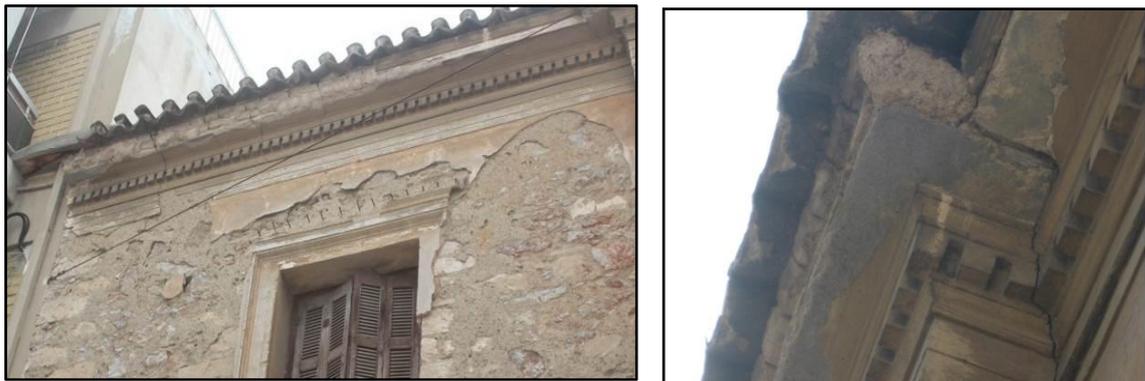
Figure 5.39: Wall cracking at the top of the building (W2-ex, 1st floor)

As for the case of wall 1, the external face of wall 2 (wall 2-ex) is characterized by the presence of small width vertical cracks at the top of the building (see Fig. 5.39), whereas the internal face of the wall (wall 2-in) is characterized by the presence of vertical cracking of the lintels of the openings and local dislocation of the stones of a part of it between openings. The cracking, both vertical and inclined, of the lintels of the openings of the 1st floor is more pronounced than that of the ground floor, with significant cracking also existing at the corner wall connections.

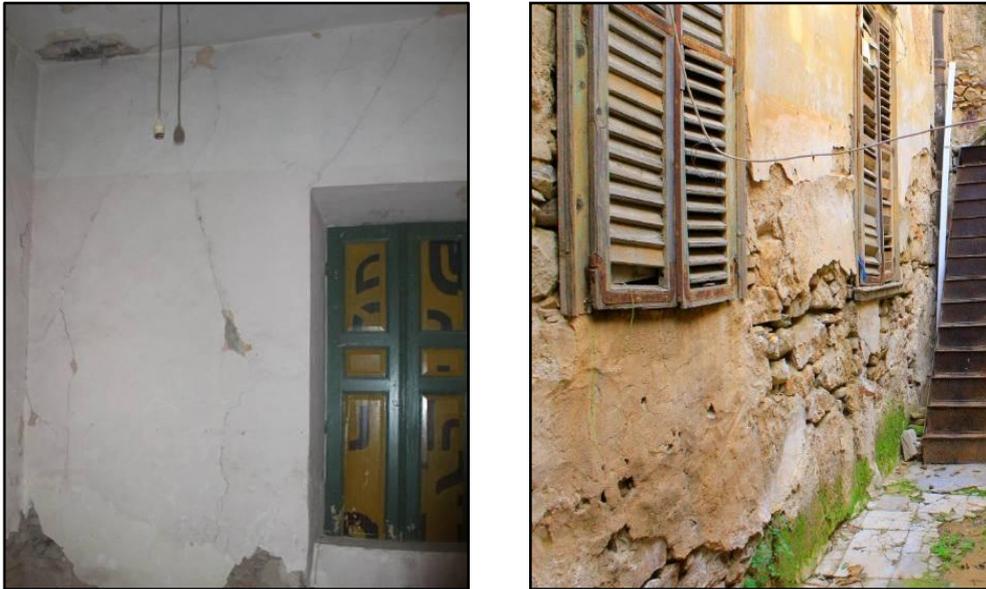
Figure 5.40: Wall cracking (W3-in, and W3-ex of ground floor)

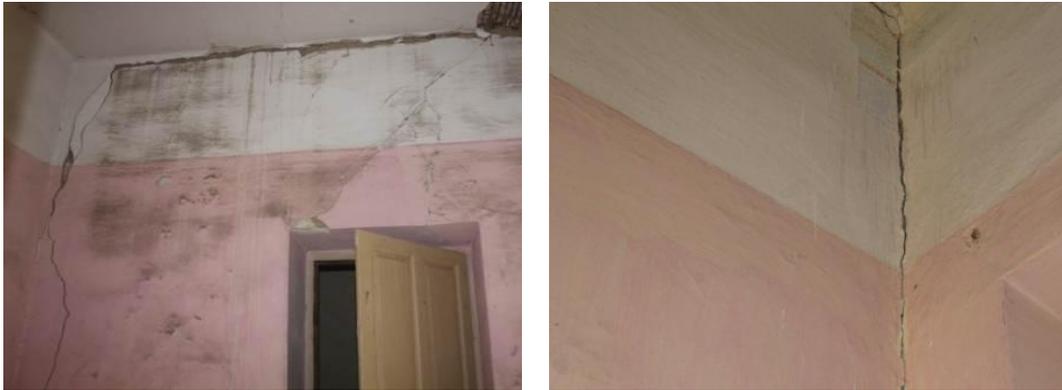
Figure 5.41: Vertical crack near wall connection (W6-in, 1st floor)

At the ground floor, small width inclined cracks are visible in some of the lintels and at the wall connection with wall 3. Cracking, both vertical and slightly inclined, is more pronounced at the lintels of the 1st floor and, particularly, at the wall corners with wall 3 (see Fig. 5.41).

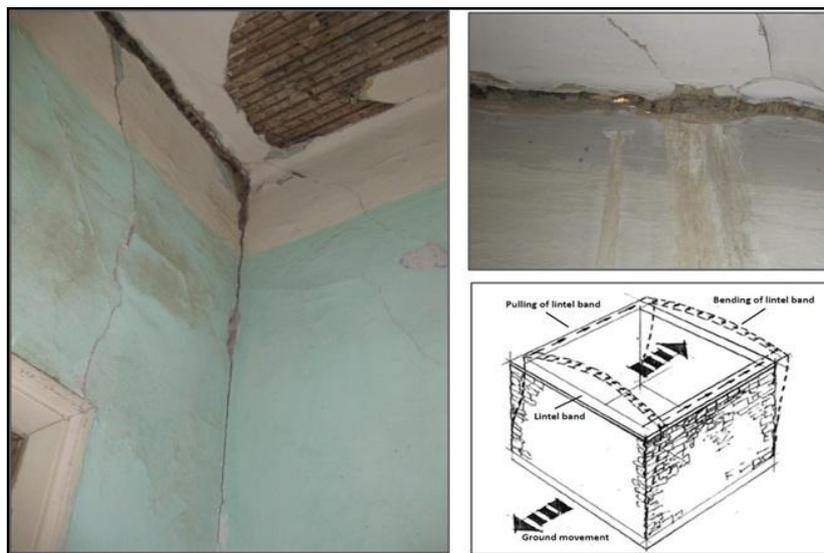
Figure 5.42 Horizontal cracks at the connection part between wall 3 and the roof in the 1st floor

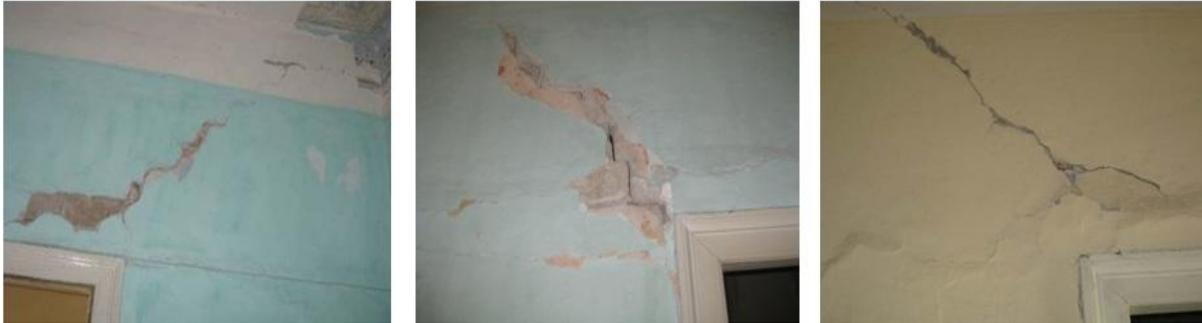
Figure 5.43: Typical diagonal cracking of secondary wall

The damage characterizing these walls is mainly cracking at the wall connections and inclined cracking of the lintels of the openings (see Fig. 5.43).

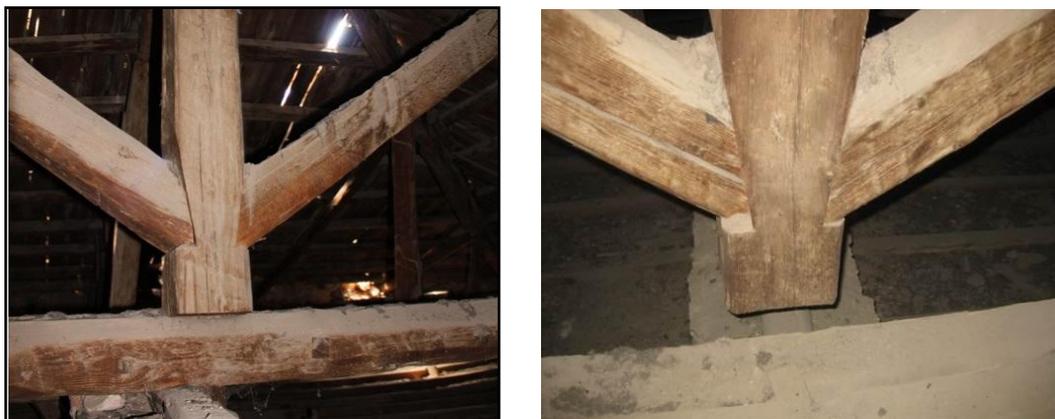
Figure 5.44: Truss deviation from vertical

The roof of the central building is significantly damaged. Although the structural members of the trusses do not appear to have suffered failure, some of the trusses exhibit a significant deviation from the vertical (see Fig. 5.44).

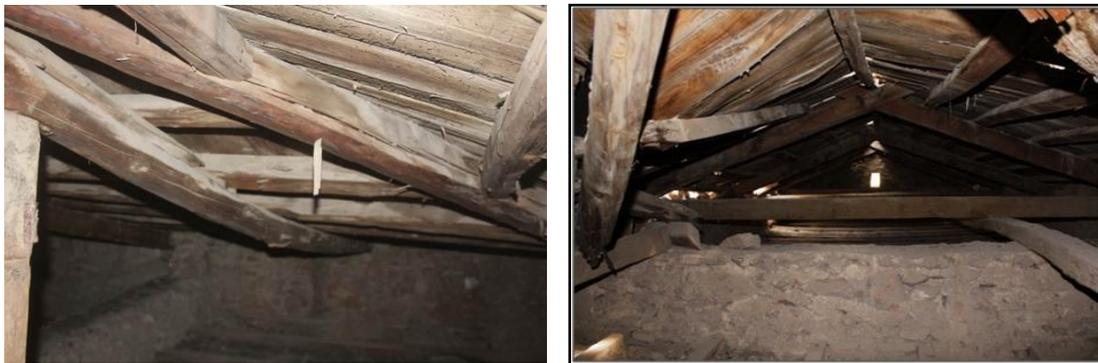
Figure 5.45: failure of truss member

Large deflections and failure has been suffered by the single-slope diagonal trusses (both members (see Fig. 5.45) and connections (Fig. 5.46)); significant deflections have also been suffered by the roof perlin.

The roof of the ‘wings’ do not exhibit visible deflections; however, there have been failures of the trusses, whereas only the perlin have deflected excessively. It should also be noted that many of the truss members have been arbitrarily replaced. Also, the large deflection of the roof trusses has caused dislocation of the wall corner joints at the region of the truss supports.

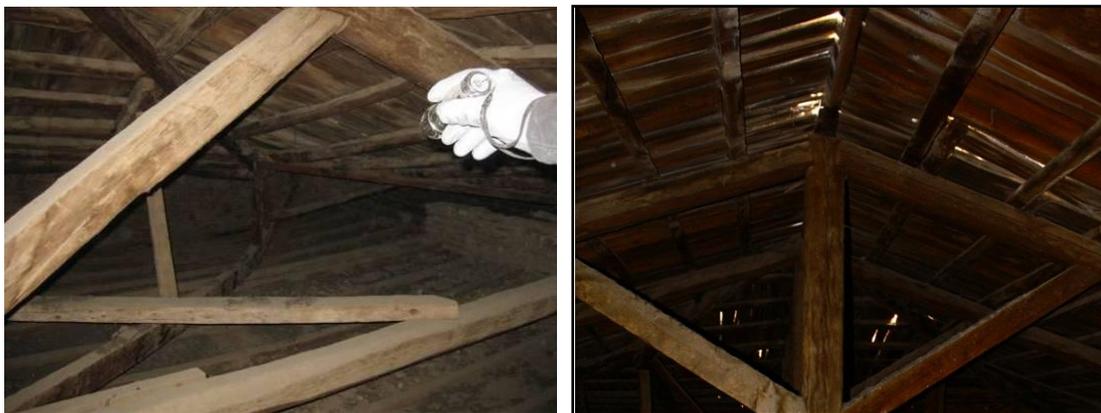
Figure 5.46: Excessive truss deflection

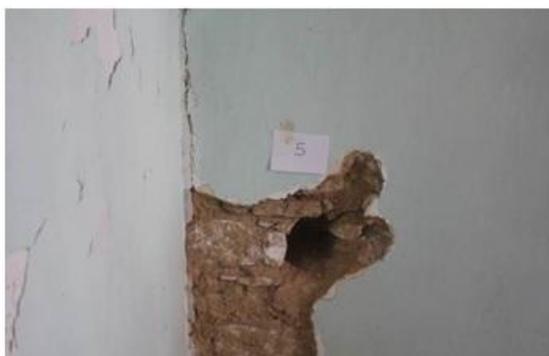
Figure 5.48: Removal of stone D7-MS

The sampling included all types of stones. It was carried out either by carefully removing relatively small stones through the use of chisel or by drilling cores out of larger stones (see Figs. 5.48 and 5.49). The material and specimen types and the locations of sampling are provided in Table 5.2, whereas the precise location of sampling is shown in Figs 5.50 and 5.52.

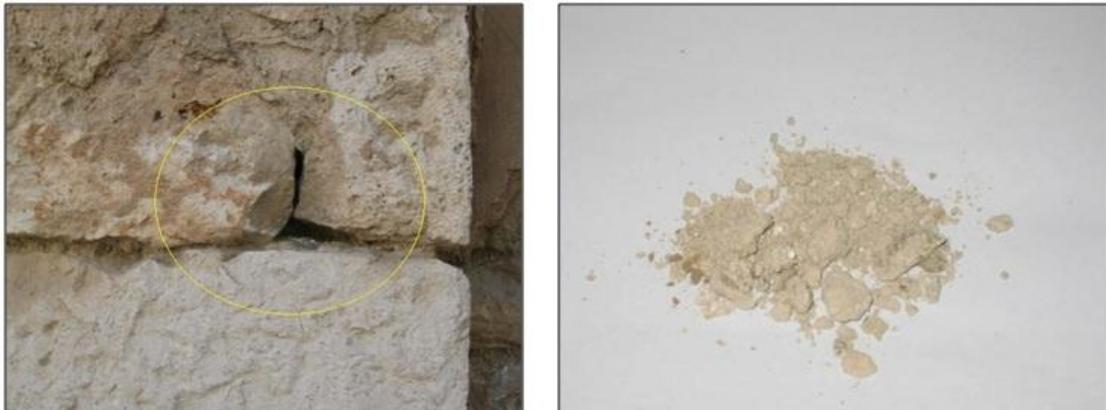
Figure 5.52: Fragmented mortar

From in situ examination the mortar was found weak and friable (see Fig. 5.52) and, as a result, it has not been possible to obtain any suitable samples to estimate its mechanical properties.

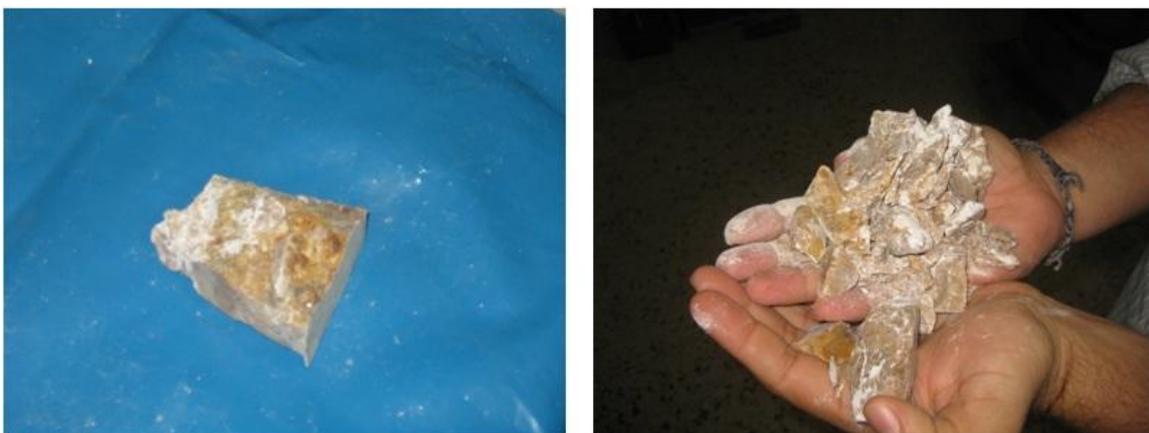
Figure 5.53 The fragmentation and bad mineralogical components of marble

In Figs 5.53, 5.54, 5.55, and 5.56 the XRD patterns of the examined stones samples are presented. According to XRF and XRD analysis, sample VS is a stone of volcanic origin, while samples LS and MS, come from carbonate rocks (crystalline to microcrystalline limestone). In sample VS, a large proportion of amorphous phase is recorded by the XRD analysis, while the main detected mineralogical phases were quartz, alunite, dolomite, and calcite. Stone MS coming from metamorphic carbonate rocks microcrystalline and grainy. The main mineral phase is that of calcite. Other recorded phases are those of quartz, muscovite, clinochlore, and anorthite, but it is estimated that they exist at a low quantity level. Stone LS is a limestone mineral with main mineralogical phase the dolomite and secondary the calcite.

From the chemical and mineralogical characterization of the main building materials in Aktaiou building, is expected that limestone, which contains dolomite and calcite to have better mechanical performance compared to marble (so the builder use it in the walls corner as a connection technique). The marble used in the building contains calcite and iron oxides which effect on its mechanical properties. According to these observations lime stone used in the Aktaiou building in wall corners acting as connection stone technique. On the other hand marbles which probably coming from the cutting process of the marbles were used as ashlar
