National Technical University of Athens (NTUA)
Faculty of civil engineering

**DAMAGE ASSESSEMENT AND REHABILITATION OF
HISTORIC TRADITIONAL STRUCTURES**

Doctoral thesis

Athens 2015

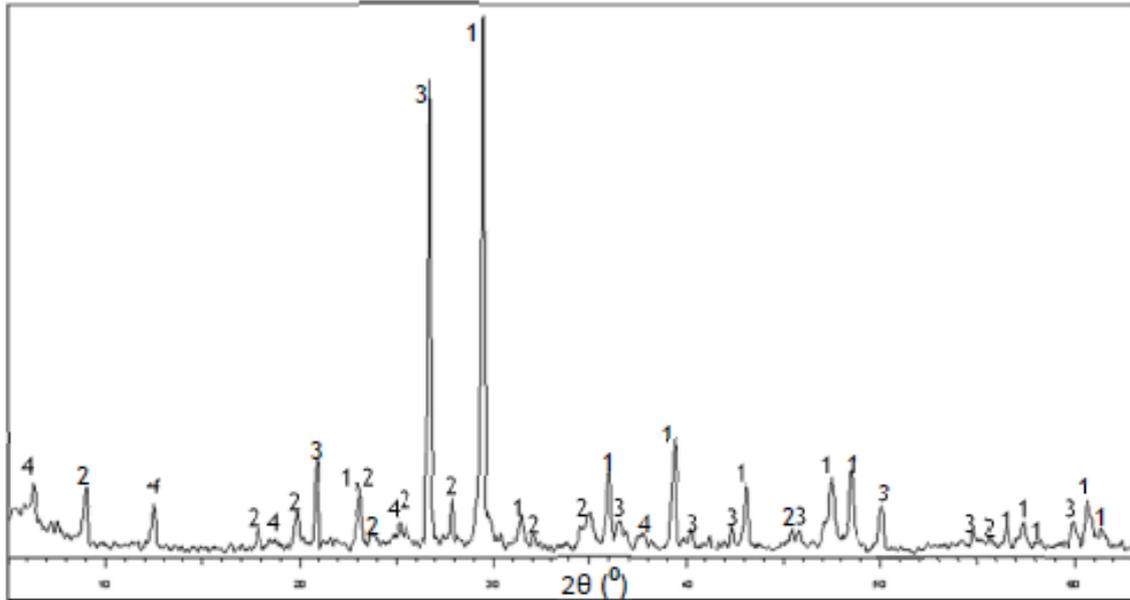
Figure 5.58: XRD pattern of mortar sample, 1: Calcite, 2: Muscovite, 3: Quartz, 4: Clinocllore

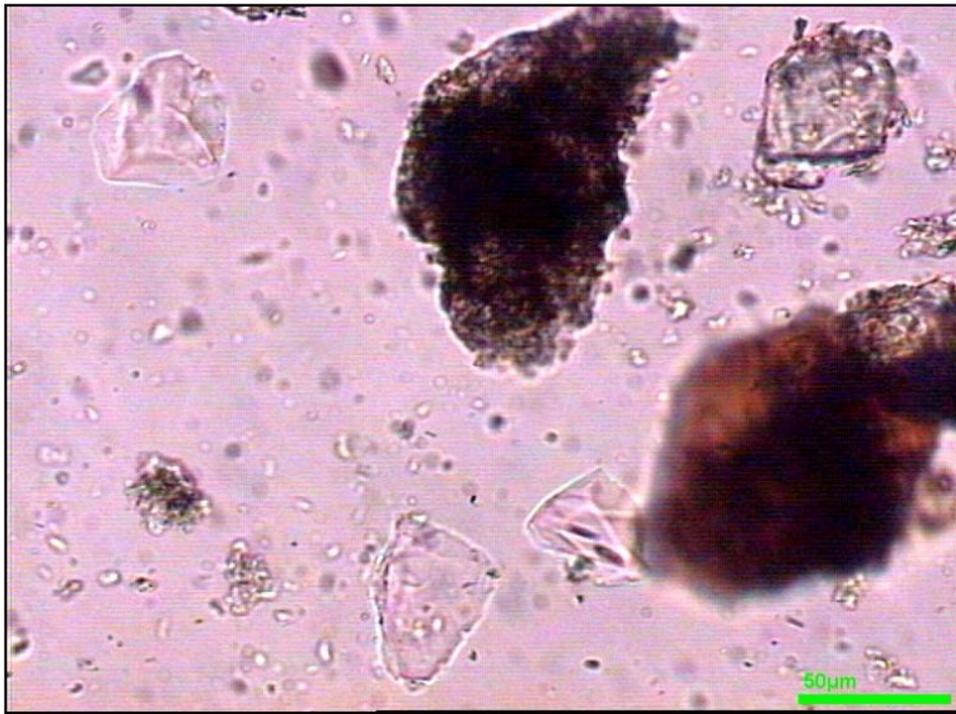
The filtered residual was dried at 105 °C and examined by optical microscopy. It was found that a finely ground glassy phase exists in the sample (Fig. 5.59), which mostly is attributed to a pozzolanic material.

Figure 5.59: Optical microscopy photographs of the mortar sample.

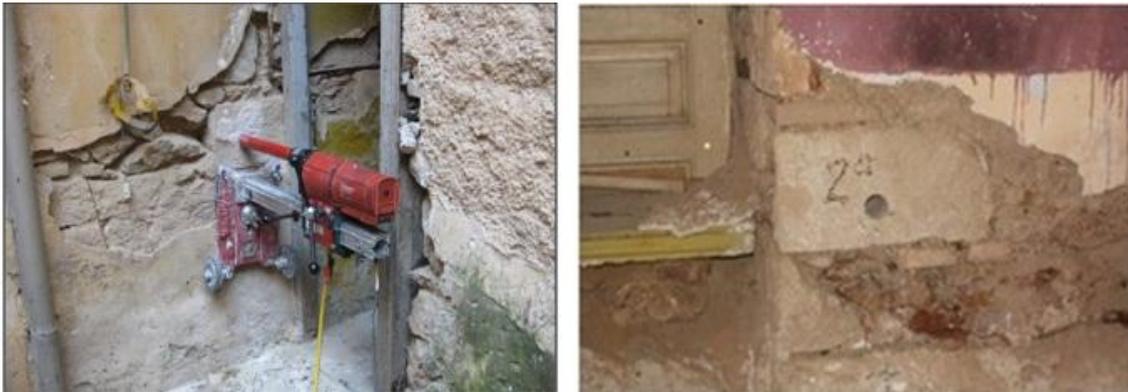
The mechanical characteristics of the samples were established from uniaxial compression tests. The samples chiselled out of the walls were machined to form cubes, whereas those cored out from larger stones (see Figs. 5.60 and 5.61) had their end faces abraded so as become cylinders with a height-to-diameter ratio of 2.

Figure 5.60: Drilling core from a ground floor stone

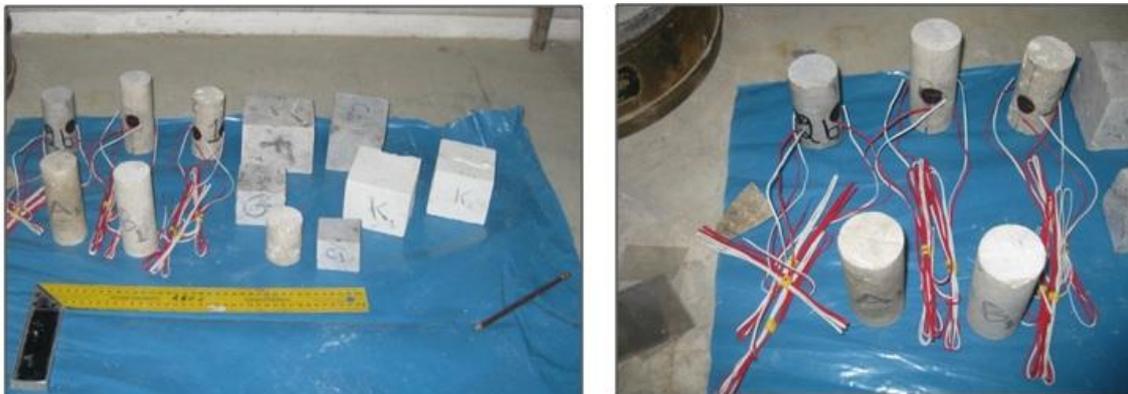
Figure 5.61 Cubic and cylindrical specimens

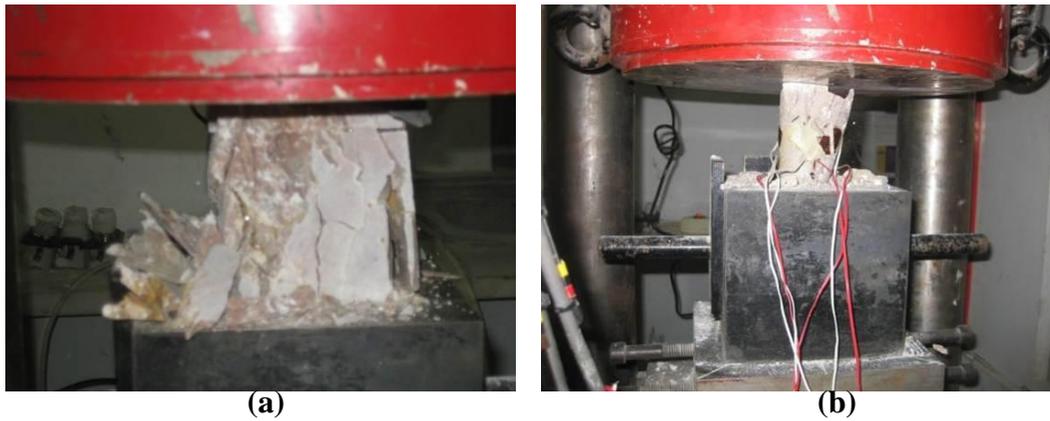
All specimens were weighted before testing. The specimens' dimensions and weight are shown in Tables 5.5 and 5.6. The cubes were used to assess strength only. The axial and transverse strains were measured by placing electrical resistance strain gauges within the middle zone of the cylinders at diametrically opposite each other in the axial and circumferential directions. The testing arrangement for the cubes and cylinders are shown in Fig.5.62. The values of the compressive strength obtained

Figure 5.62: Testing arrangements for (a) cubes and (b) cylinders

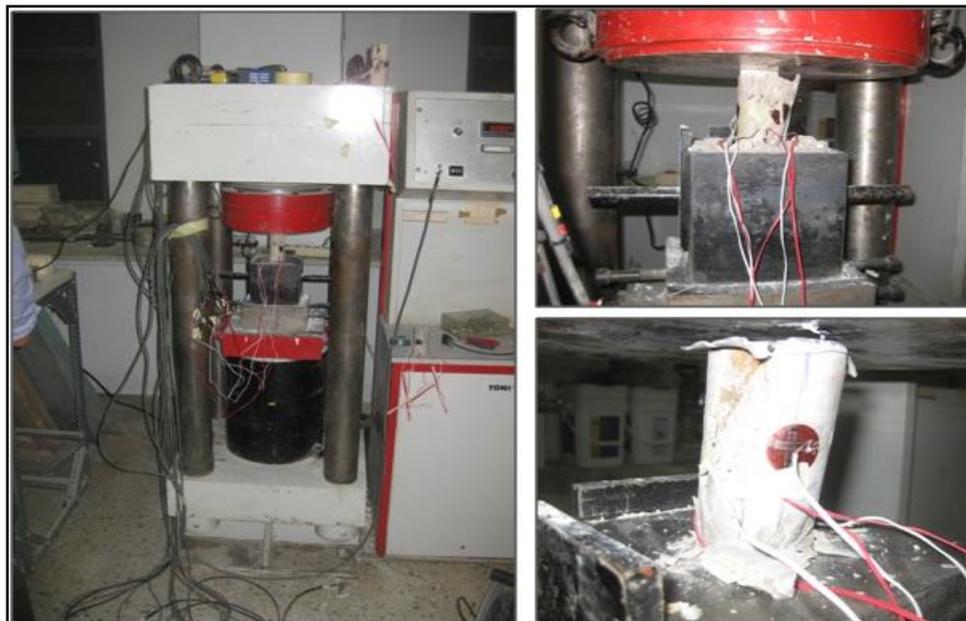
For specimens D10, D11, D12, The axial and transverse strain was measured using strain gauges (see Fig. 5.64) and the stress-strain curves obtained from testing specimens in linear uniaxial compression are shown in Fig. 5.65, 5.66, and 5.67.

Figure 5.64: strain gauges test

For each curve, only the branch corresponding to low deformation level is presented, as for larger deformations strain gauges do not perform reliably, due to their local detachment from the specimens.

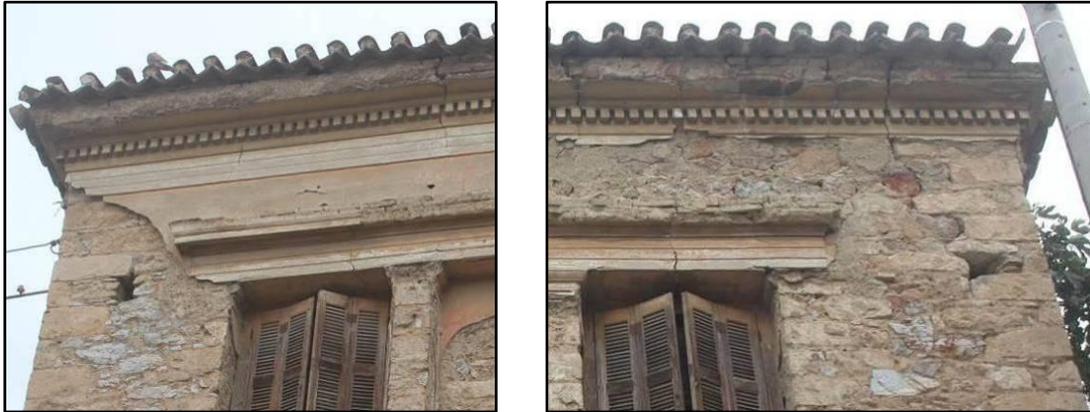
Figure 5.68: Cracking of the wall crowning

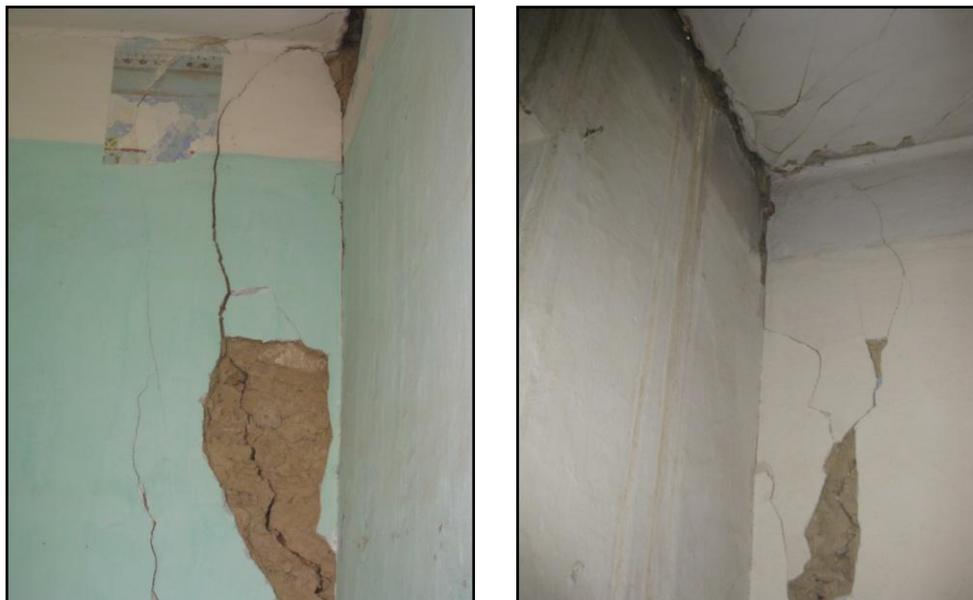
As indicated in Fig. 5.69, the near vertical cracking suffered in the region of the connection of intersecting bearing walls occurred at some distance from the connection itself and this is indicative of tensile failure of the wall masonry rather than failure of the connection.

Figure 5.69: Near vertical near the primary wall intersection

This type of cracking is more pronounced (larger crack widths) at the 1st floor due to the lack of a bracing of the wall crowning. The presence of blind anchors across the wall width (see Fig. 5.18) may have contributed to this type of cracking.

Fig. 5.76 shows the tensile stresses exceeding the tensile strength of the masonry developing in the region of the intersecting walls. It should be noted that it has been assumed that the walls are monolithically connected and this has led to the development of the critical tensile stresses to develop at a small distance from wall connection.

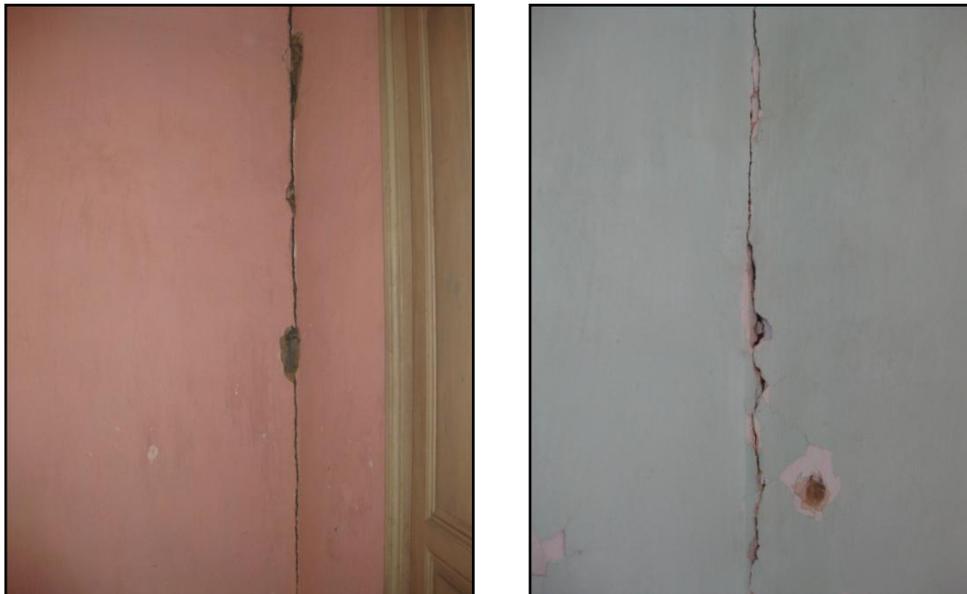
Figure 5.70: Wall separation along the interface between primary and secondary walls

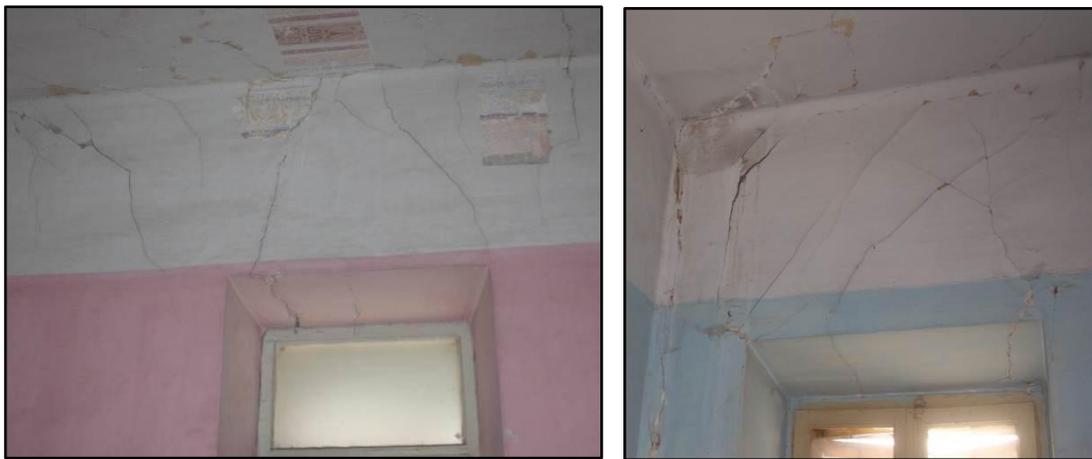
Figure 5.72: Masonry cracking of external wall above windows

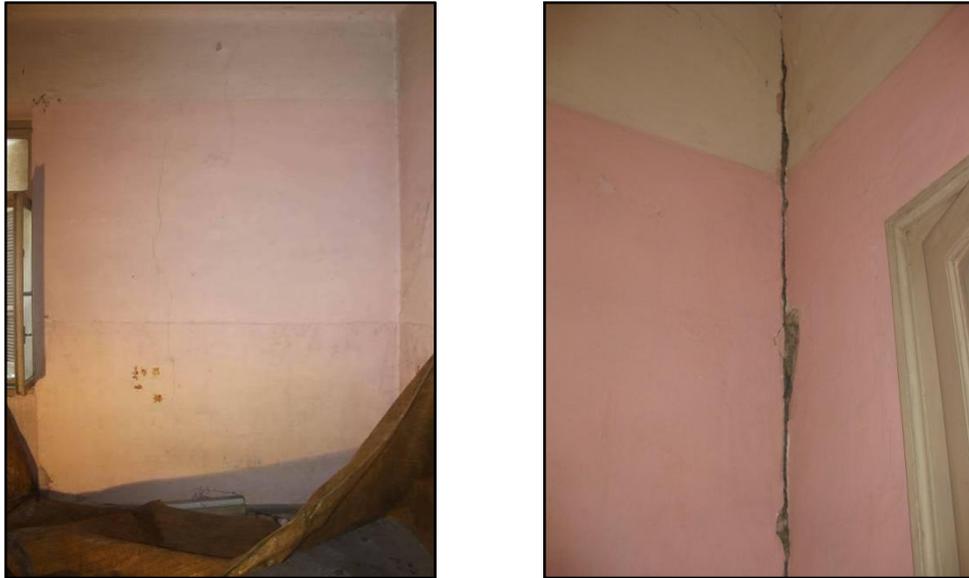
Figure 5.73: Detachment of non bearing walls from bearing walls at 1st level due to lack of connection

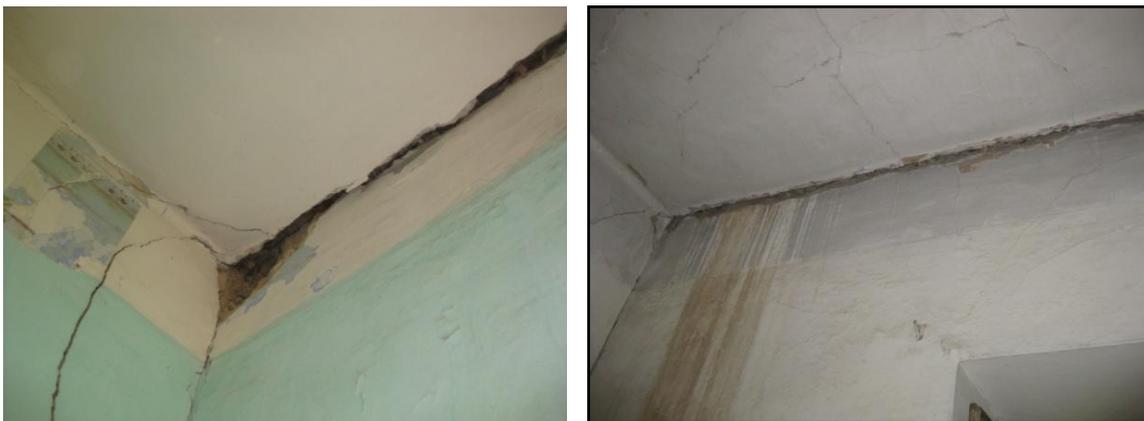
It appears there is separation of the roof from bearing wall (see Fig 5.74). The opening caused in the separation allowed rain water to leak from the roof inside the building, the earthquake movement and the separation may have been caused by relative movements under seismic excitation allowed by the leak of connection between wall and roof.

Figure 5.74 Isolation parts between main bearing walls and the roof

- Replacement of the existing roof with a roof of the same morphology, bracing of the supporting wall crowning with a layer of reinforced concrete, and development of diaphragmatic action through the use of metal rods in crisscrossing arrangement.

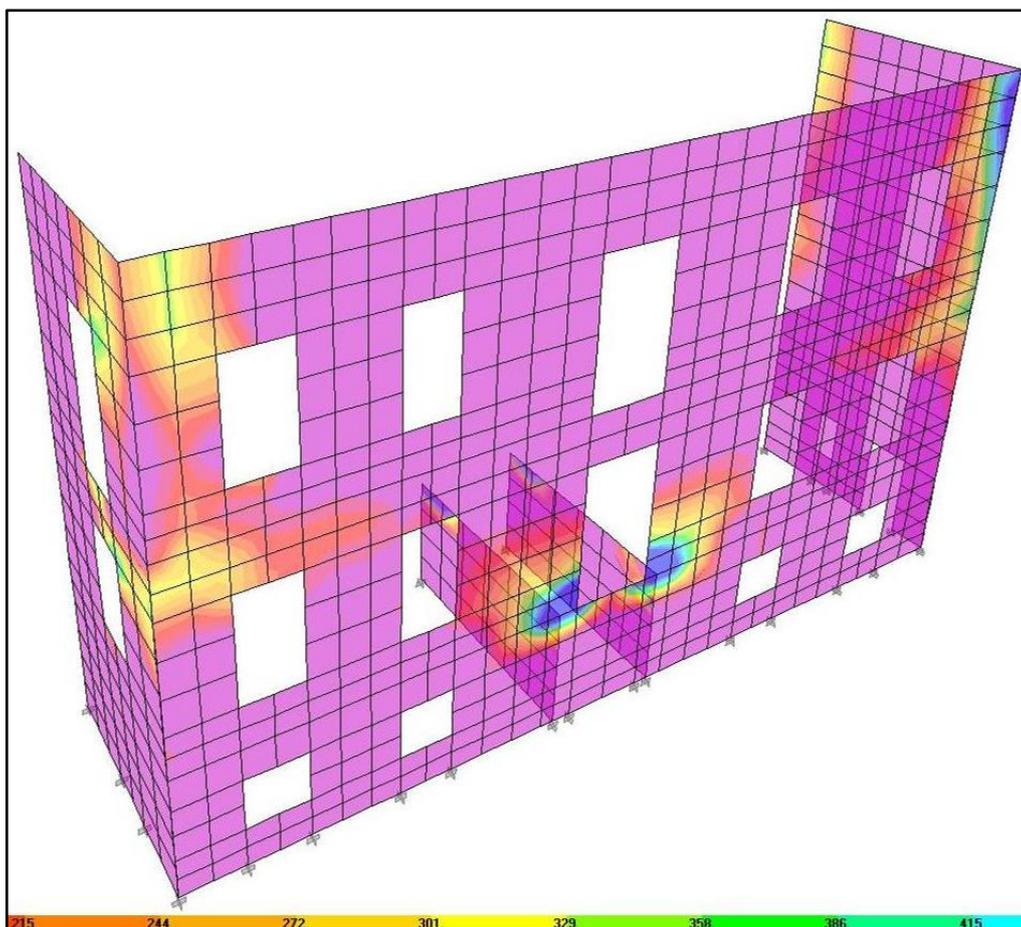
Figure 5.75: Tensile stresses (in kN/m^2) exceeding the tensile strength of masonry developing at the wall crowing under seismic action in the direction y-y (i.e. along the building's façade in Aktaiou street)

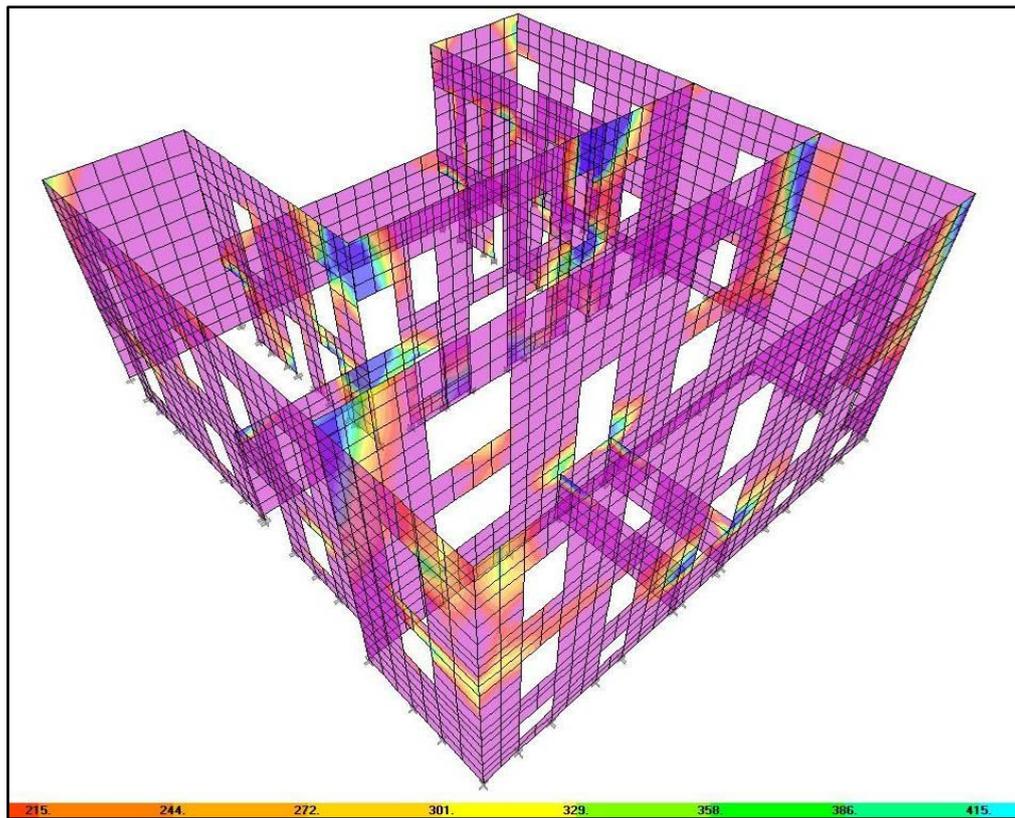
Figure 5.76: Tensile stresses (in kN/m²) exceeding the tensile strength of masonry developing in the region of the wall intersections under seismic action in the direction y-y (i.e. along the building's façade in Aktaiou street)

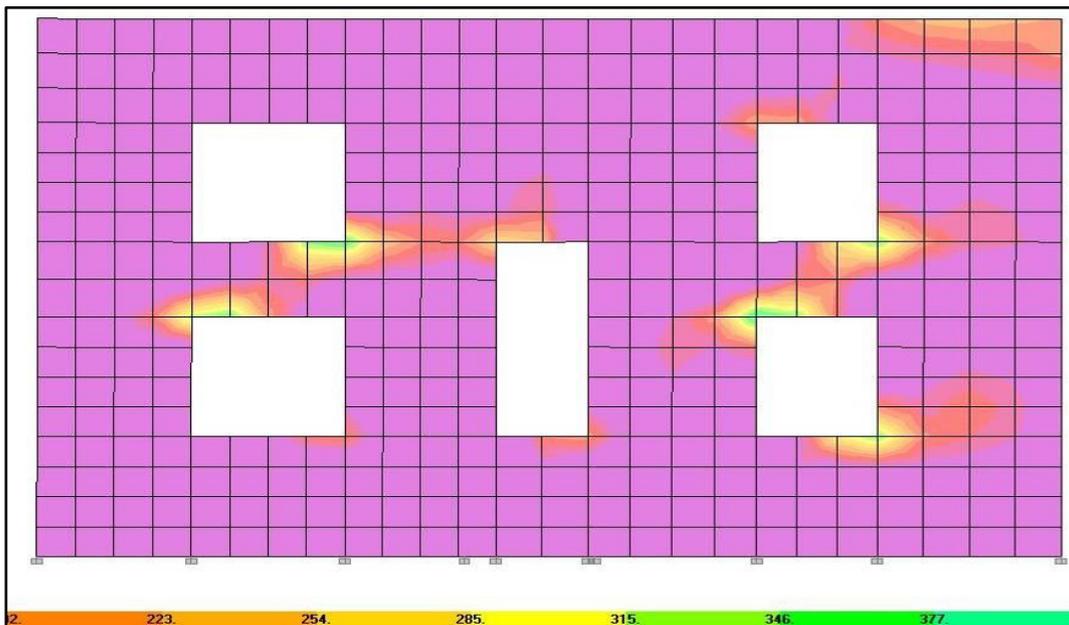
Figure 5.77: Tensile stresses (in kN/m²) exceeding the tensile strength of masonry developing in the region of the openings of a typical internal wall in the x-x direction (i.e. parallel to the building's façade in Lykomidon Street)

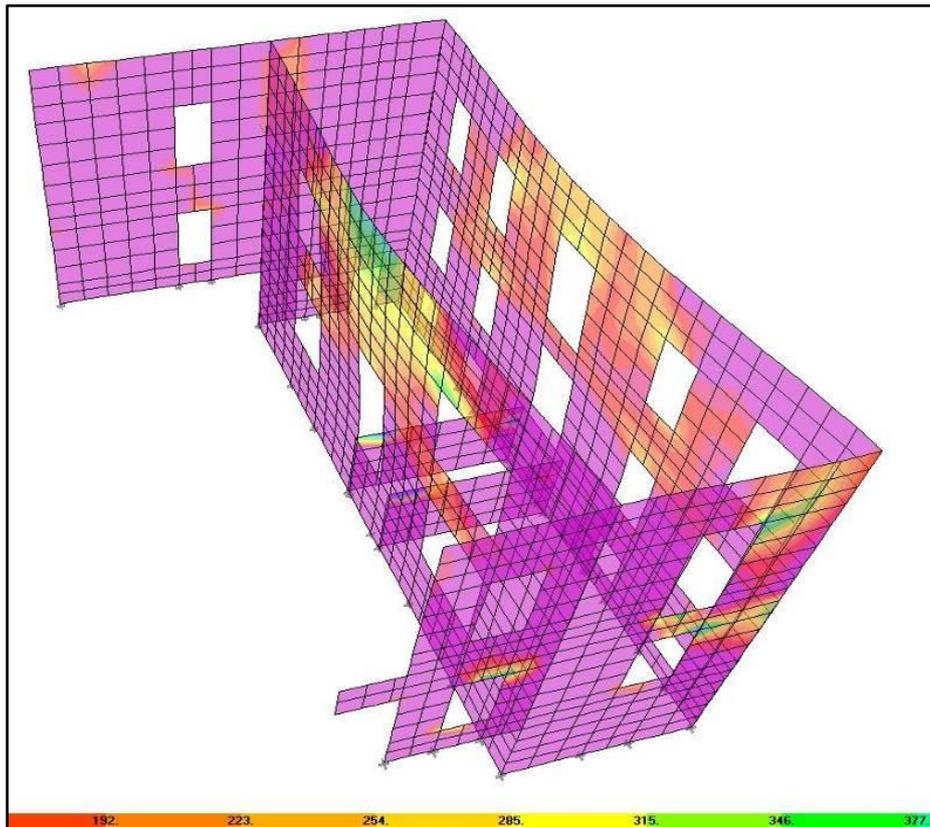
Figure 5.78: Deformed shape and related tensile stresses exceeding the tensile strength of masonry (in kN/mm^2) under the combined action of the service load and seismic excitation in the x-x direction

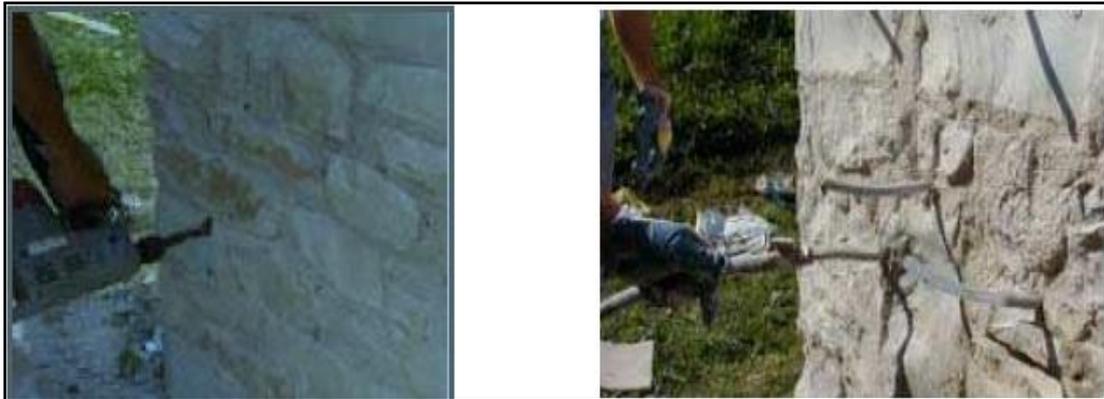
This is particularly suited for the rehabilitation of the masonry that has internal interconnected cracks. The injection of the grout is made through tubes placed in holes drilled throughout the wall surface. For the external cracks the coating should be previously removed. Fig. 5.79 shows processes of drilling and grouting, whereas Fig. 5.80 shows a schematic representation of the location of the injection tubes.

Figure 5.79: Process of drilling (left) and grouting (right)

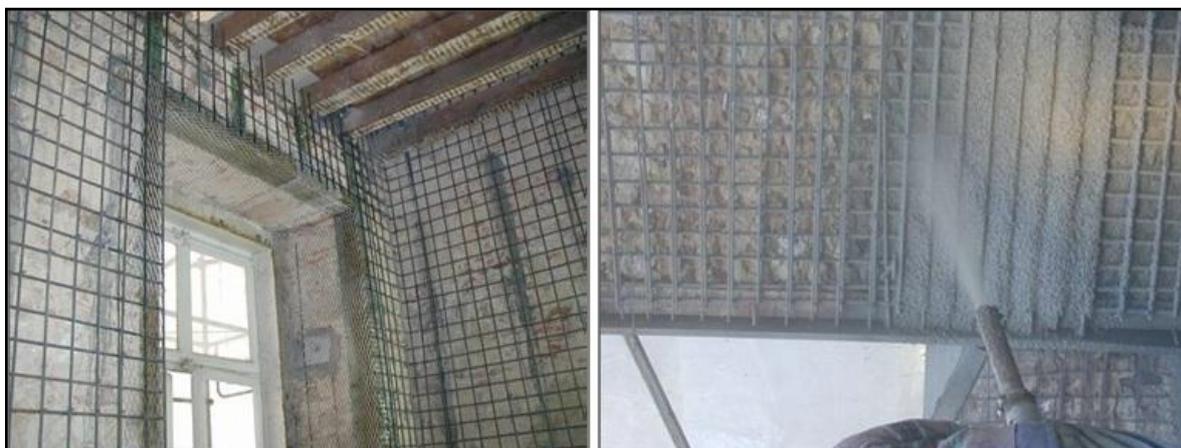
Thin layers of cement paste coating 10 mm thick reinforced with a steel mesh connected to the walls with transverse anchoring rods will be placed on either side of the walls as indicated in Fig. 5.81

Figure 5.81: Steel mesh of cement paste coating

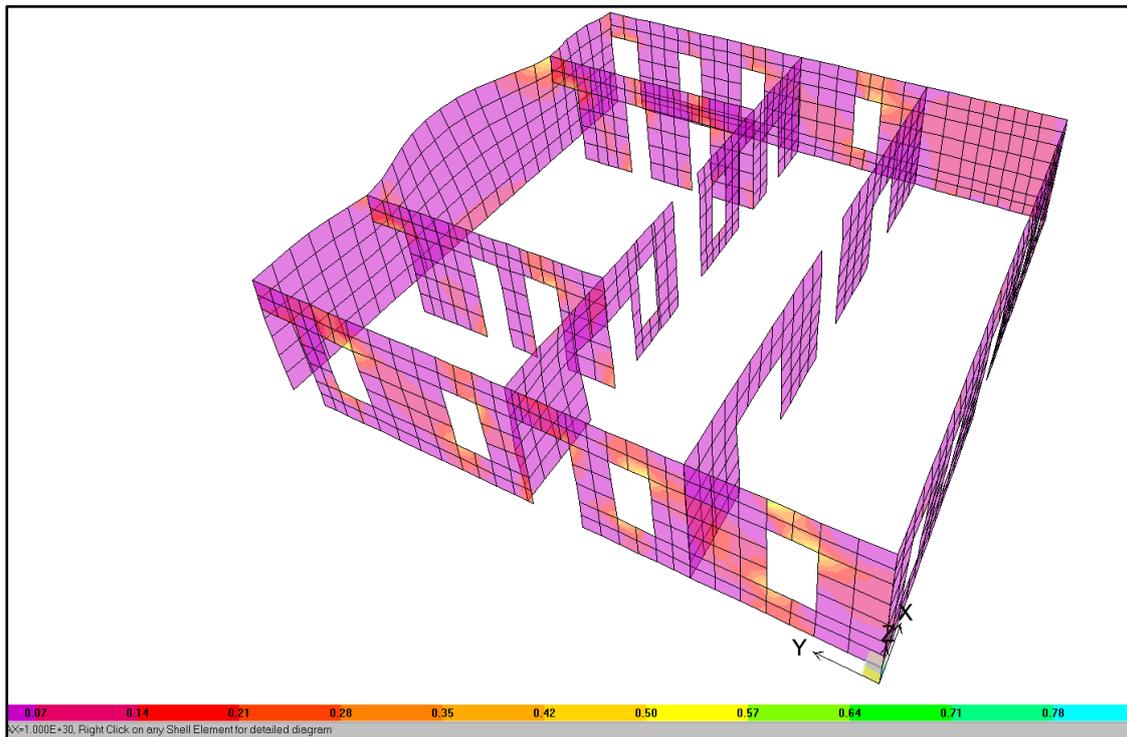
Figure 5.82: Location and intensity of principal tensile stresses (in MPa), larger than the tensile strength of the masonry, developing in the walls of 1st level in the y-y direction of the building under seismic action.

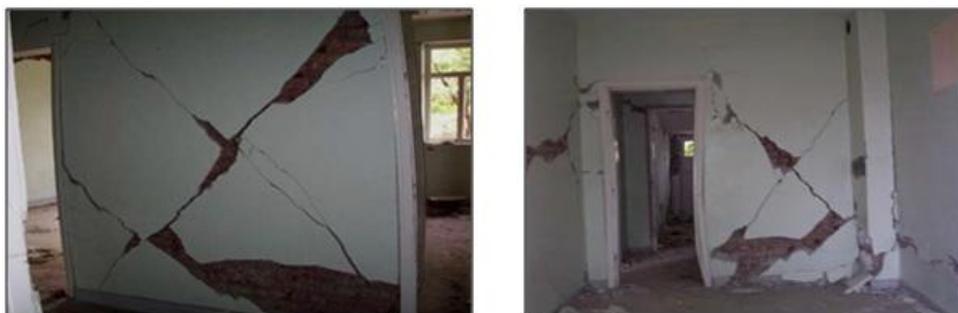
Σχήμα 2.5: Βλάβητοιχώματοςλόγωαπουσίαςεγκάρσιας υποστήριξης (Doğangünetal 2008)

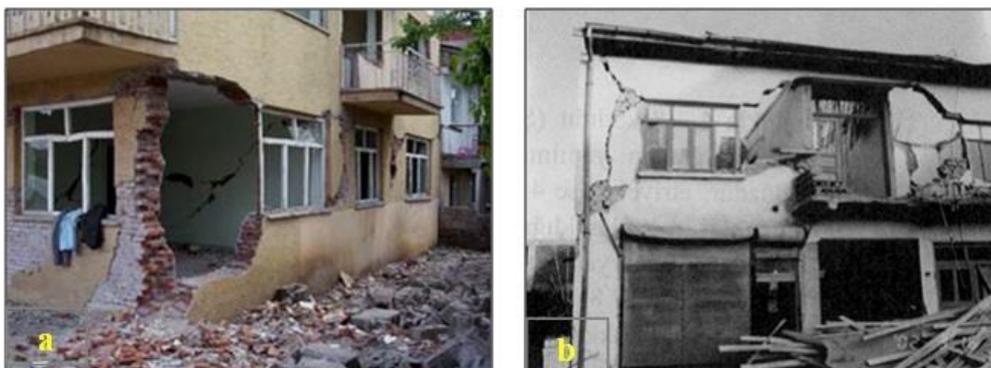
Σχήμα 2.6: Κατάρρευση γωνίας και κατακόρυφη ρηγμάτωση κοντά στη γωνία κτιρίου από τοιχοποιία (Doğangün A. et al., 2008)

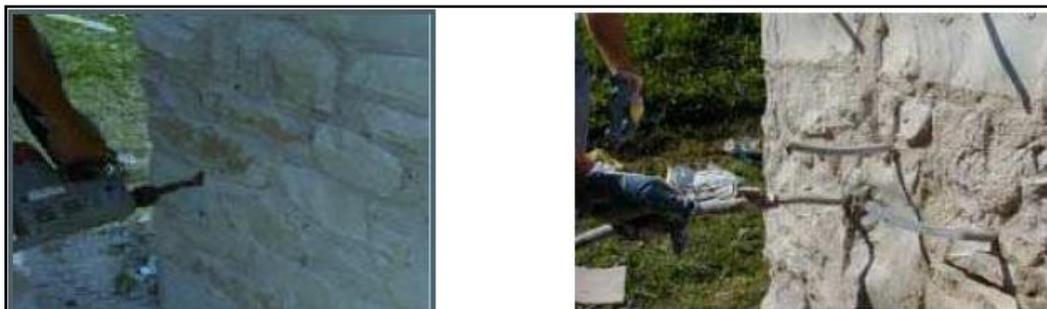
Η λύση αυτή βασίζεται στην έγχυση (μέσω σωλήνων έγχυσης τοποθετημένων σε οπές που έγιναν για το σκοπό αυτό σε πολλά σημεία του τοίχου) ρευστού τσιμεντοκονιάματος σε εσωτερικά κενά και ρωγμές (βλέπε Σχ. 4.1) Αυτή η τεχνική δείχνει βελτιώνει τα μηχανικά χαρακτηριστικά της τοιχοποιίας. Είναι πιο κατάλληλη για λιθοδομή (Meireles και Bento 2013).

Σχήμα 4.1: Τεχνικές έγχυσης ρευστού τσιμεντοκονιάματος (Meireles and Bento 2013).

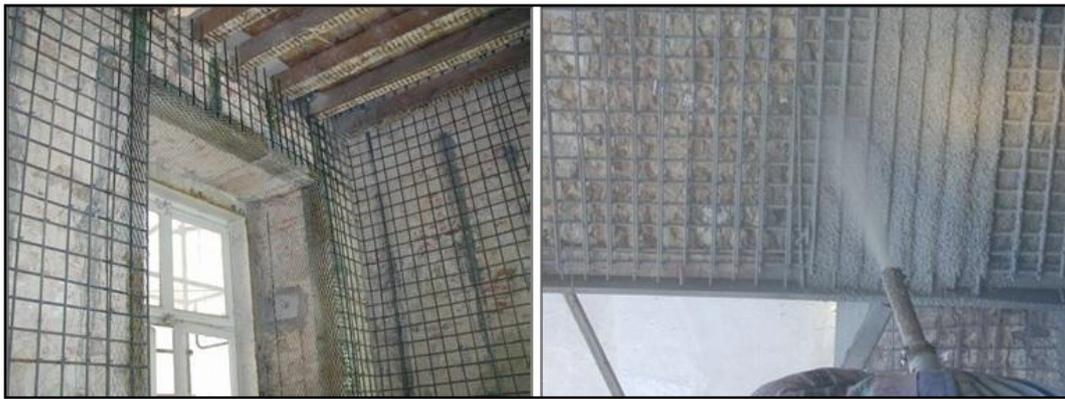
Σχήμα 4.2: Τοιχοποιία ενισχυμένη με μεταλλικό πλέγμα στο εσωτερικό του κτιρίου (Rashadul 2008)

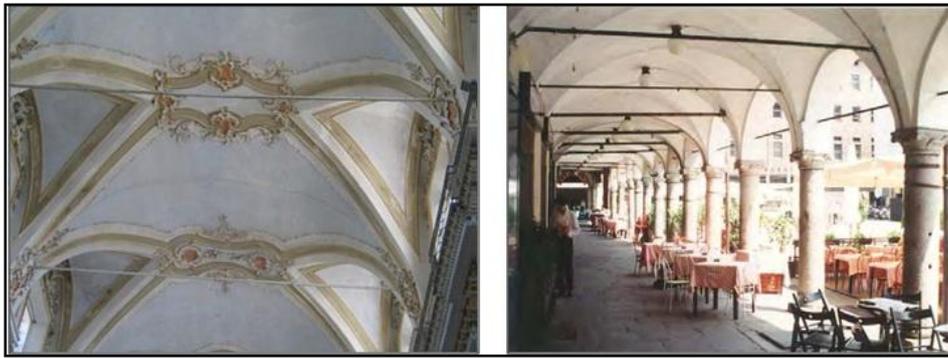
Η προένταση μπορεί να επιβληθεί για το κλείσιμο ή τον έλεγχο ρωγμών σε στοιχεία τοιχοποιίας ή για την αύξηση της καμπτικής ροπής ρηγμάτωσης σε νέες κατασκευές. Προένταση έχει εφαρμοστεί με επιτυχία σε ποικιλία κατασκευών από τοιχοποιία. Η έλευση προηγμένων σύνθετων υλικών παρέχει μια εναλλακτική λύση για μέτρα προστασίας από διάβρωση που είχαν υιοθετηθεί παλαιότερα. Ειδικότερα, τα ινοπλισμένα πολυμερή έχουν ελκυστικές ιδιότητες για εφαρμογές προέντασης (Rashadul 2008).

Σχήμα 4.4: Χρήσηελκυστήρωναπόμεταλλικέςράβδους σε τόξα (Rashdul 2008)

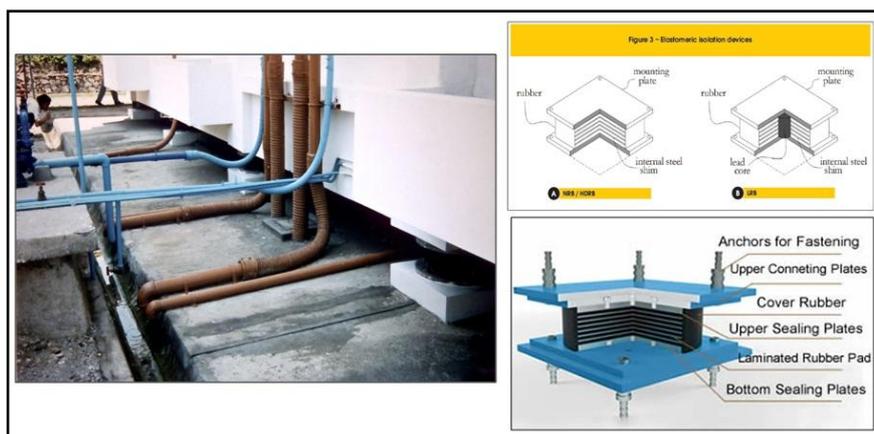
Σχήμα 4.6:Συστήματα σεισμικής μόνωσης

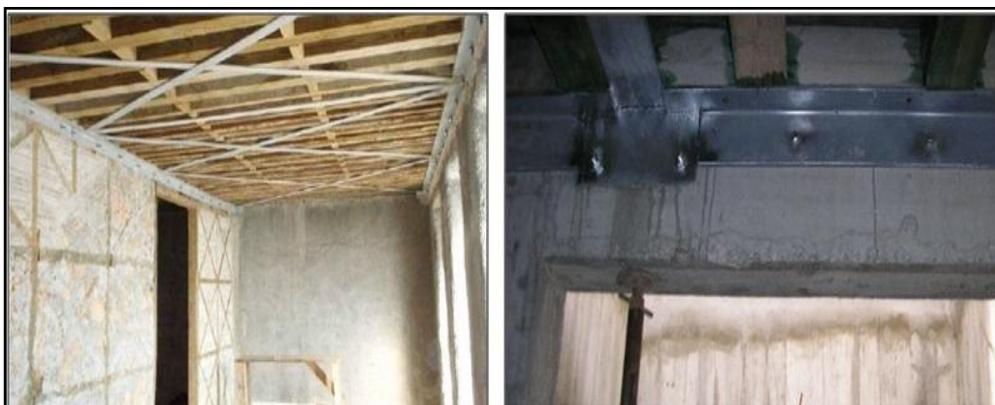
Η αύξηση της δυσκαμψίας των δαπέδων επιτρέπει την ανακατανομή των οριζόντιων δυνάμεων μεταξύ των διαφόρων κατακόρυφα δομικά στοιχεία, και, στη συνέχεια, όταν υπάρξει αδυναμία περαιτέρω ανάληψης φορτίου από ορισμένα στοιχεία, οι οριζόντιες δυνάμεις μπορούν να αναδιανεμηθούν στα γειτονικά υπόλοιπα στοιχεία. Η αύξηση της δυσκαμψίας των δαπέδων επιτυγχάνεται με την προσθήκη στο δάπεδο μιας οριζόντιας κατασκευής αποτελούμενης από ράβδους χάλυβα τοποθετημένες χιαστί όπως φαίνεται στο Σχ. 4.7 και έχει αναπτυχθεί εδώ και πολλές δεκαετίες.

Σχήμα 4.7: Αύξηση δυσκαμψίας δαπέδου μέσω Προσθήκης κατασκευής από χιαστί τοποθετημένες ράβδους χάλυβα διατομής L .

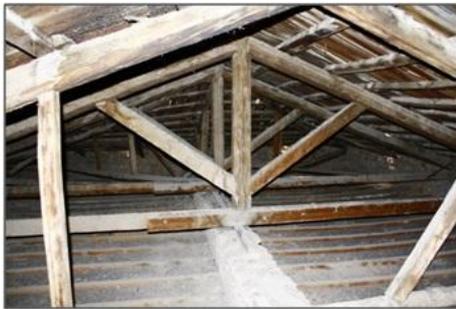
Σχήμα 5.7: Δικτύωμα κεντρικής στέγης

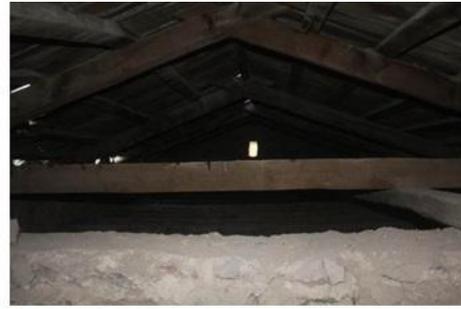
Σχήμα 5.8: Δικτύωμα πλευρικών στεγών

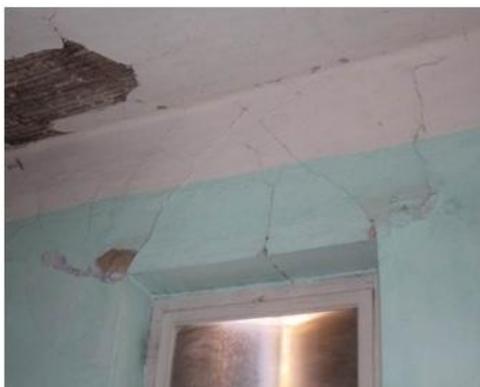
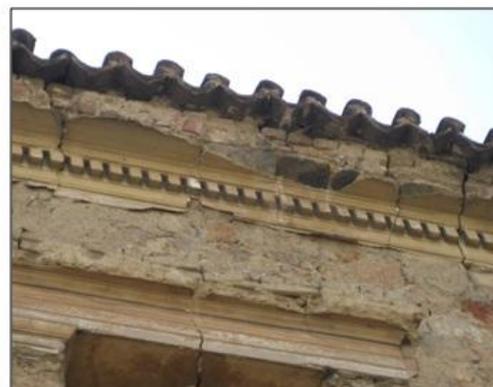
- Κεκλιμένες και κατακόρυφες ρωγμές με μικρό σχετικά πλάτος που δεν εκτείνονται σε όλο το πάχος του τοιχώματος (βλέπε Σχ. 5.9).
- Κατακερματισμός του κονιάματος τοιχοποιίας.
- Εκτεταμένη απόσπαση και απώλεια του σοβά του τοίχου.
- Ενεργές βαθιές ρωγμές ανάμεσα στον τοίχο και την οροφή (βλ. Σχ. 5.10).
- Διαγώνιες ρωγμές στους τοίχους (βλ. Σχ. 5.11).
- Τοπικές αστοχίες και νεγάλα βέλη των φερόντων μελών της στέγης και κατάρρευση των ξύλινων χαγιατιών (βλ. Σχ. 5.12).

Σχήμα 5.9: Ρηγμάτωση υπέρυθρου στο εσωτερικό (W1-in, 1^{ος} όροφος) και εξωτερικό (W1-ex, 1^{ος} όροφος) του κτιρίου

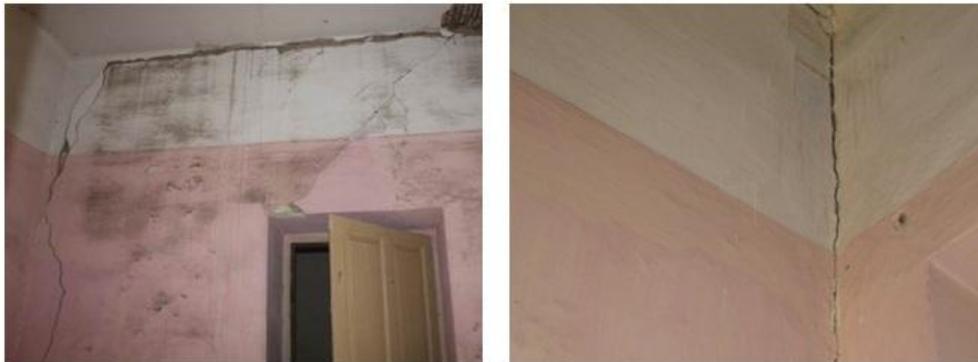
Σχήμα 5.10: Κατακόρυφη ρηγμάτωση στη σύνδεση τοίχων(W6-in, 1^{ος} όροφος)

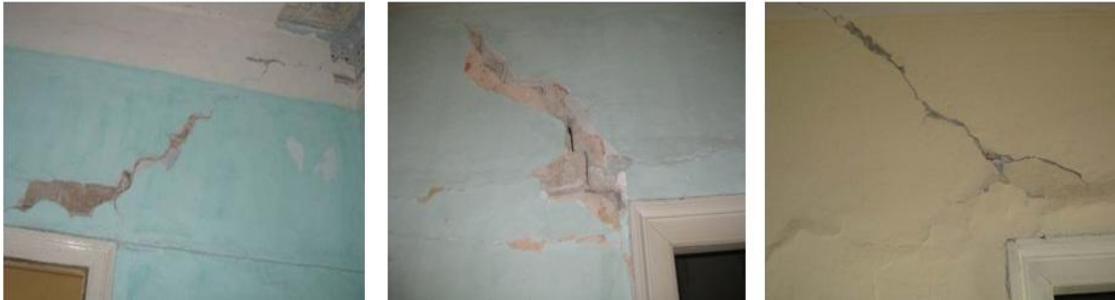
Σχήμα 5.11: Χαρακτηριστική διαγώνια ρηγμάτωση δευτερεύοντος τοίχου

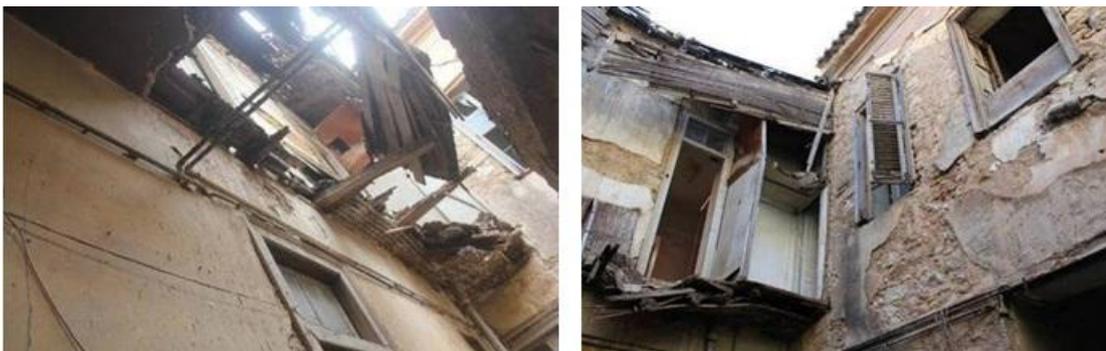
Σχήμα 5.12: Χαγιάτια σε κατάρρευση

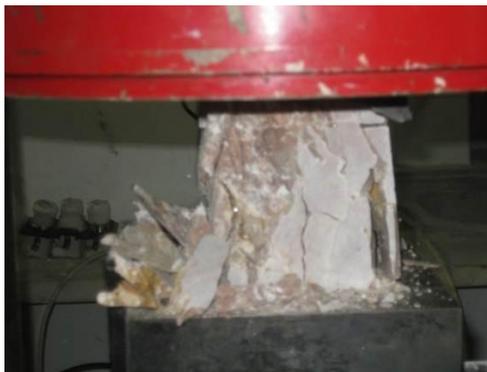
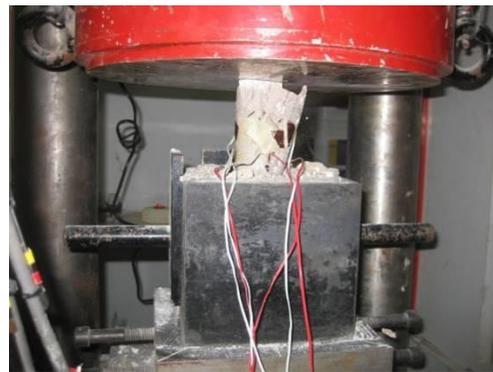
Σχήμα 5.15: Διάταξηδοκιμής (α) κύβωνκαι (β) κυλίνδρων

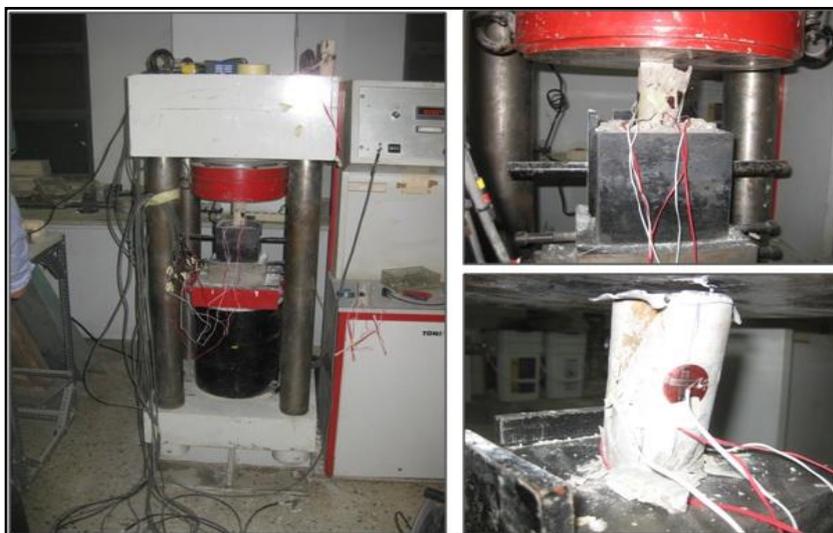
Σχήμα 5.16: Πειραματική διάταξη δοκιμής κυλίνδρων

Η μέση θλιπτική αντοχή που προέκυψε από τα πειράματα ήταν 25,2 MPa για το μάρμαρο, 33,5 MPa για τον ασβεστόλιθο και 5,3 MPa για την ελαφρόπετρα. Για κάθε καμπύλη, μόνο ο κλάδος που αντιστοιχεί σε χαμηλό επίπεδο παραμόρφωσης παρουσιάζεται, καθώς για μεγαλύτερες παραμορφώσεις τα ηλεκτρομηκυσιόμετρα δεν αποδίδουν αξιόπιστα, λόγω της τοπικής αποκόλλησής τους από τα δείγματα.
