EXPERIMENTAL STUDY OF ROCKING ISOLATION :
APPLICATION TO THE RETROFIT OF AN EXISTING BUILDING

MSc Thesis
Nonika Antonaki

Supervised by
Professor G. Gazetas
Dr. I. Anastasopoulos

June 2012

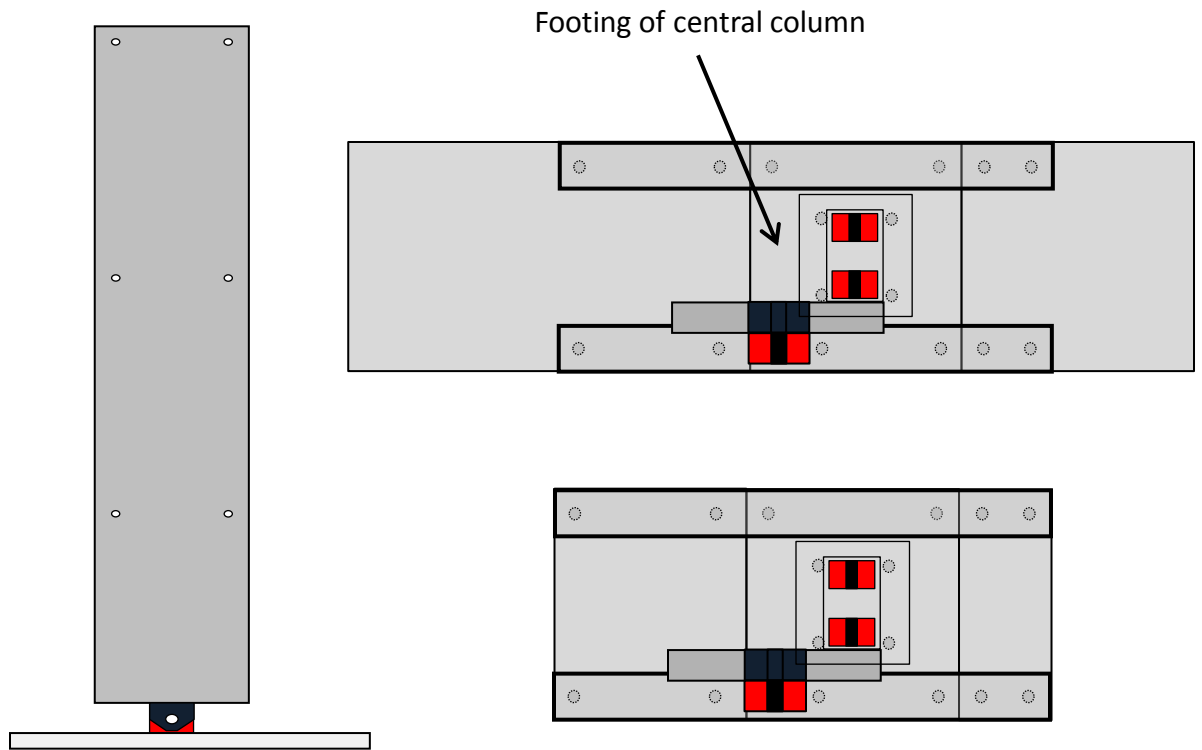
Figure 2.3 Schematic illustration of reinforcing wall and its foundation.

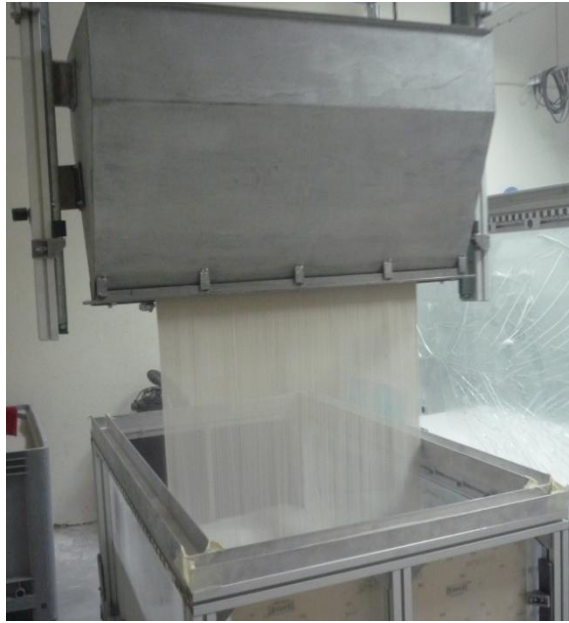
Figure 2.5 Photograph of electronically controlled sand raining system. Summary of pluviation results : relative density D_r versus pluviation height, raining speed and opening aperture size.

The physical models of the building were installed inside a transparent soil container. The soil consists of dry “Longstone” sand, a very fine industrially-produced uniform quartz sand having a mean grain size $d_{50} = 0.15$ mm [Anastasopoulos et al., 2010b]. In order to ensure a specific value of sand density and its repeatability in every experiment, the Laboratory’s sand raining system is used. Through this system, it is possible to choose and audit the mechanical characteristics of the soil. This procedure is called sand pluviation. The density depends on the height measured from the bottom of the sandbox, the aperture of the device and the velocity of the soil hopper. The selection of the suitable values of these three parameters is made according to Figure 2.5, which summarizes the results of an

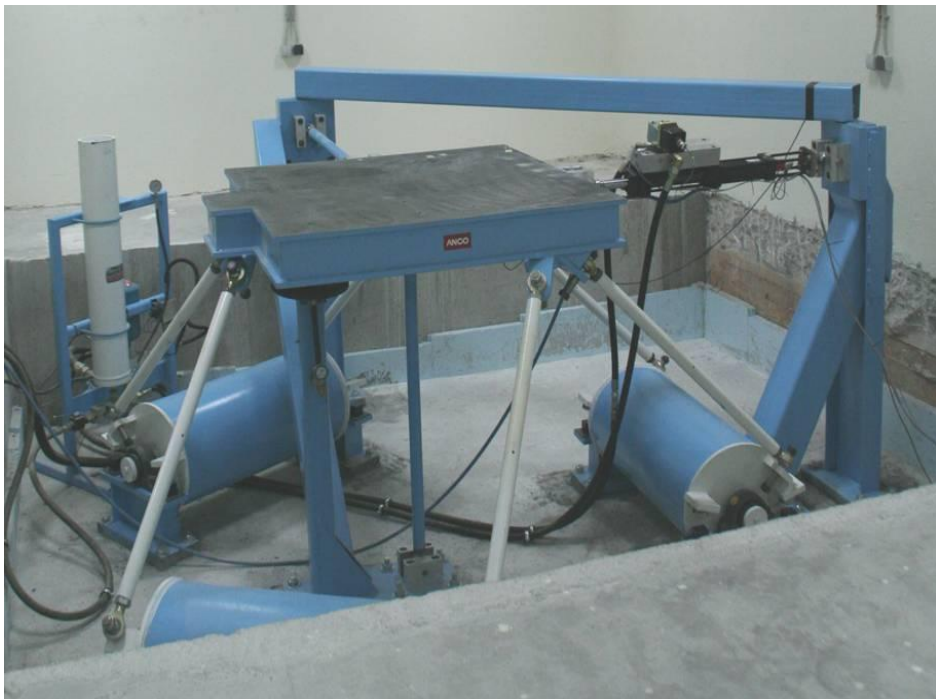
Figure 2.6 Photograph of the pushover apparatus.

Horizontal displacements are applied through a pushover apparatus, which consists of a servomotor joined to a screw-jack actuator (Figure 2.6). The servomotor is controlled by a computer, where the desired displacement, acceleration and velocity can be selected. A device capable of measuring the applied load (load cell) is connected at the edge of the actuator. A load cell of 10 kg loading capacity is used for the calibration of beams and columns and one of 200 kg loading capacity for the walls.

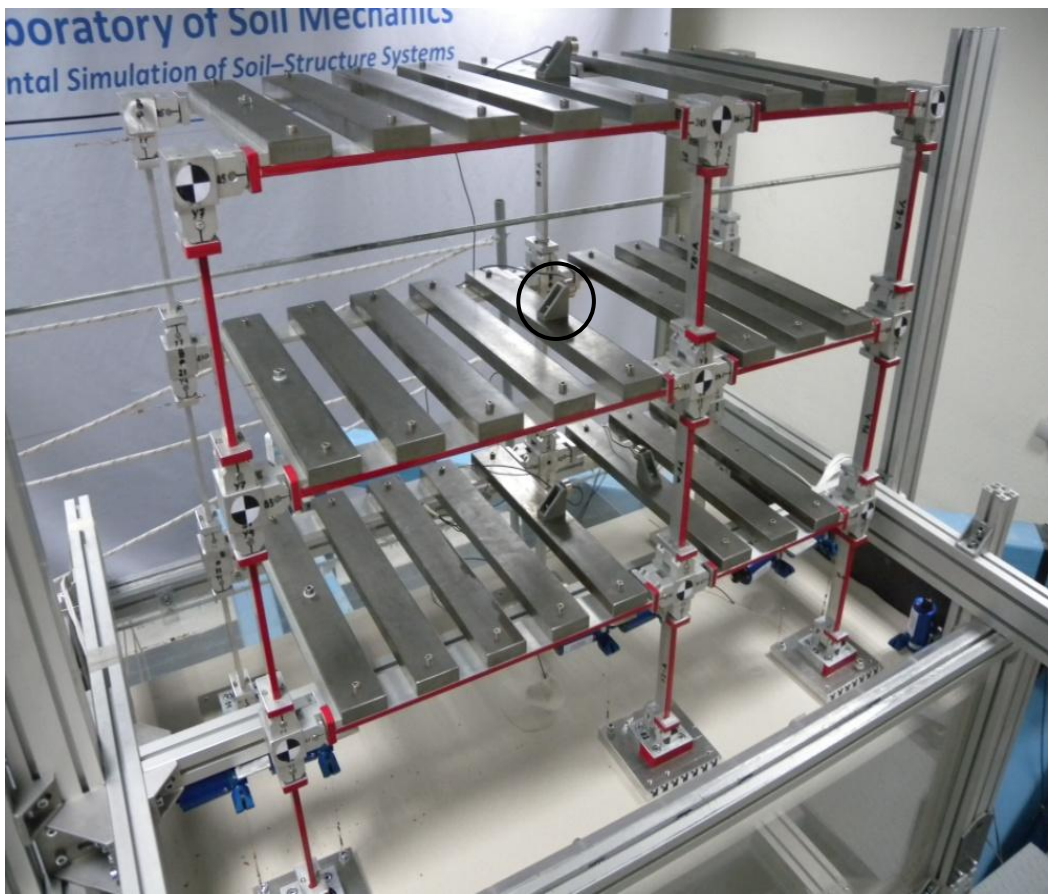
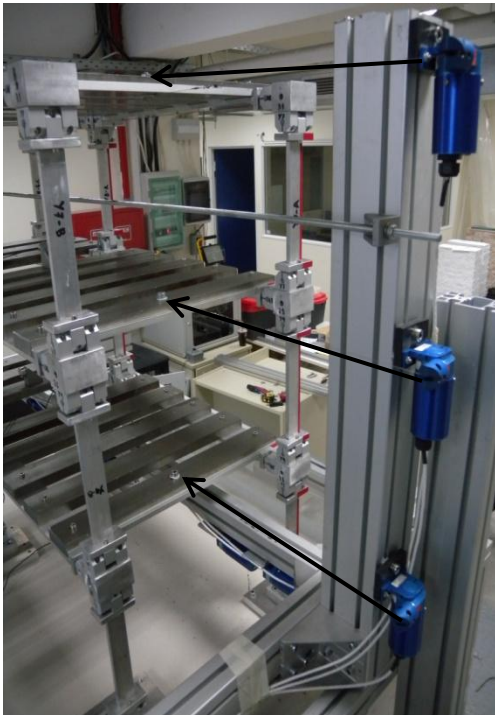
Figure 2.10 Photograph of accelerometers and wired displacement transducers.

A number of instruments were used to measure accelerations and displacements. The horizontal in – plane acceleration was measured by accelerometers on every storey, as well as in a small depth from the soil surface. The exact set - up of the instruments is shown in Figure 2.9. The horizontal in – plane displacement of each storey was measured by wired displacement transducers and was processed in order to calculate the inter – storey drift. A fourth displacement transducer measured the sliding of the central footing, which was then

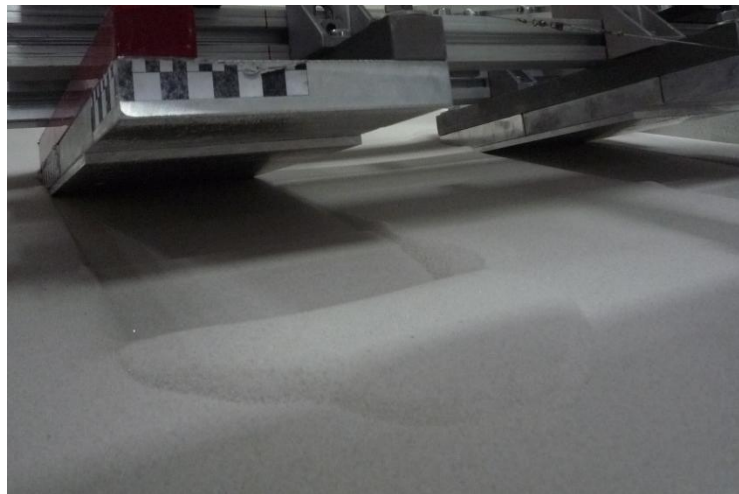
Figure 2.12 Photographs of model during a pushover test.

dense sand as previously described. The horizontal displacement was applied by the pushover apparatus close to the center of mass of the model, below the second storey. Six wired displacement transducers were used to measure the displacement that was imposed, the settlements of both footings and the sliding of the system (Figure 2.11). A load cell was attached to the pushover apparatus and measured the reaction force throughout the test (Figure 2.12).

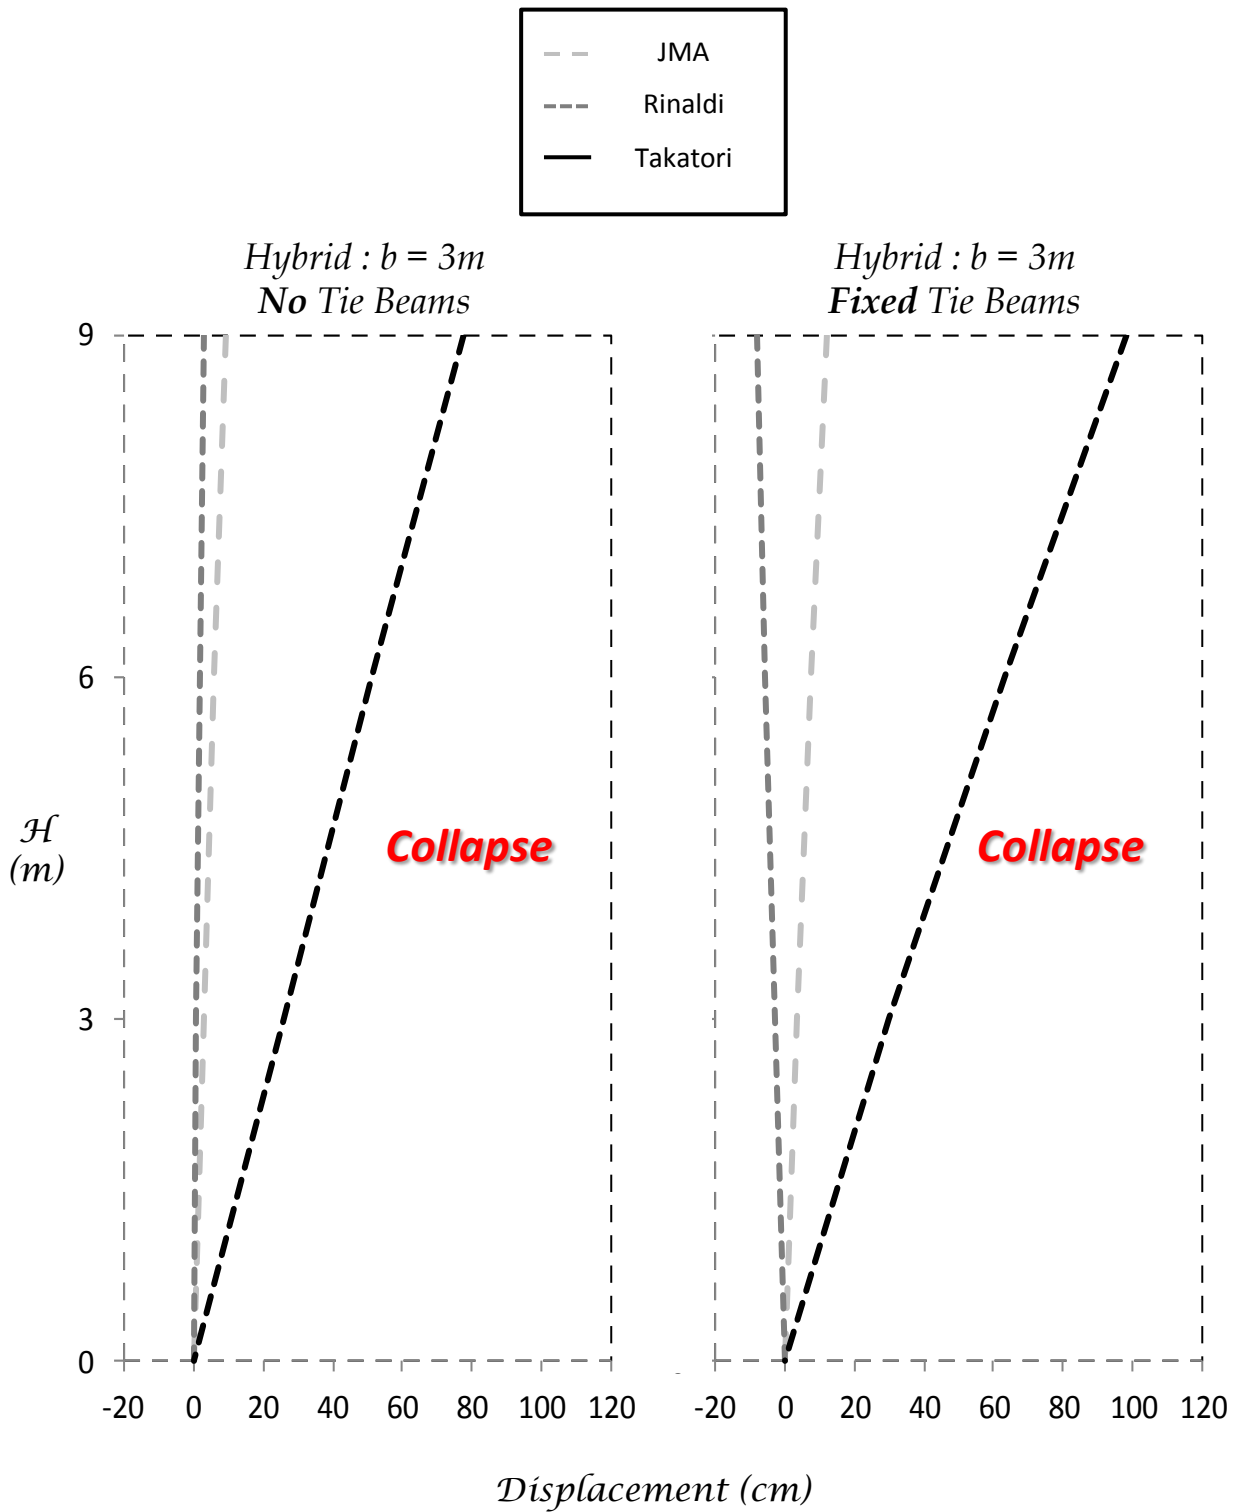
Figure 5.13 Comparison of displacement distribution with height between retrofitted building with rocking isolation ($b = 3\text{m}$) and with fixed tie beams after being submitted to seismic records of high intensity.
