Photographic Record

Former 12th Primary School

Vas.Georgiou 27 & Mpizaniou St.

M.Xofi - 2011

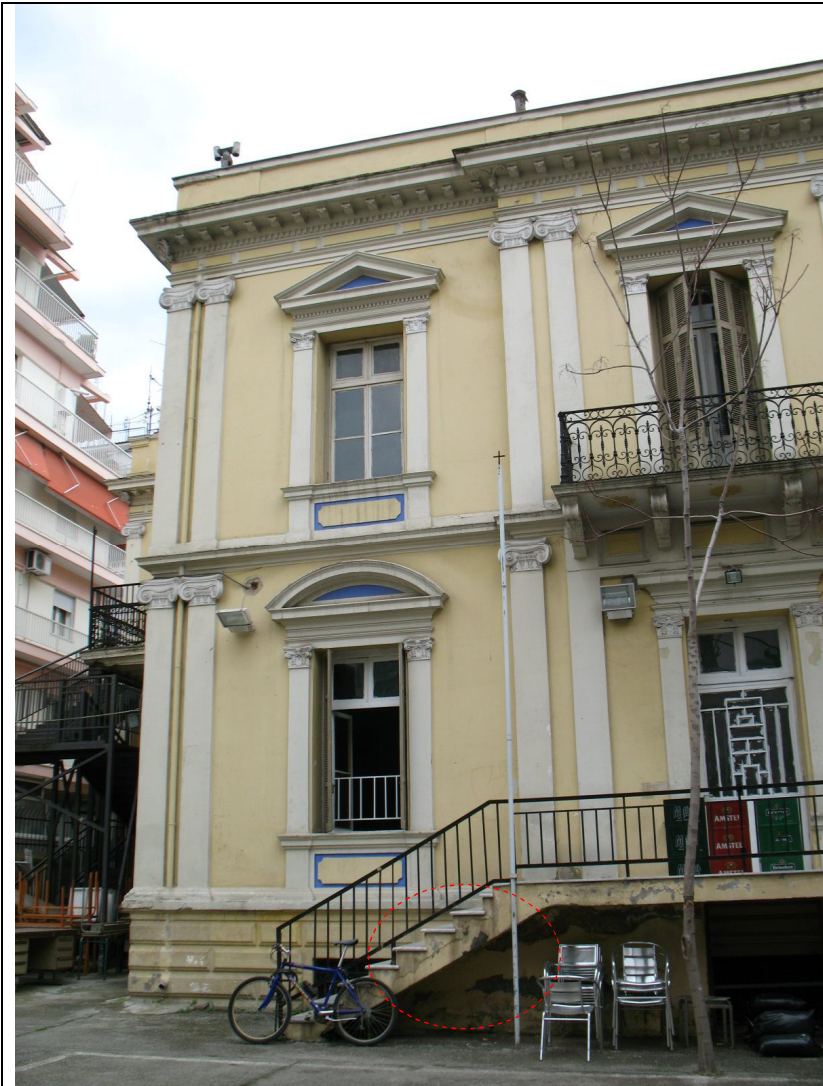
Description: Ph.10a- North part of west elevation.

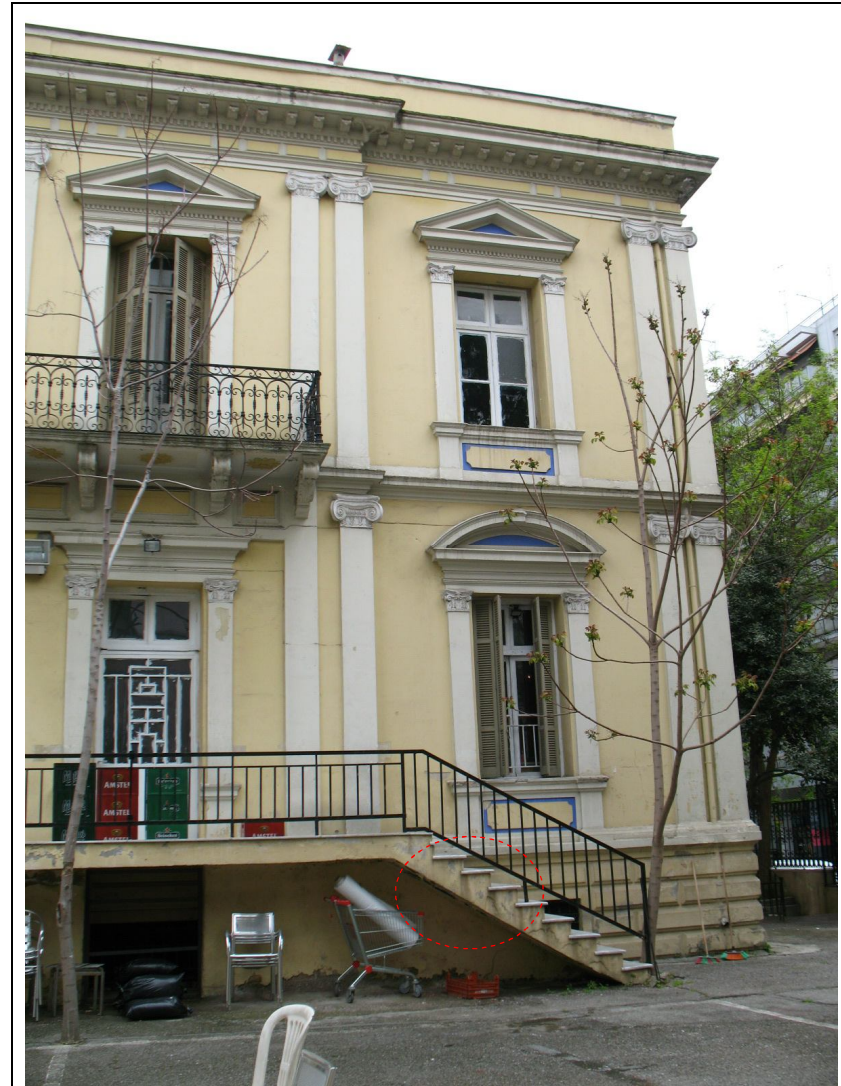
Description: Ph.10b- South part of west elevation.

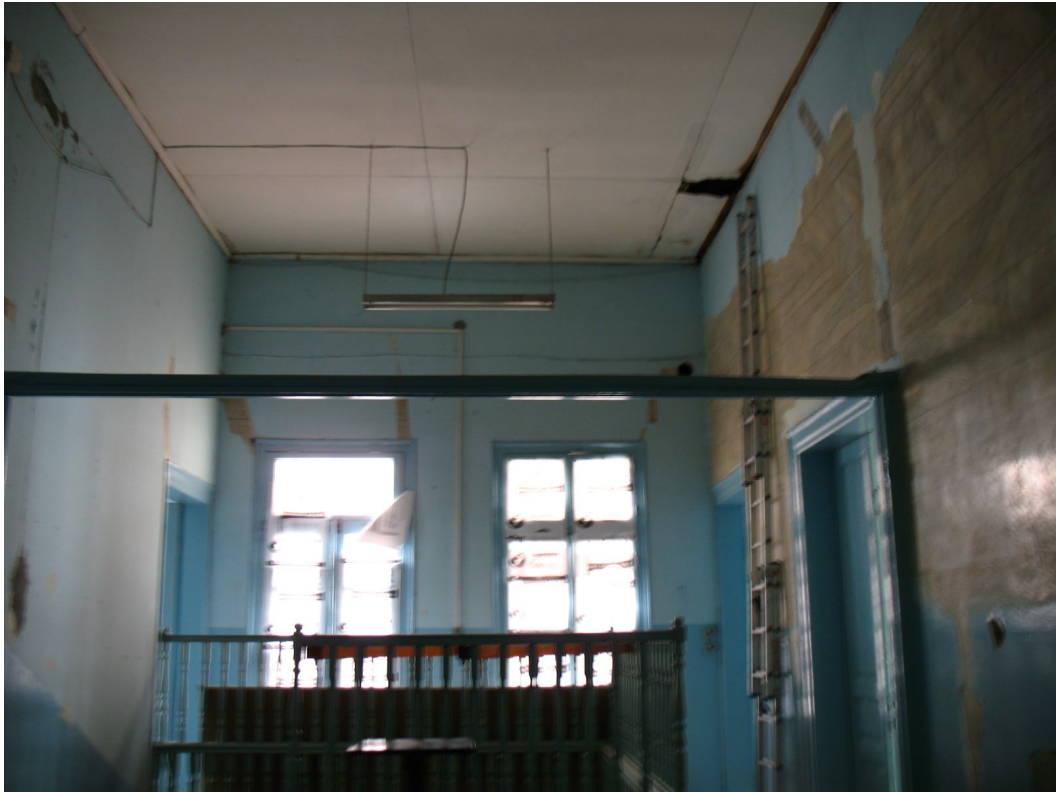
Description: **Ph.20-** Inside view of photo 18 – room O1 at 1st floor level with the floor opening of the staircase.

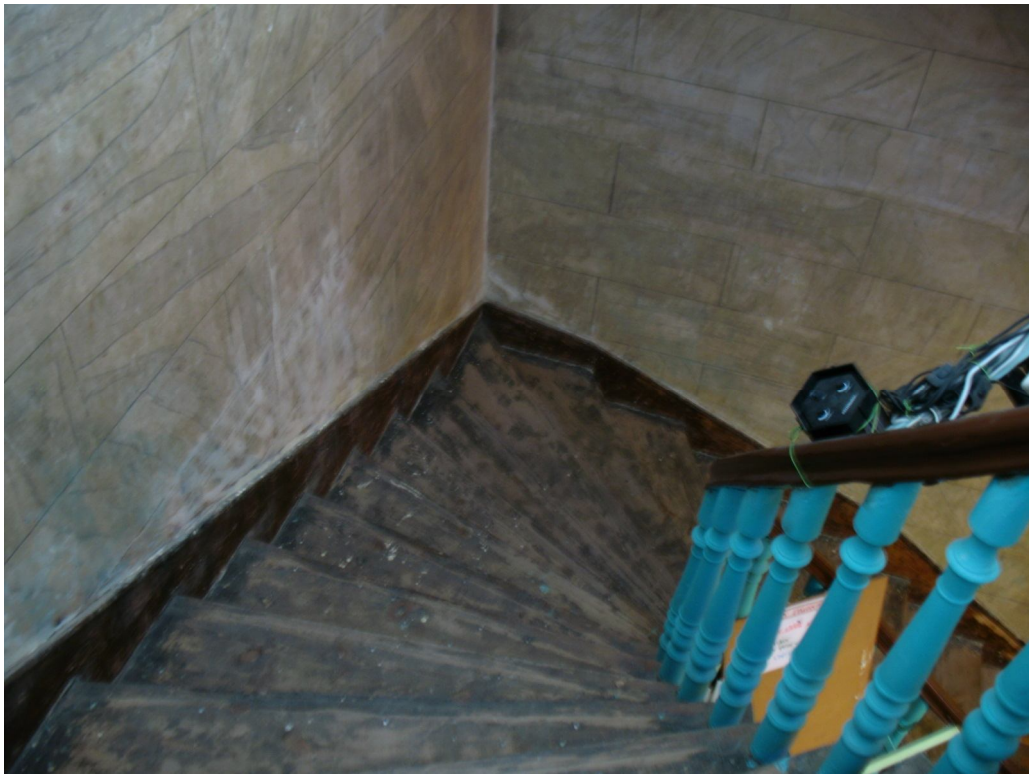
Description: **Ph.21-** Section of the timber staircase coming from the ground floor level.

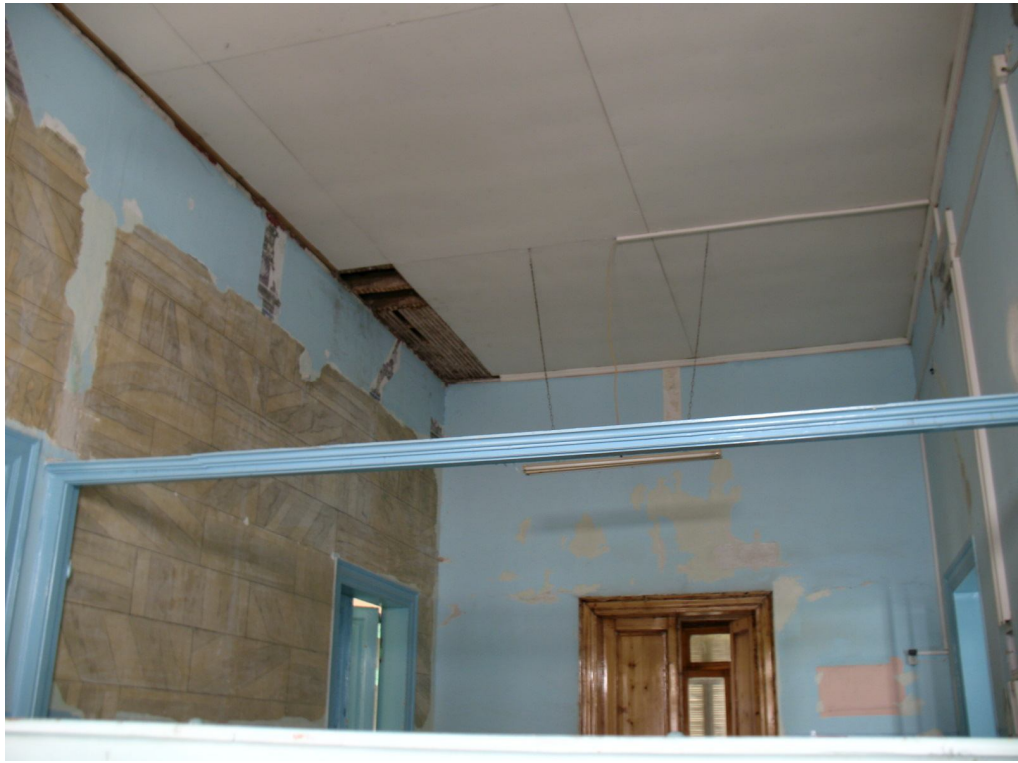
Description: Ph.22- Opposite view (from ph.20) at room O1 from the corridor O11 showing the door entrances at rooms O1 α and O6 (left).

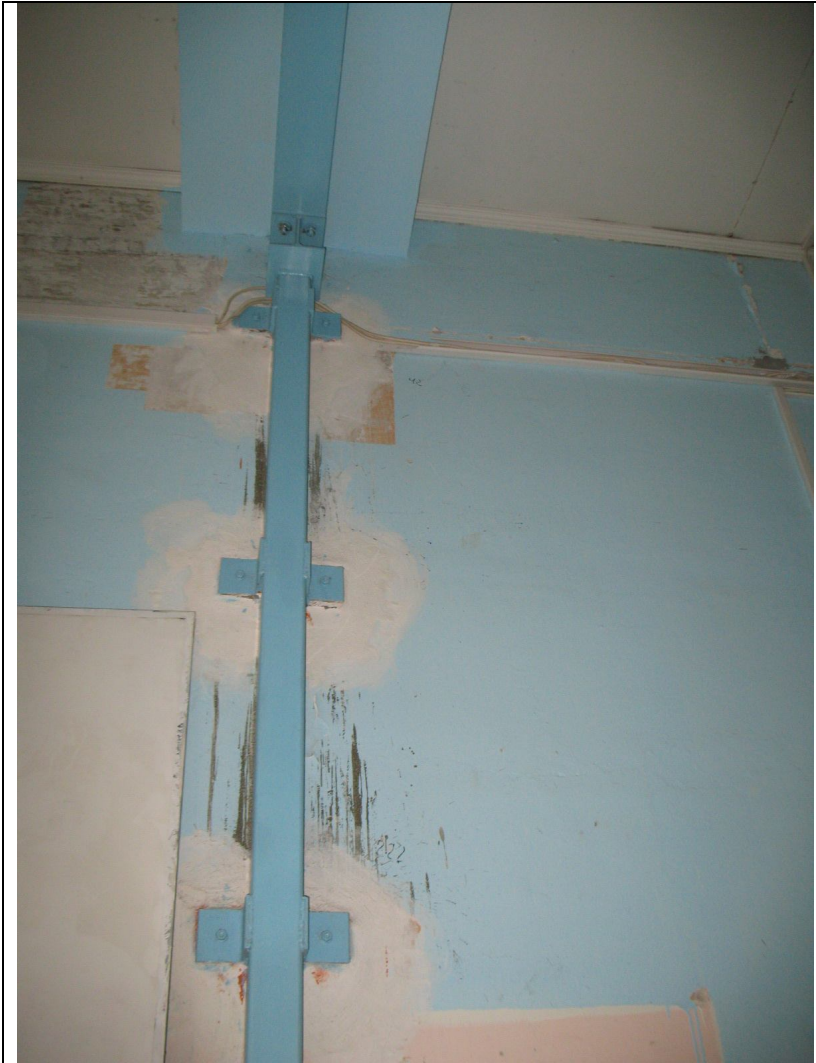
Description: Ph.25b- Opposite detail of the frame on the wall between rooms O3-O4 and O1.

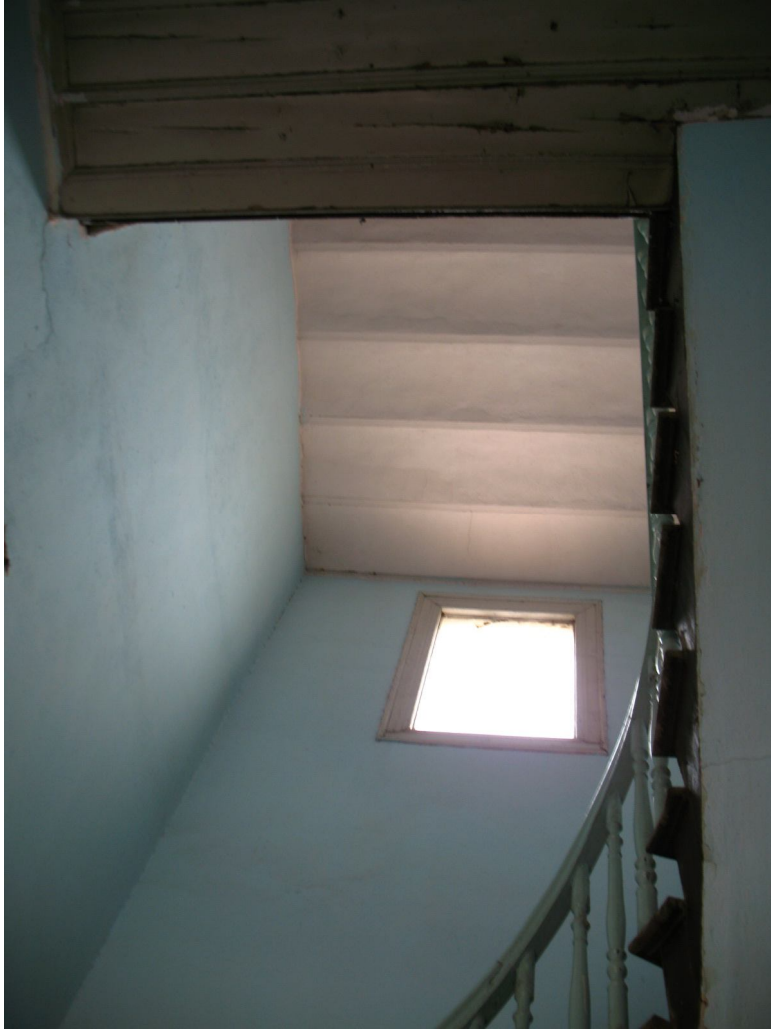
Description: Ph.28- Secondary timber staircase going to the terrace at roof level.

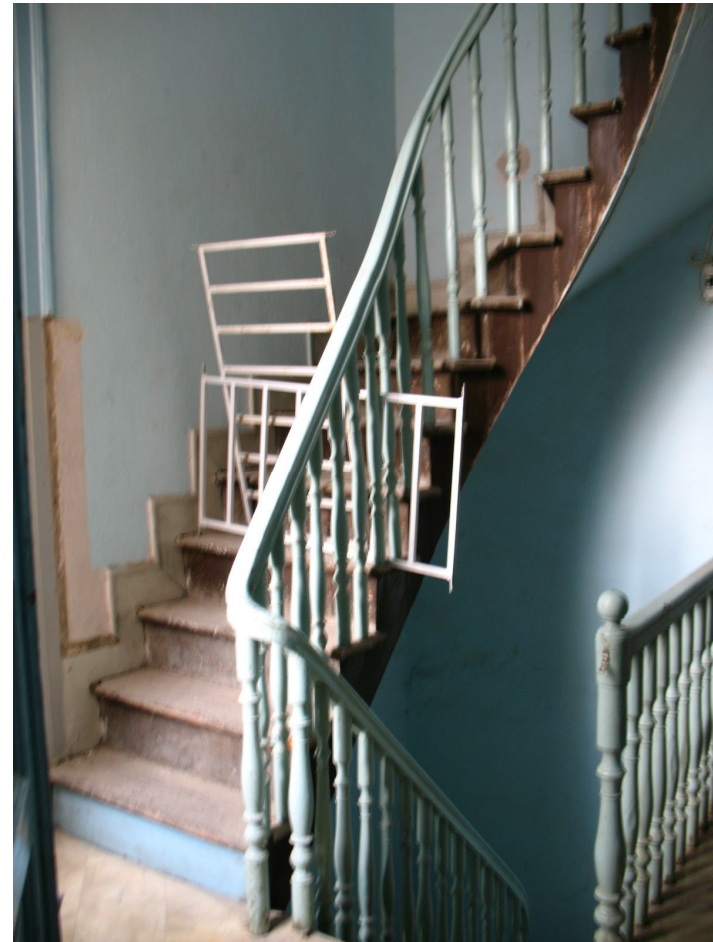
Description: Ph.29- View of the staircase (ph.28) at 1st floor level going down to ground floor.

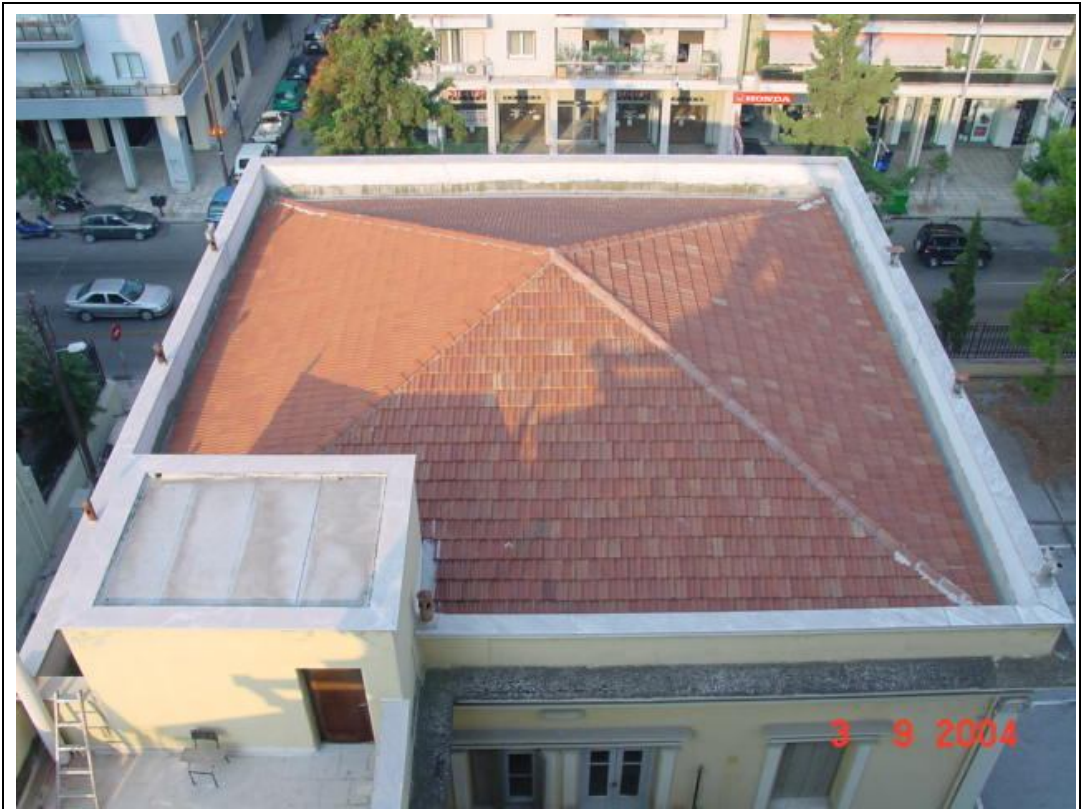
Description: Ph.42– Panoramic view of the hipped roof and terrace of the building.

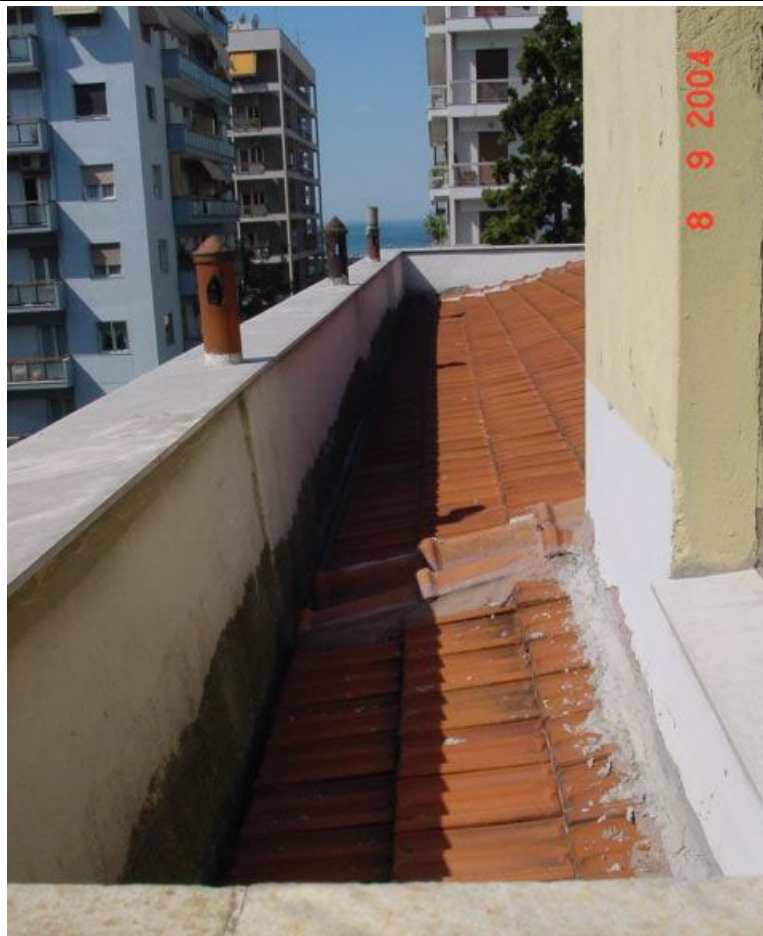
Description: Ph.43– Parapet inside view with the enclosed roof along the east elevation of the building. At the right hand side is shown the window of the staircase leading to the roof terrace.

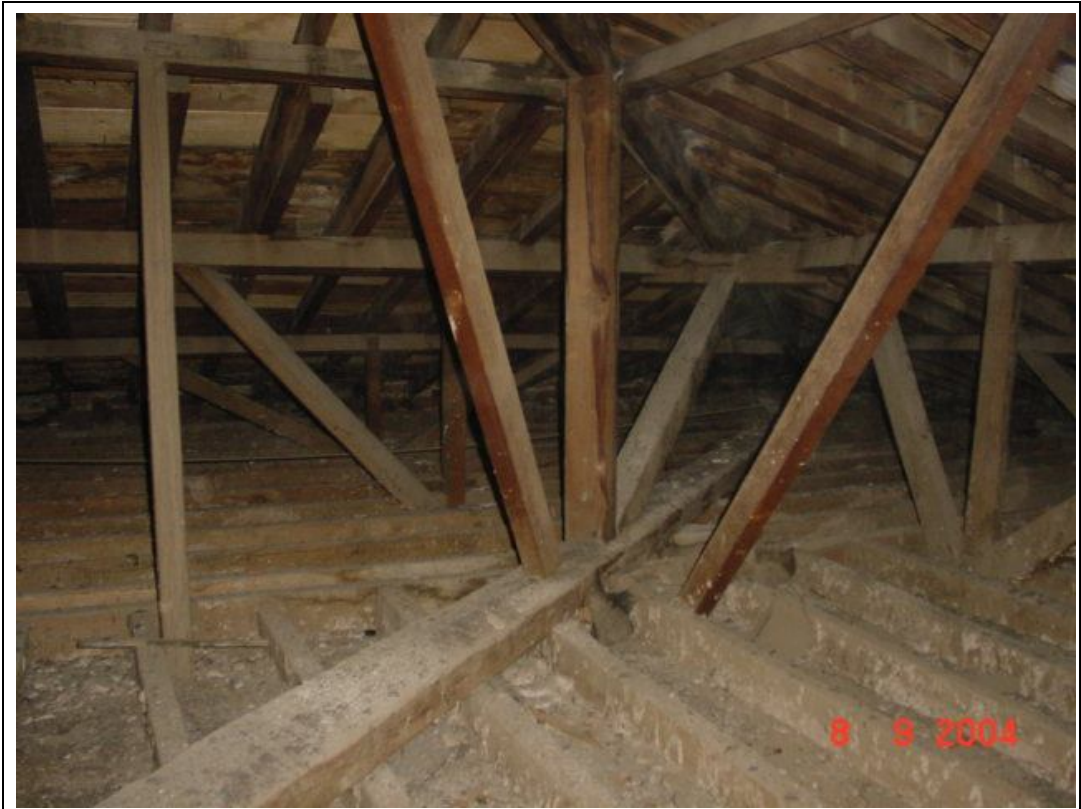
Description: **Ph.46**– Part view of the main diagonal timber roof truss and the secondary trusses for the support of roof elements.

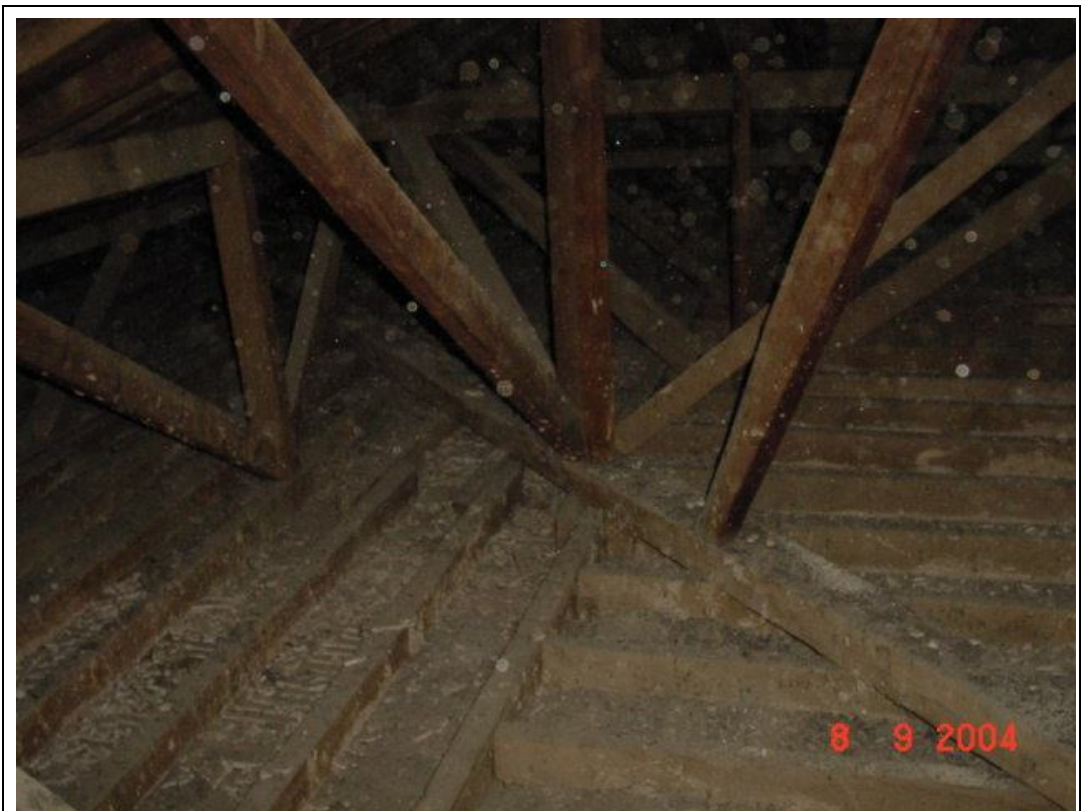
Description: **Ph.47**– Another side view of similar elements, as per ph.46.

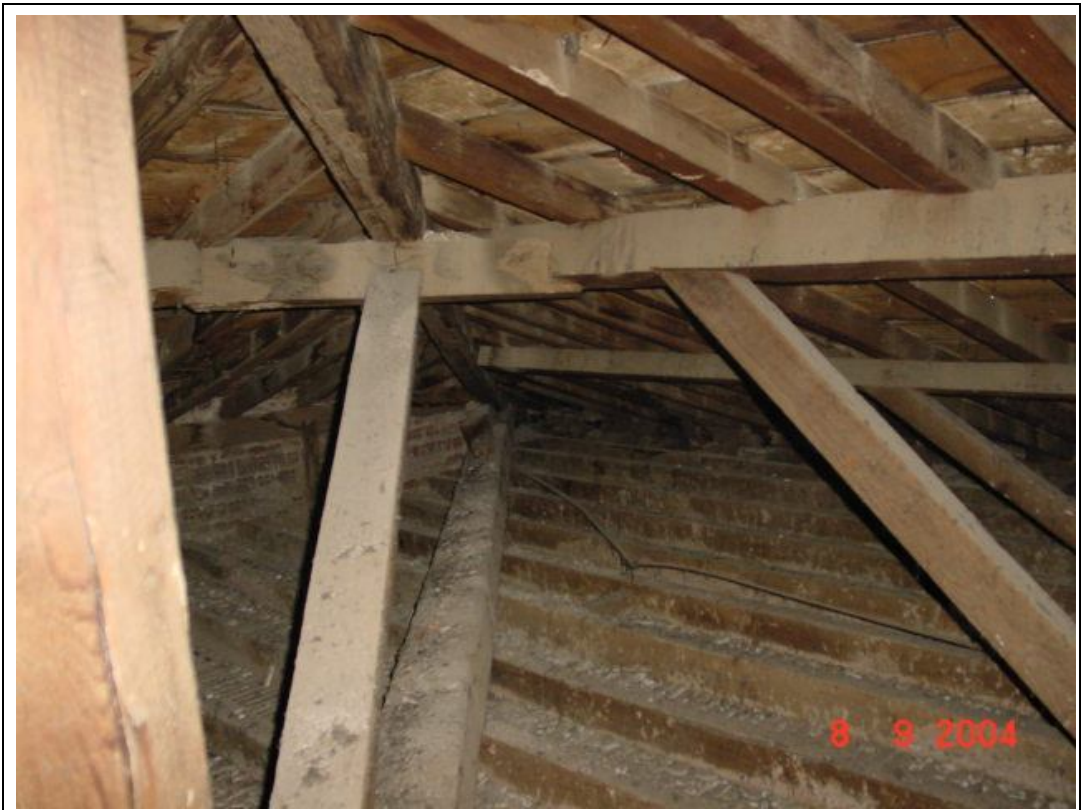
Description: Ph.48- NE view of the roof area inside showing the south wall of the staircase that leads to the roof terrace.

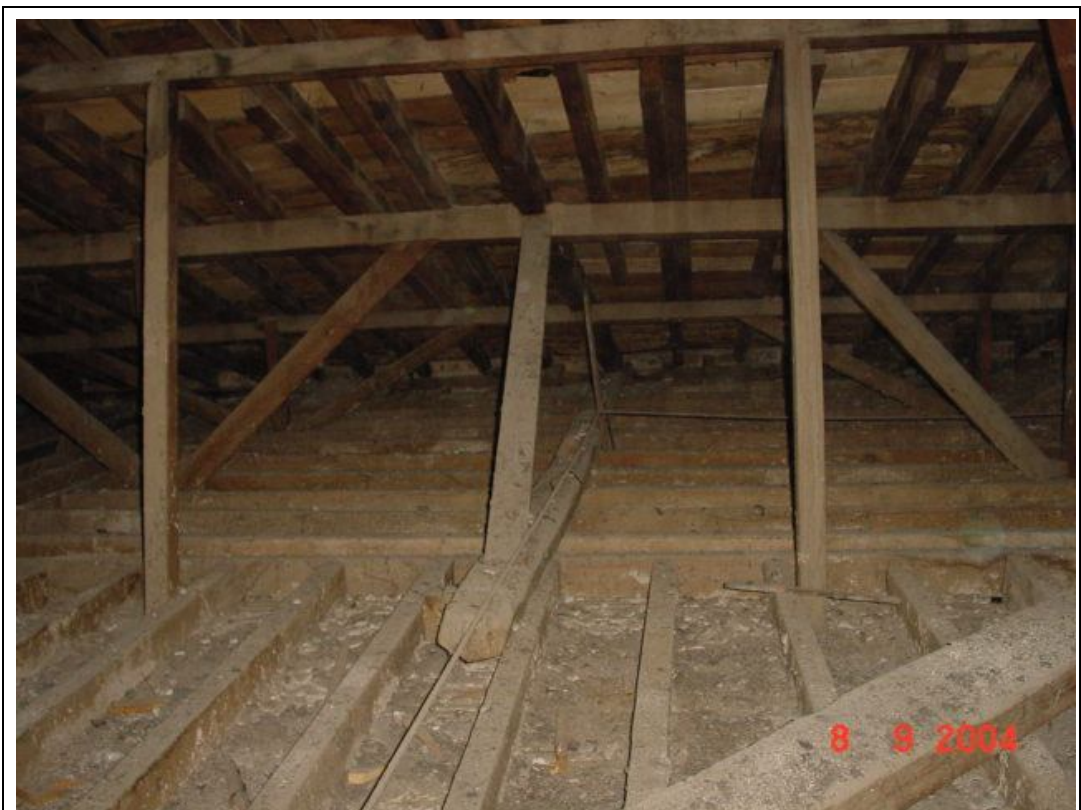
Description: Ph.49- View of the east area of the roof showing the secondary truss for the support of sloped roof elements.

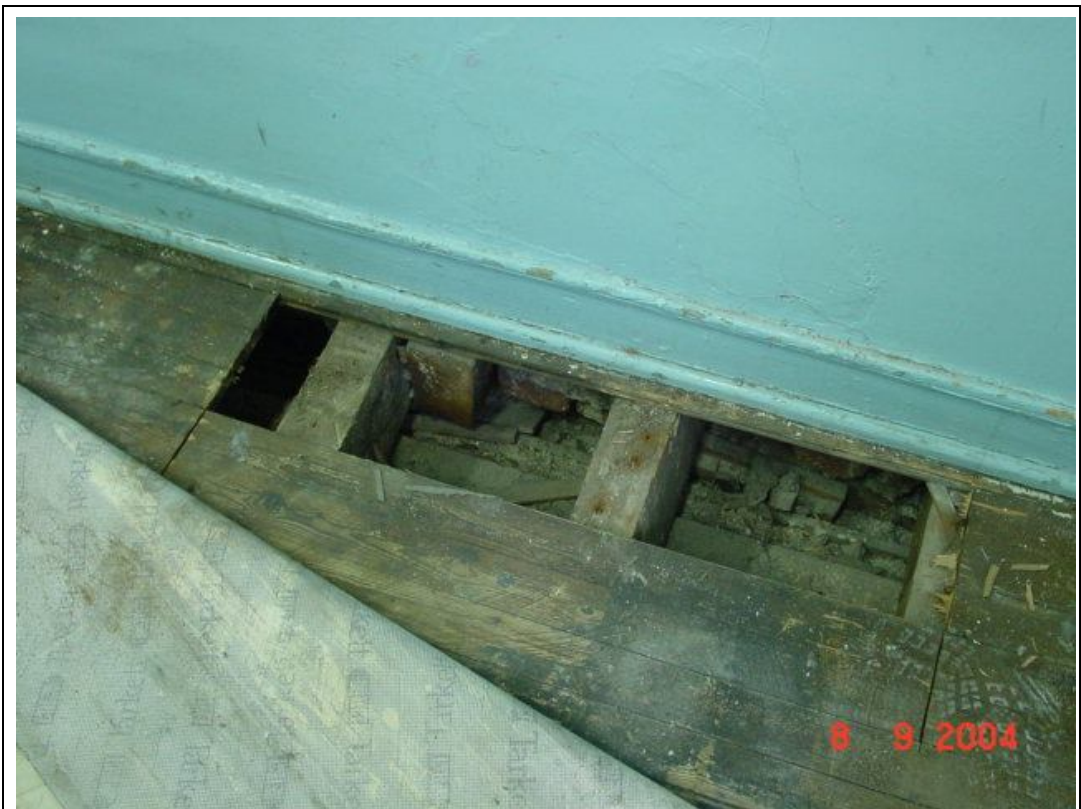
| Description: | Ph.54- Exposed floor section between rooms O5 – O6 showing the transverse timber beams being supported directly to the ground floor wall. |

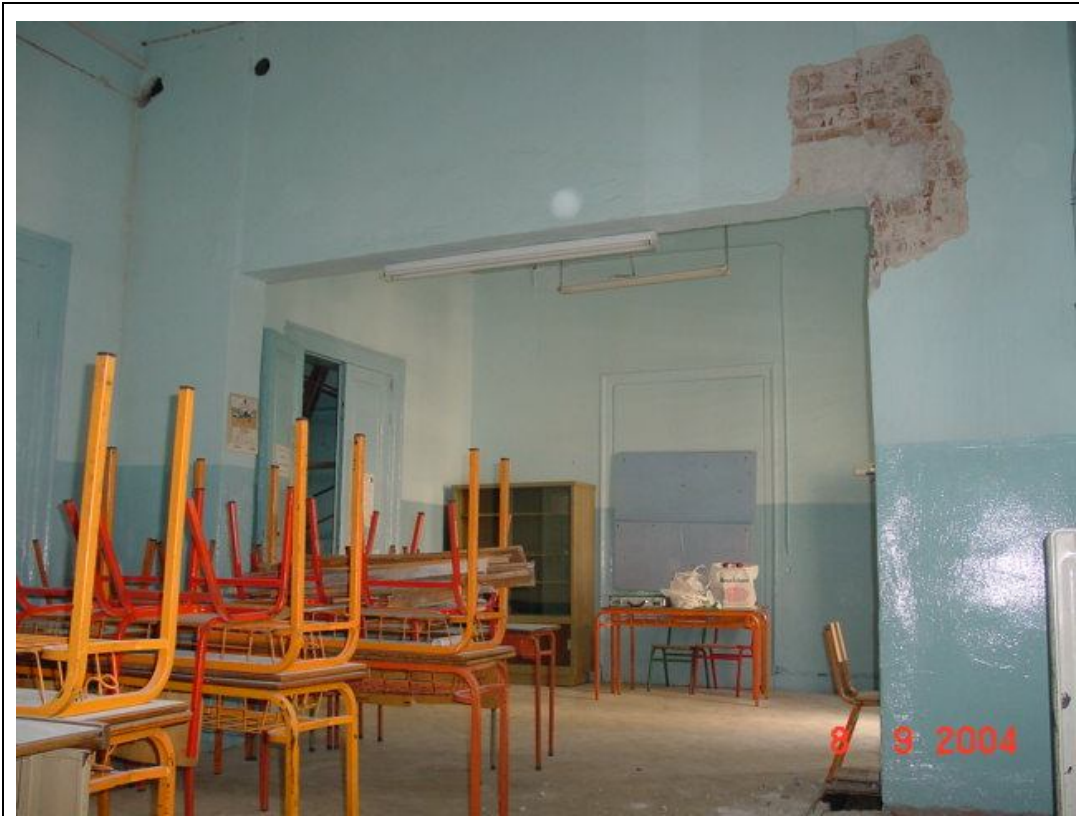
Description: Ph.58- Detail of the ph.57.

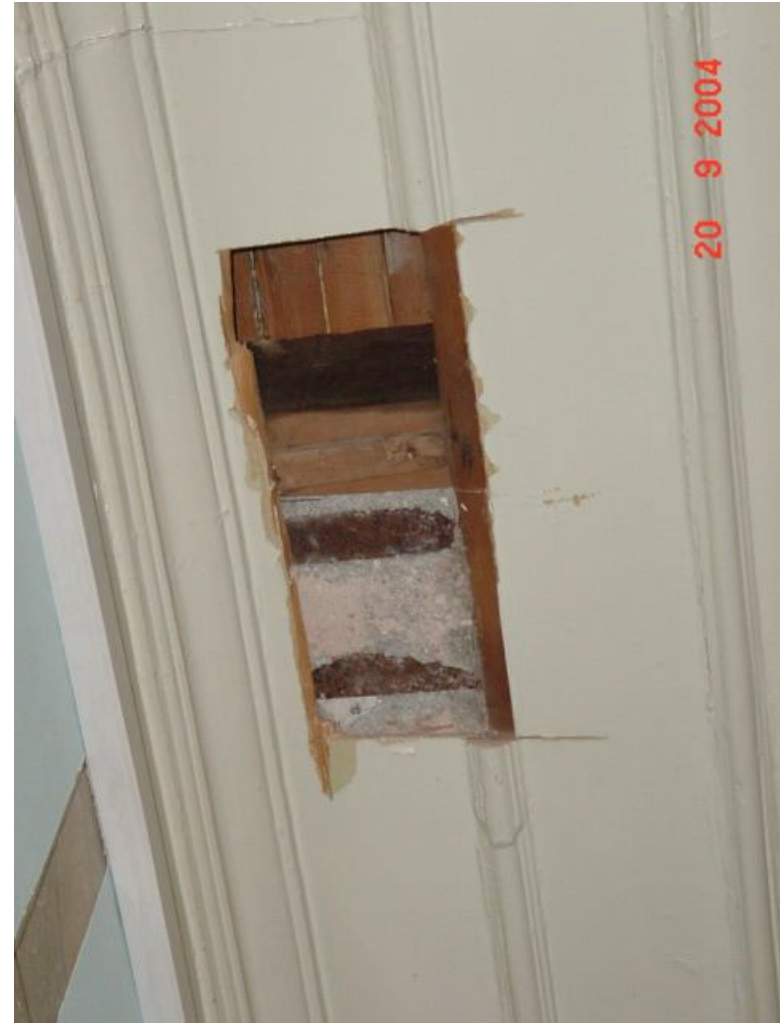
Description: Ph.61- Location of the ground ceiling at room I1 (under the 1st floor wall between rooms O1 – O1α).

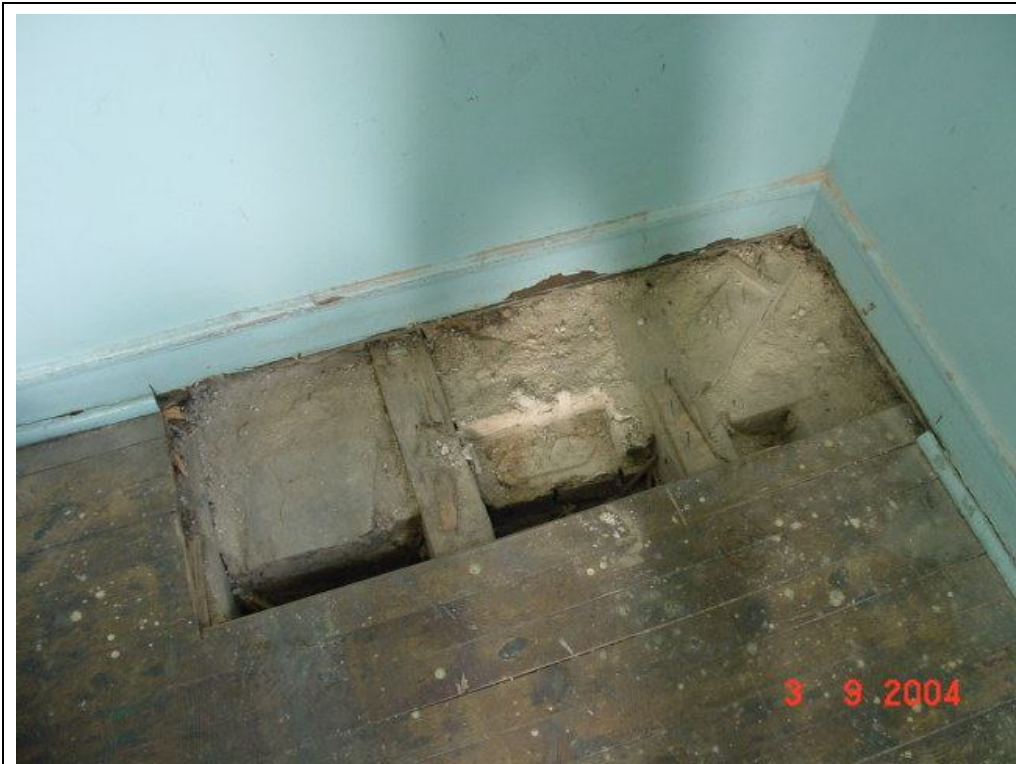
Description: Ph.67- Better detail of photo 66.

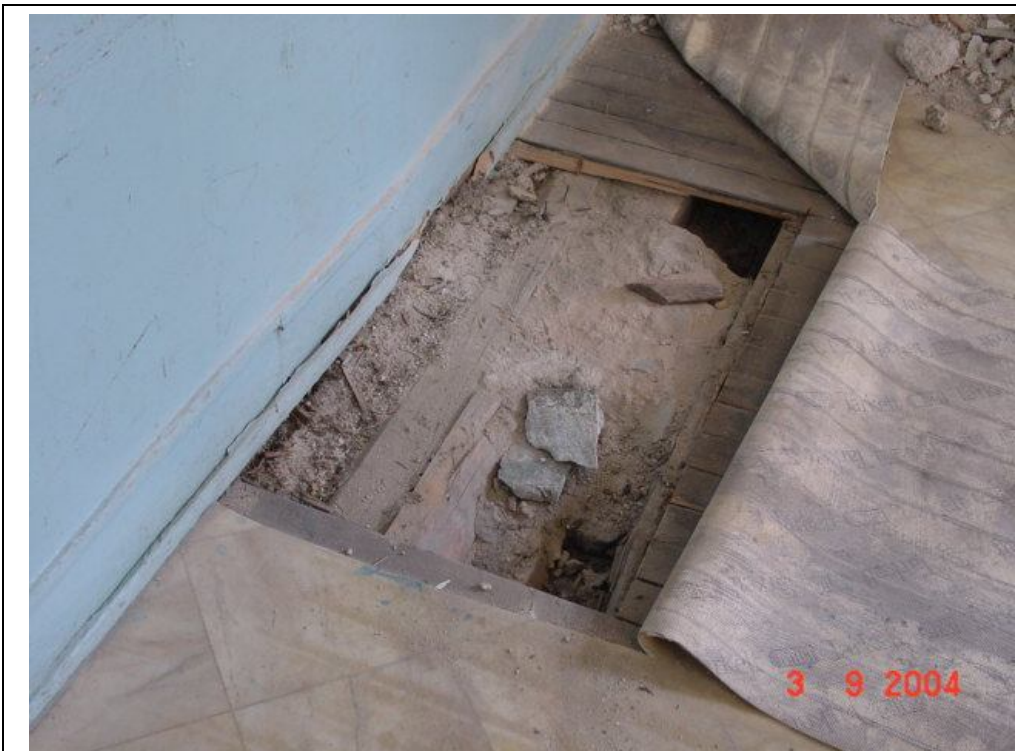
| Description: | Ph.68- Section cut of the timber floor at SE corner of room 12 showing timber beams supported directly to the basement wall below. |

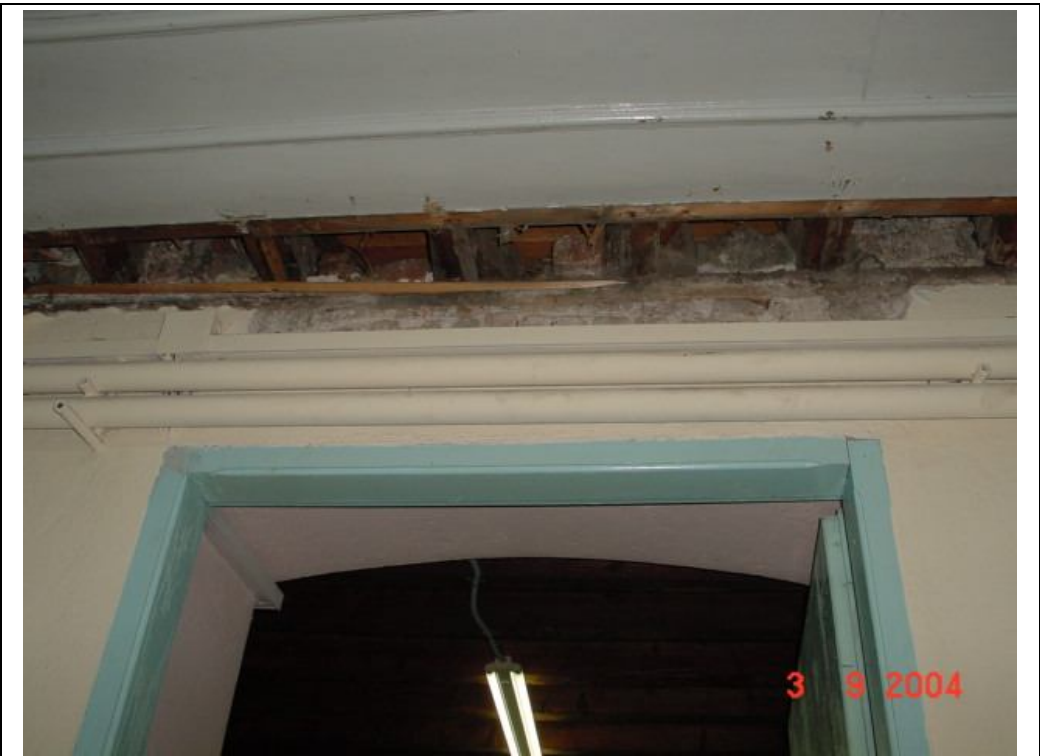
| Description: | Ph.70 – General view of Y1 at basement. |

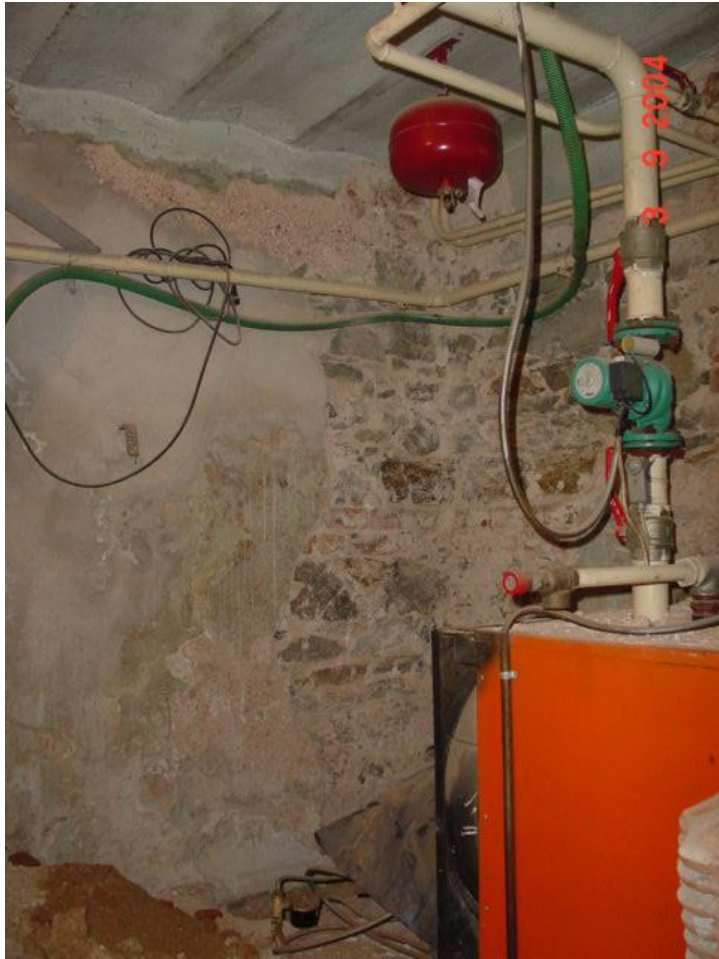
Ph.73– Ceiling of room Y8 showing the closure of the original opening of the staircase to the basement.
