**INVESTIGATION OF THE EFFECT OF SEISMOLOGICAL PARAMETERS ON  
THE RISK ESTIMATION OF A CONVENTIONAL REINFORCED CONCRETE  
FRAME-WALL, EARTHQUAKE RESISTANT BUILDING.**

A Thesis By  
Eng.Ibrahim Mohammed ElBatran

School of Civil Engineering  
(**A**nalysis and **D**esign of **E**arthquake **R**esistant **S**tructures) **ADERS** Program  
National Technical University of Athens, Greece

**8/10/2014**

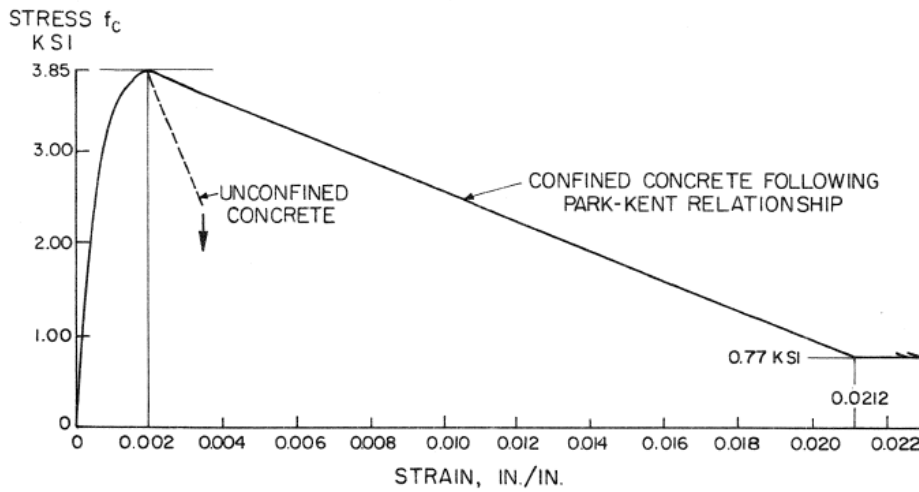
Figure 2.3 Stress-strain curve for unconfined and confined concrete.

The concrete used to build the original set so as to have resistance cylindrical specimen 28 days equal to 26.5 Mpa or 3.85 KSI (1 KSI = 6.89 MPa) and the composition was made with normal weight aggregates and cement Type 1 Portland. Figure 2.3 below shows the stress-strain Relationship.

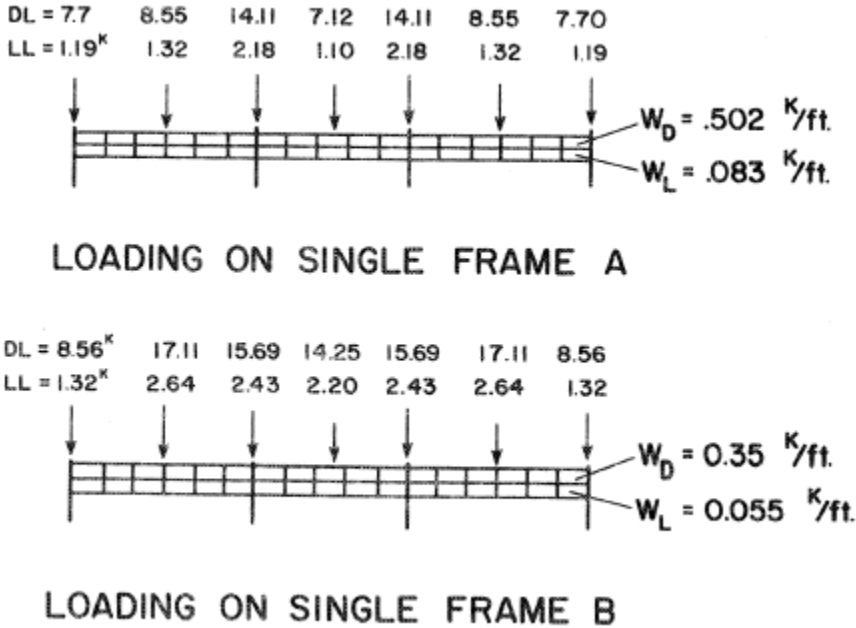
Figure 2.13 Prototype Gravity Loading.

Finally, at each level are grouped masses which correspond to loads (dead and live) transmitted within the transverse beams in them, and also weights of columns leading to these nodes. The ultimate static load each beam eventually introduced in the model of the program is given in the figure 2.13 below.

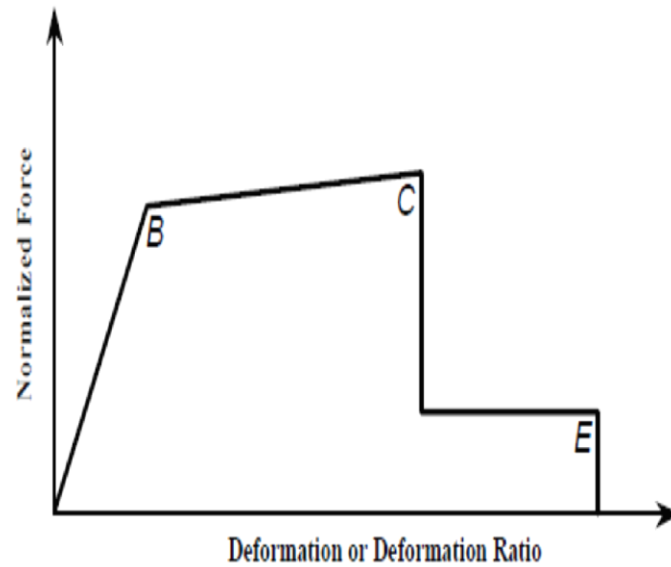
**Figure 3.1** Idealized Component Load versus Deformation.

The ATC-40 and FEMA-273 documents have developed modeling procedures, acceptance criteria and analysis procedures for pushover analysis. These documents define force-deformation criteria for hinges used in pushover analysis. As shown in Figure 1, five points labeled A, B, C, D, and E are used to define the force deflection behavior of the hinge and three points labeled IO, LS and CP are used to define the acceptance criteria for the hinge. (IO, LS and CP stand for Immediate Occupancy, Life Safety and Collapse Prevention respectively.) The values assigned to each of these points vary depending on the type of member as well as many other parameters defined in the ATC-40 and FEMA-273 documents.

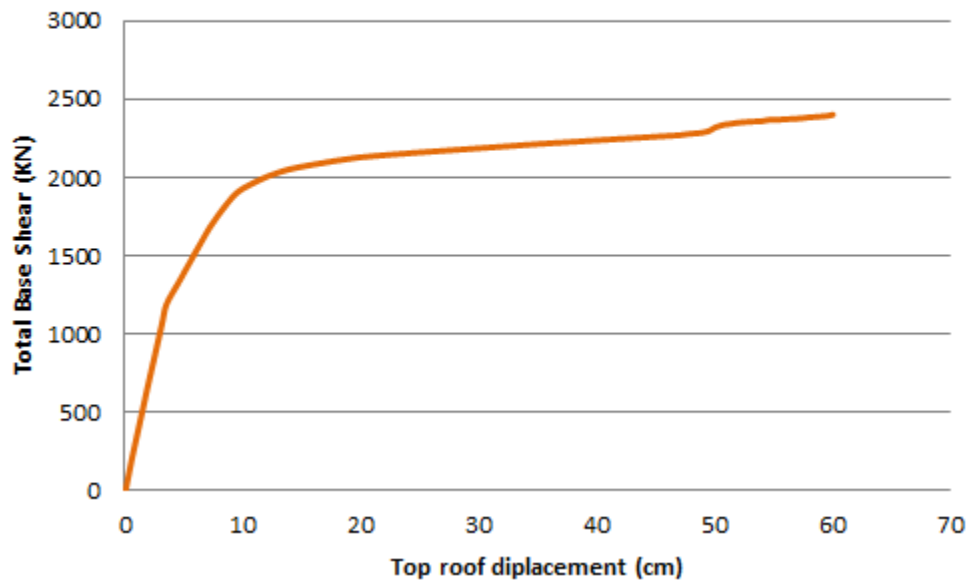
**Figure 3.2** Push-over curve of the frame-wall building imported from SAP Analysis.

For analysis monitored displacement of the building roof was chosen as 1m (one meter). The resulting pushover curves in positive Y- direction, in terms of Base Shear vs. Roof Displacement ( $V-\Delta$ ), have shown in Figure 6.1. The slope of the pushover curves is gradually reduced with the increase of the lateral displacement of the building.

Following HAZUS procedure to determine the limit states as In figure 3.2, Structural Damage Limit states are obtained as shown in table1.

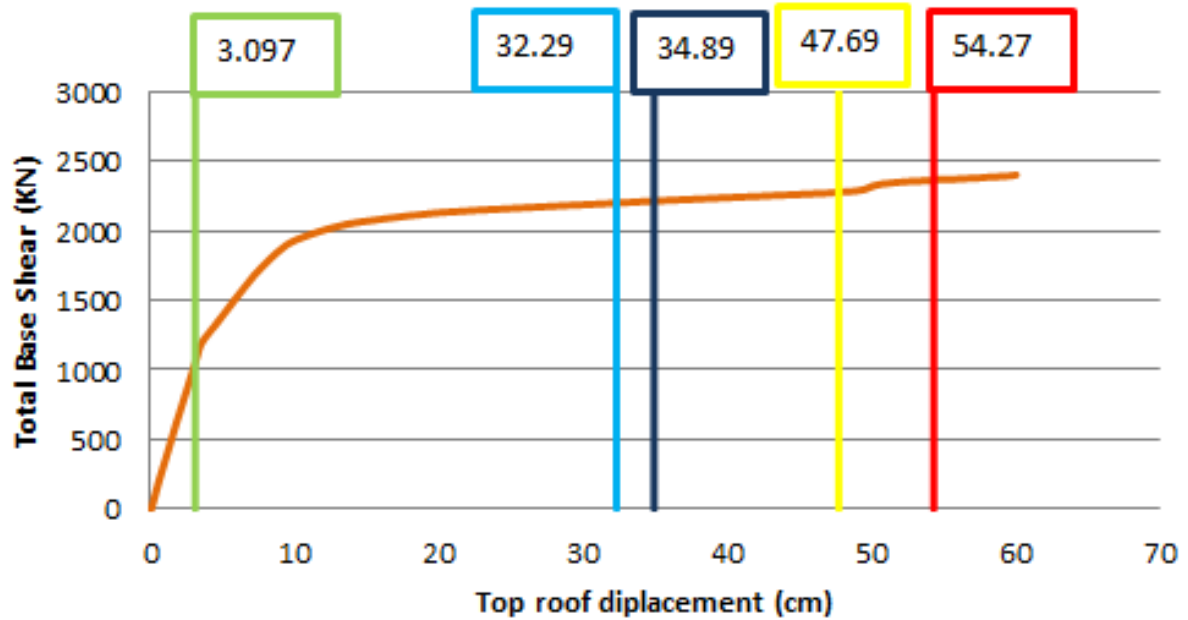
**Figure 3.7** Push over curve with defined damage limit state using Hazus criteria

The **light blue curve** which defines the slight limit, i.e. the time when the first failure plastic hinge, corresponding to a mean value of 0.3229 m.

The **blue curve** that defines the medium level fault corresponds to the point on the pushover in which only 5% of plastic hinges failed and is equivalent to average price movement equal to 0.34894 m.

The **yellow curve** which defines the extensive damage, i.e. 25% of plastic hinges fail, corresponding to a mean value 0.4769 m.

Finally, **red curve** that defines the total damage, i.e. 50% of plastic hinges fail, corresponding to a mean displacement 0.5427 m. In Figure 6.7 the pushover curve and the average displacement which define the fault levels are presented.

Direction	Limit State	Base shear (KN)	Displacement (m)
Y	Yield	1055	0.030978
	Slight	2200	0.3229
	Moderate	2210	0.34893
	Partial Collapse	2229	0.4769
	Collapse	2360	0.5427

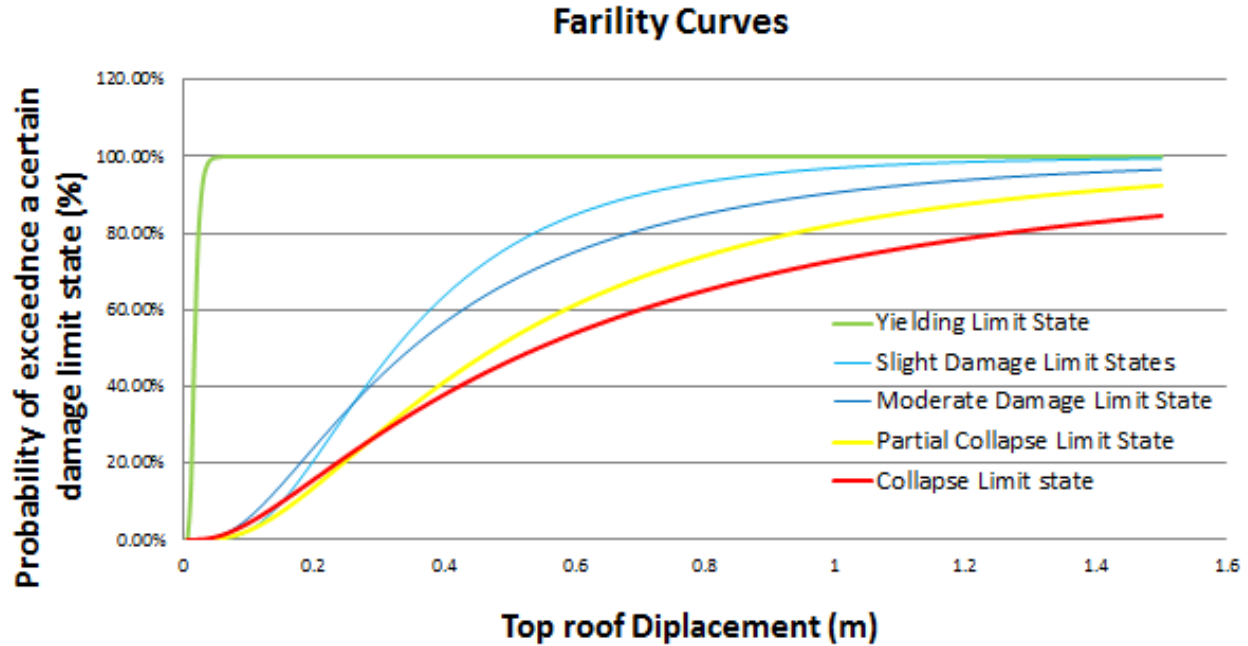
Figure 3.8 Fragility curve of a Frame-wall building.

Replacing the equation the values of spectral displacement  $SD$ ,  $d_s$  and the standard deviation  $\beta_{ds}$ . for each level, the five curves vulnerability, and are given in Figure 6.5.

From the Figure 6.8 it is visible that the uncertainty to attain a limit state is decreasing from yielding 100% to the collapse state 70-75% respectively. The maximum displacement experienced by the structure during non-linear static analysis is 0.5427m that leads to the complete collapse mechanisms of structure.

Therefore, by applying the equation 3-16 estimated the value of the standard deviation for each level. So for the value for the yield curve  $\beta_{ds} = 1$ , while for the slight = 0.6, moderate = 0.8 and extensive and collapse limit  $\beta_{ds} = 1$ . The equation for calculating the probability distribution of fragility curve is given below.

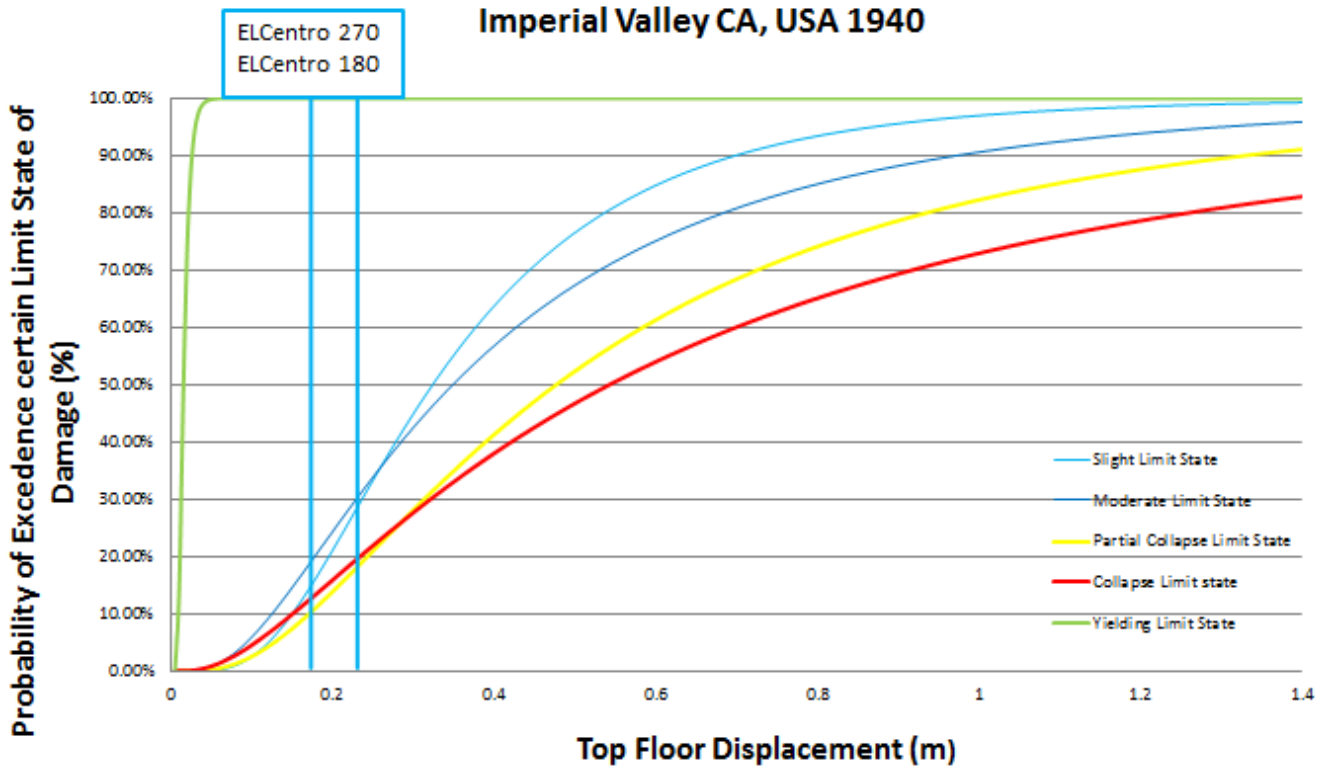
Figure 5.1 Fragility curves showing damage limit state for recording station in Imperial Valley, USA, 1940.

Imperial Valley earthquake from 1940, had a magnitude of Mw=6.6. The stations exhibit a backward directivity. The results place our building in the slight damage state area. This is the result of the big distance of the station from the rift.

Location	Mw	Dir/Ty	C/D	Displacement	Limit State
ELC 180-1	6.6	B	8.0	0.231	SLIGHT
ELC 270-1				0.1733	SLIGHT

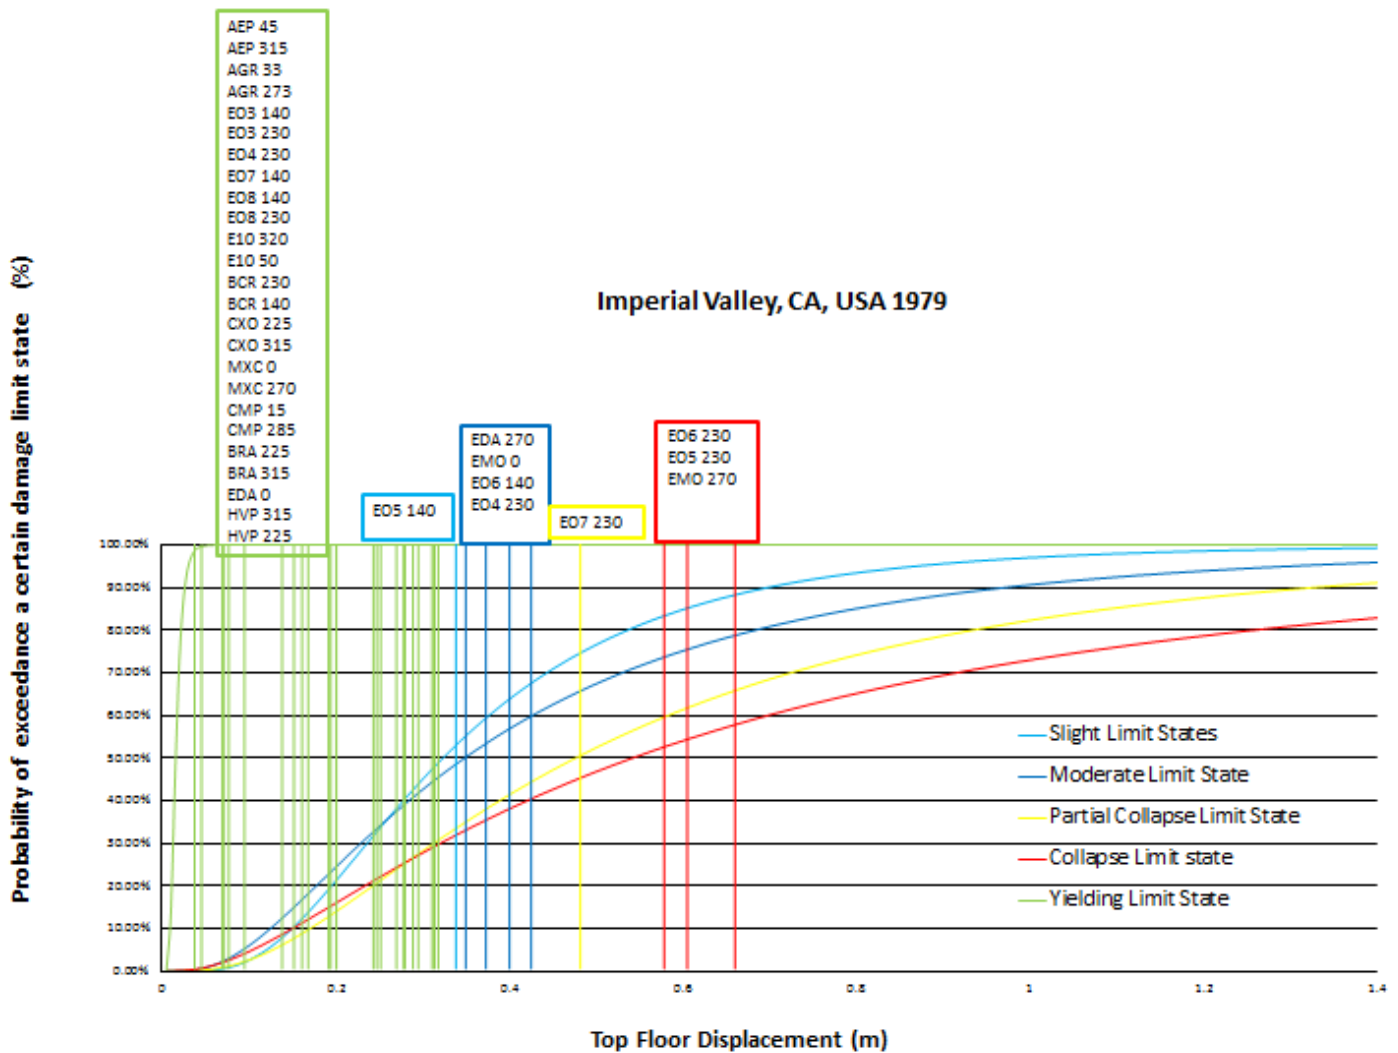
Figure 5.2 Curves showing damage limit state for recording station in Imperial Valley, USA, 1979.

The earthquake in the Imperial Valley from 15-10-1979 had a magnitude of 6.4. Most of the stations showed forward directivity, but AGR, CXO and MXC showed neutral directivity. the displacement that put the building in the collapse damage state such as E05, E06, EMO, are influenced by the fact that the stations are very near the rift and a have forward directivity. Below is given the Map 8.1 for a better understanding of the diversity of displacement.

EDA 270-1				0.394	MODERATE
HVP 315-1		F	6.9	0.2488	YIELD
HVP 225-1				0.252	YIELD

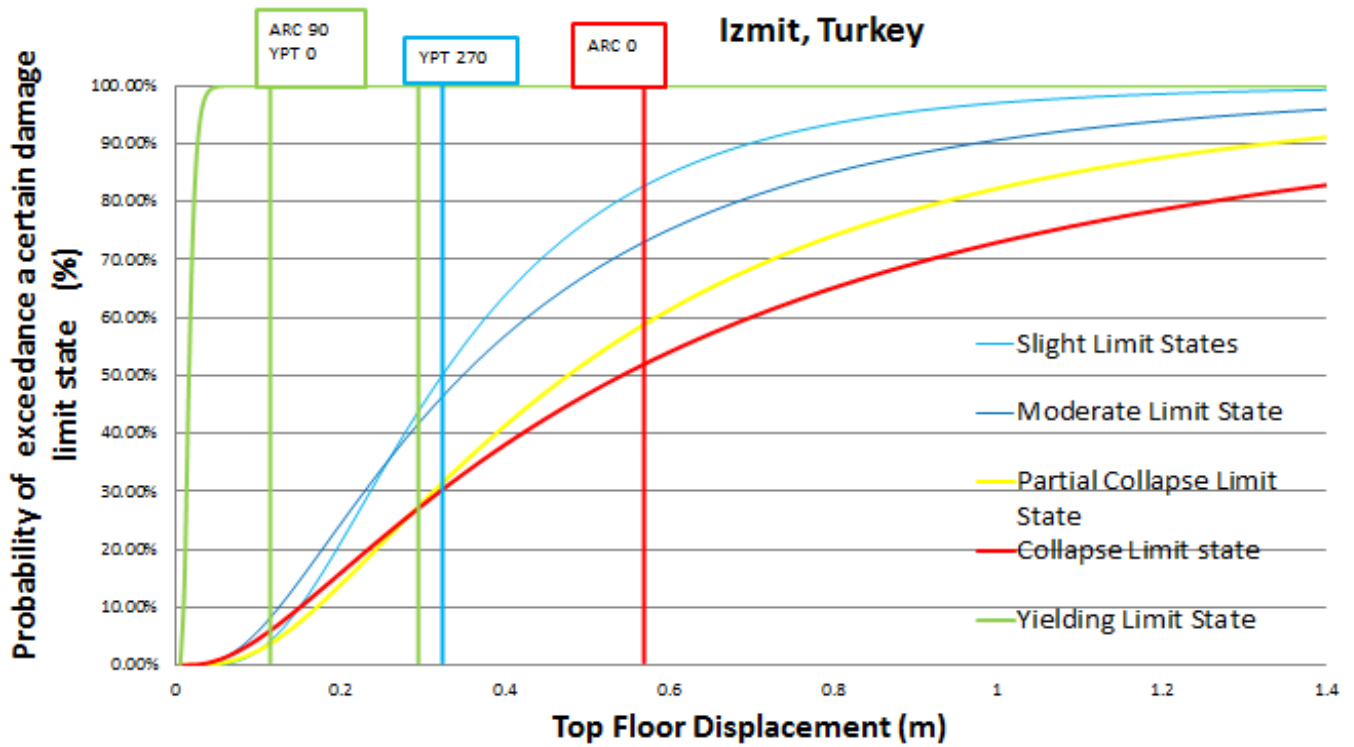
Figure 5.4 Fragility curves showing damage limit state for recording station in Izmit, Turkey.

The Izmit earthquake had a magnitude of 7.4 on Richter’s scale. It was recorded by 2 stations ARC and YPT. Both of them showed a forward directivity pattern, but ARC was at a far distance from the trace of the fault, 14 km, even though it forces the building to collapse.

Location	Mw	Dir/Ty	C/D	Displacement (m)	Limit State
ARC 000-1	7.4	F	14	0.5695	COLLAPSE
ARC 090-1				0.1145	YIELD
YPT 000-1	2.6	F	2.6	0.2949	YIELD
YPT 090-1				0.3243	SLIGHT

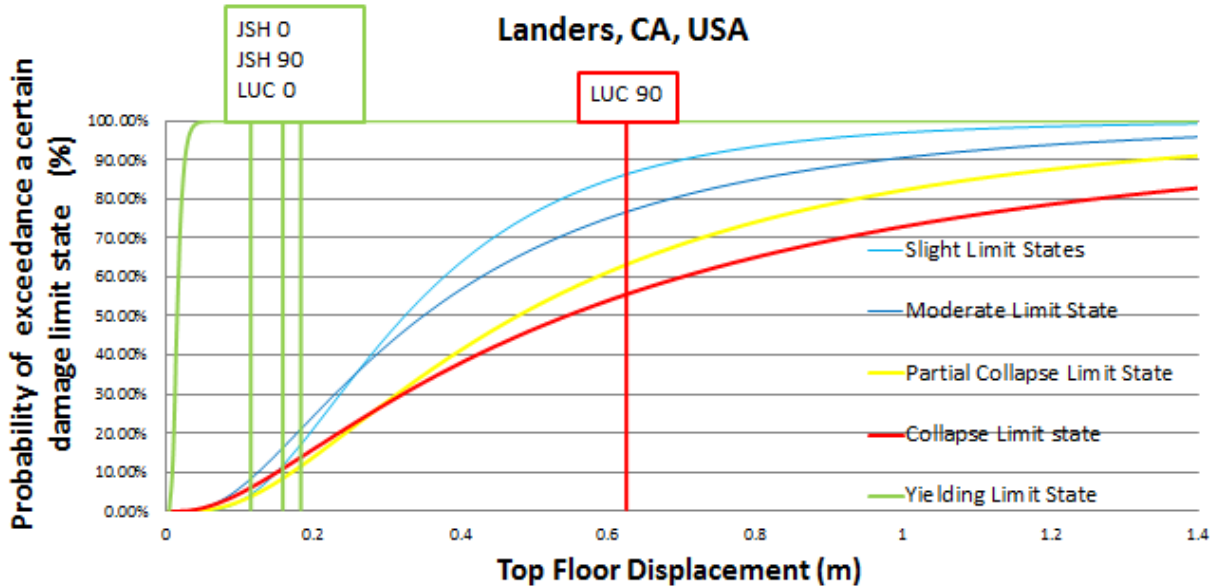
Figure 5.5 Fragility curves showing damage limit state for recording station in Landers, USA.

The earthquake from Landers, had a magnitude of 7.3 on Richter’s scale. The JSH station received backward directivity and is at far distance from the trace of the fault (11.6 km) as a consequence the building lies in the yielding area. In contrast, the LUC station showed a pulse nature and also a short distance from the trace of the rift (1,1 km) played significant role in the results, resulting in building collapse. The map below shows the rupture and the locations of stations. Even if the earthquake magnitude was great and showed a forward directivity, it seems that the distance of the rift played an important role in the building’s behavior.

Location	Mw	Dir/Ty	C/D	Displacement (m)	Limit State
JSH 000-1	7.3	B	11.6	0.1155	YIELD
JSH 090-1				0.1834	YIELD
LUC 000-1		F	1.1	0.1588	YIELD
LUC090-1				0.6247	COLLAPSE

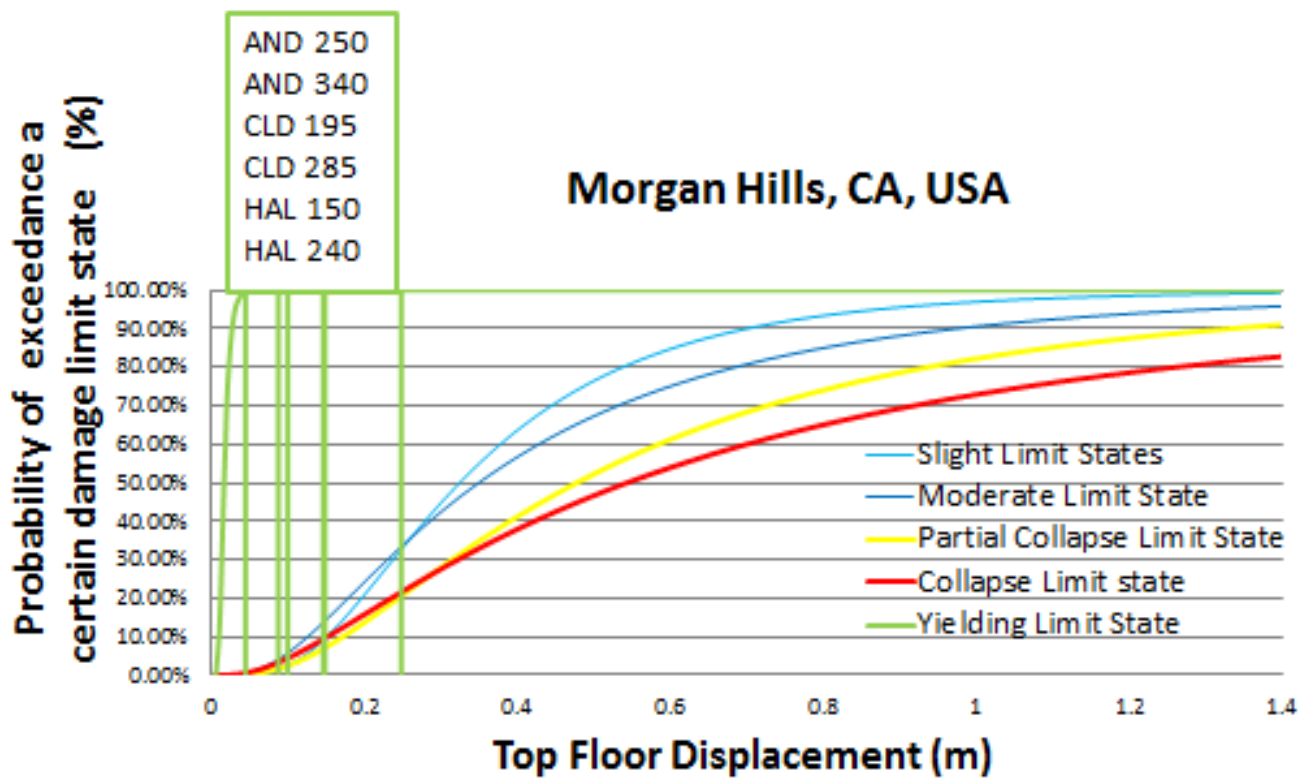
Figure 5.9 Fragility curves showing damage limit state for recording station in Morgan Hill.

Morgan Hill earthquake had a magnitude of 6.2 on Richter’s scale. The epicenter of the quake was located near Mount Hamilton in the Diablo Range of the California Coast Ranges, although nearby communities, including Morgan Hill did not suffered serious damage. Recordings revealed that the building maintained a yielded area.

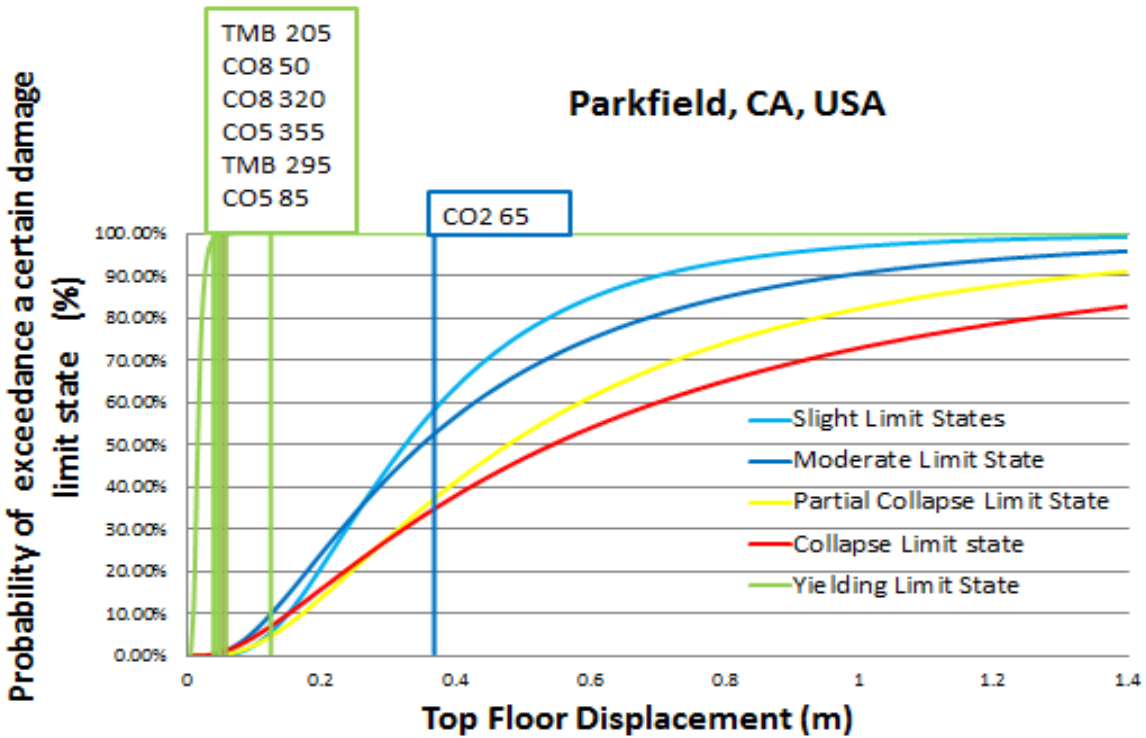
Figure 5.16 Fragility curves showing damage limit state for recording station in Park field, USA.

The Park field Earthquake had a magnitude of 6 on the Richter’s scale. The stations record a forward directivity for all the station. The results place our building in the yielded area, with CO5 85 near the upper limit of the yield zone, While station CO2 065, due to its small distance from the rift, just 0.1 km, brings our building in the moderate area.

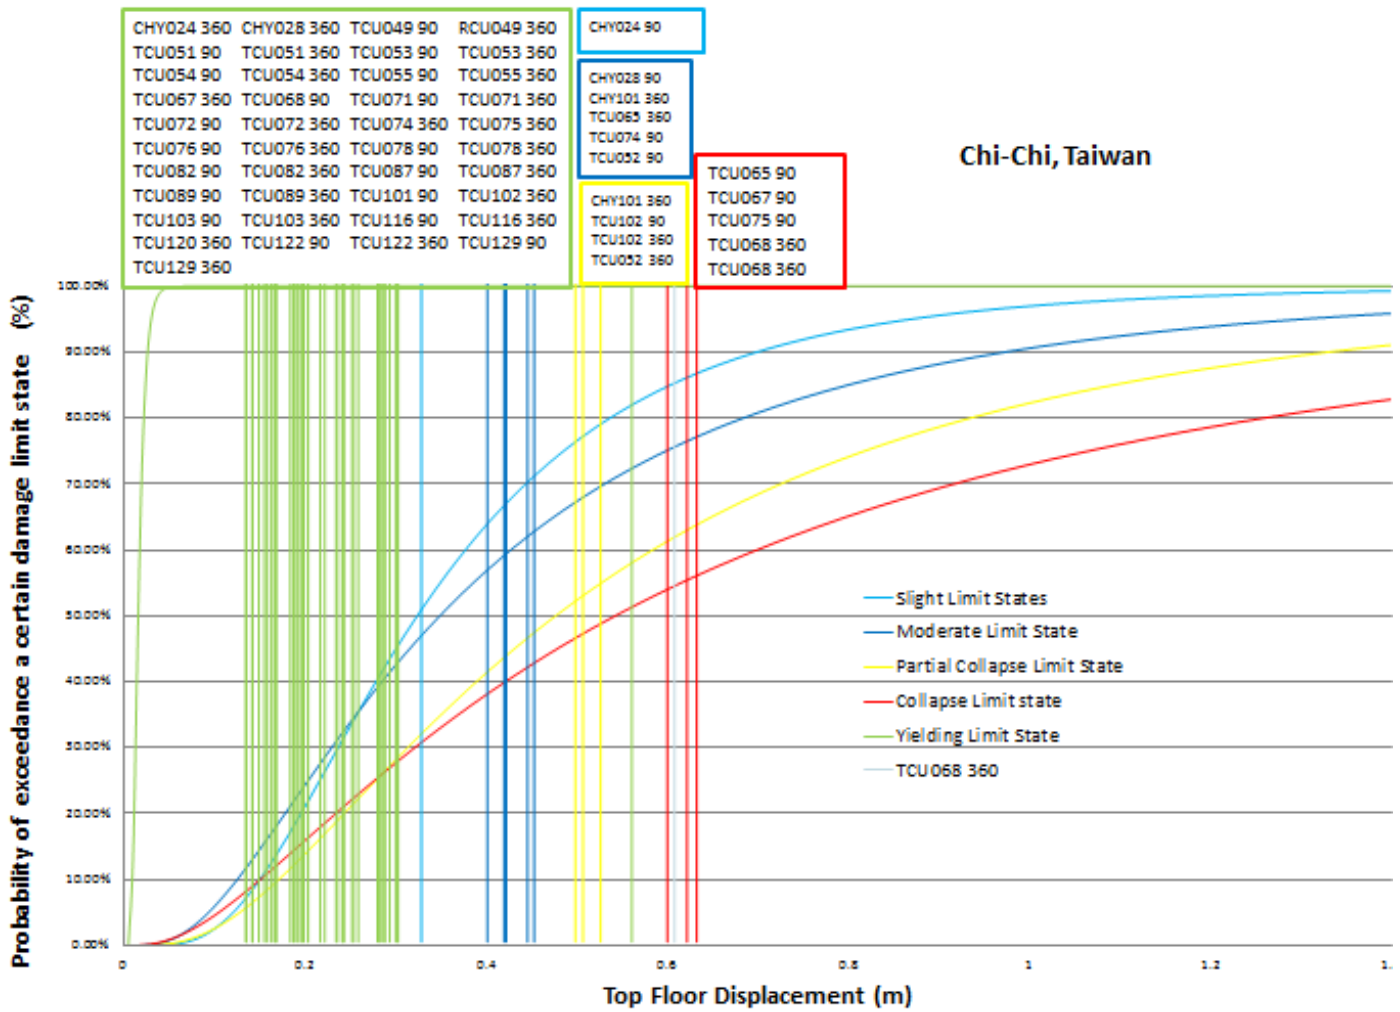
Figure 5.17 Fragility curves showing damage limit state for recording station in Chi-Chi, Taiwan.

The Chi-Chi Earthquake has a seismic magnitude of 7.6. The stations are showing a forward directivity, except Chi028 (neutral directivity). Mostly of the results maintained the building in the upper limit of the yield zone, exception being made by the station TCU068 (90,360), TCU065 90, TCU075 90 , TCU067 90 which places our building in the collapsed area, the main cause being the combination of the forward directivity, near position distance of the stations from the rift, and the magnitude of the earthquake, made the building not capable to resist

to its lateral load. Other stations like TCU052 360 TCU102 (90,360), and CHY101 360 placed the building in the partially collapsed area, again making the correlation between its directivity and the distance of the station from the rift.

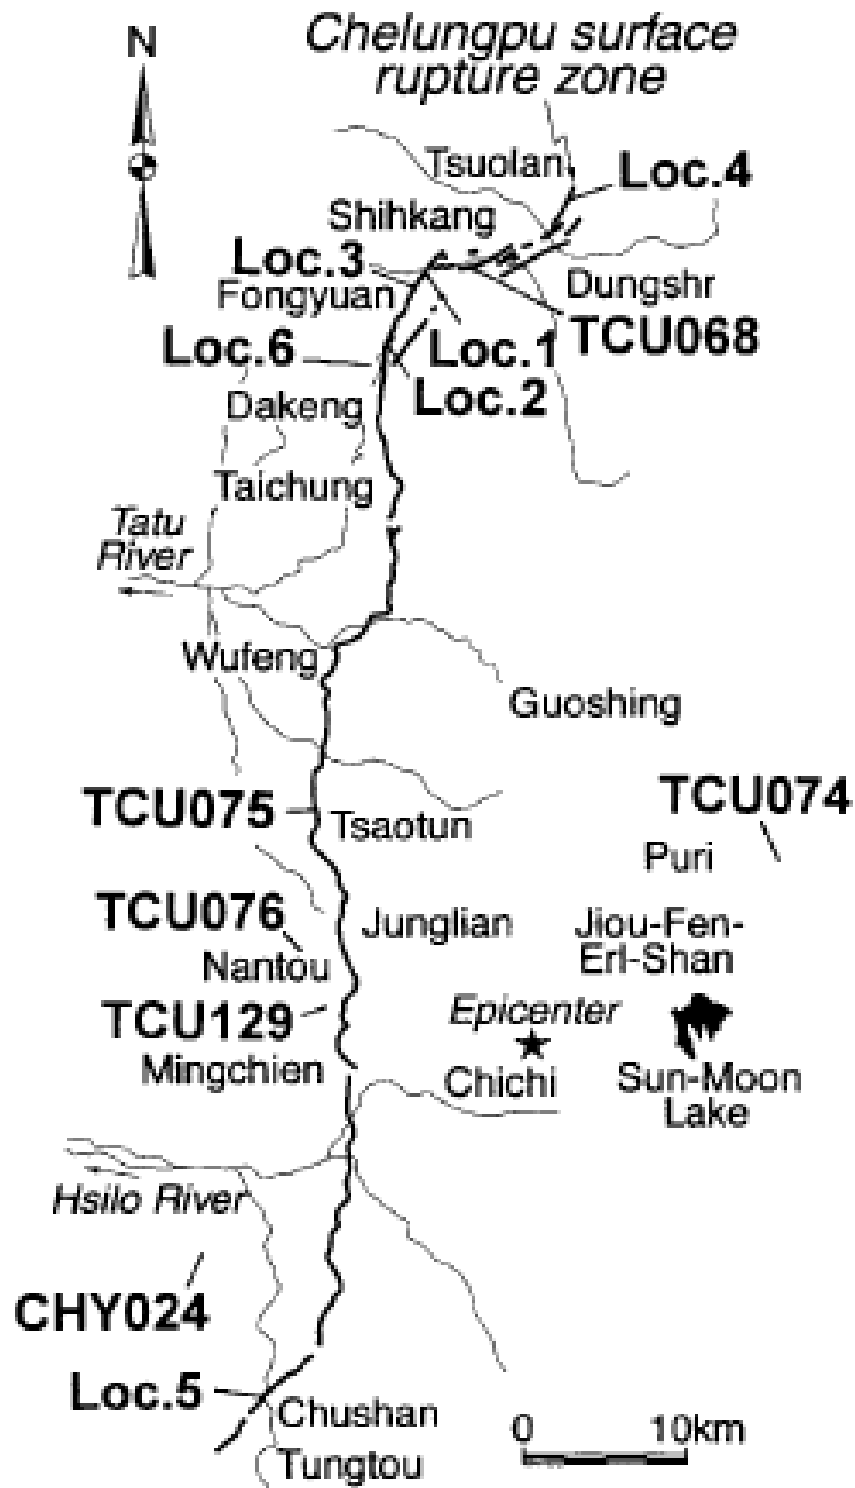
Figure 5.23 The surface ruptures zone and the locations of seismic. The star shows the focus of the main earthquake.

The surface rupture from the September 21, 1999 Taiwan earthquake extends for about 75km along the north-south trending Chelungpu with vertical displacements of 1-8 km. At the fault’s northern end, near Fengyuan, it curves toward the northeast and splinters into complex branches. This area of faulting, which trends towards the northeast, extends for an additional 10 km and was not previously considered an active fault.

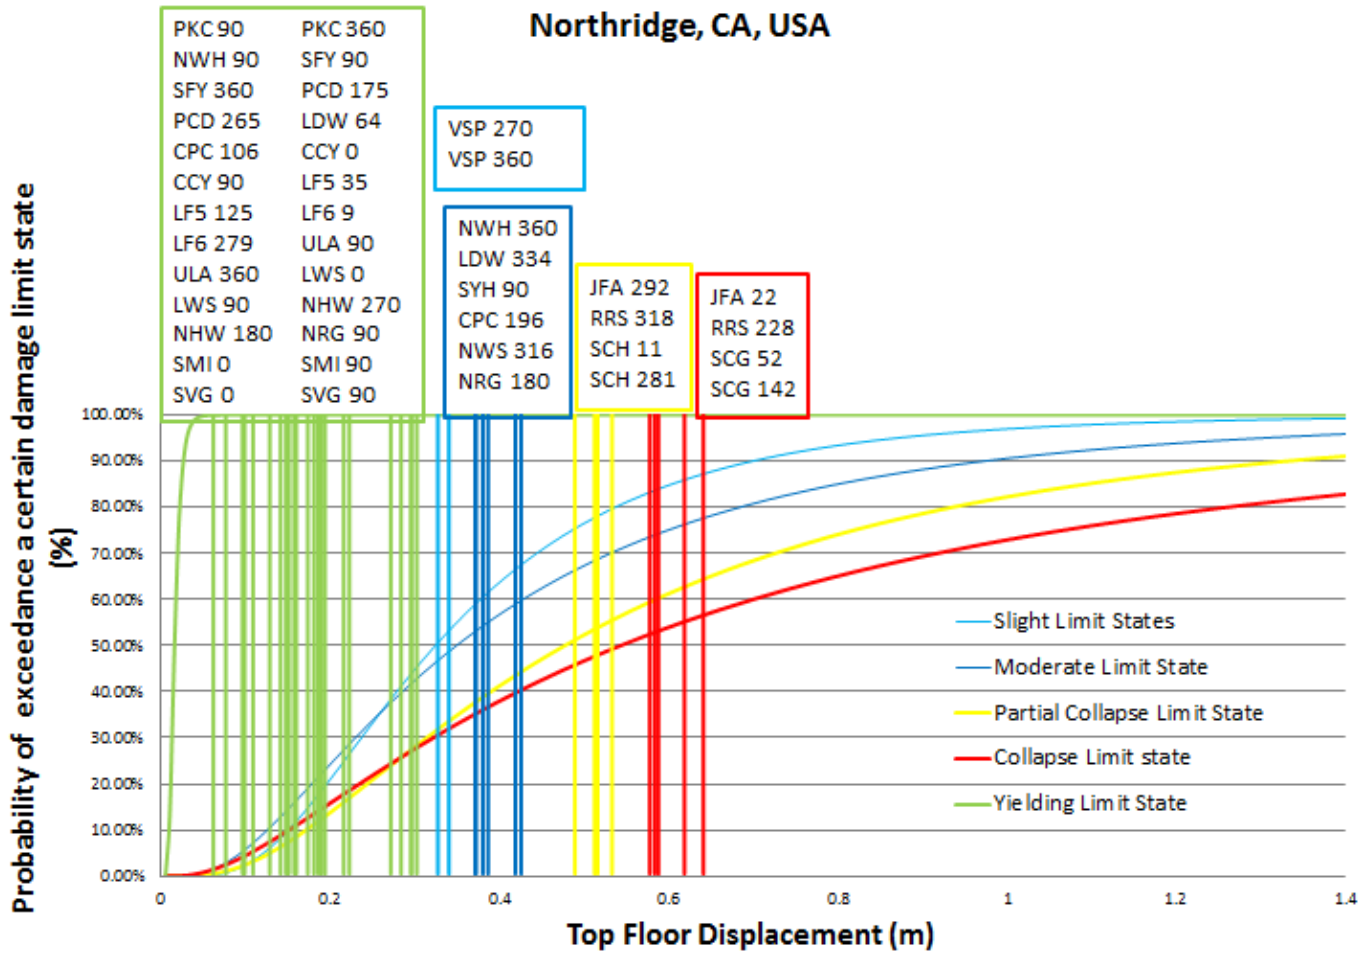
Figure 5.28 Fragility curves showing damage limit state for recording station in Northridge, USA.

The earthquake of Northridge California from 17-01-1994 had magnitude of 6.7 the stations which have maintained the building in the moderated area were mainly in positions which showed reverse and neutral directivity this is justified by the fact that all these stations were long distances from the surface of the rift, which is why we have experienced small movements. The recordings with the largest displacements were SCH, JFA, RRS, and SCG records holding forward directivity, although they have forward directivities like many other station records, they have the largest displacements as they are closer to the rift.

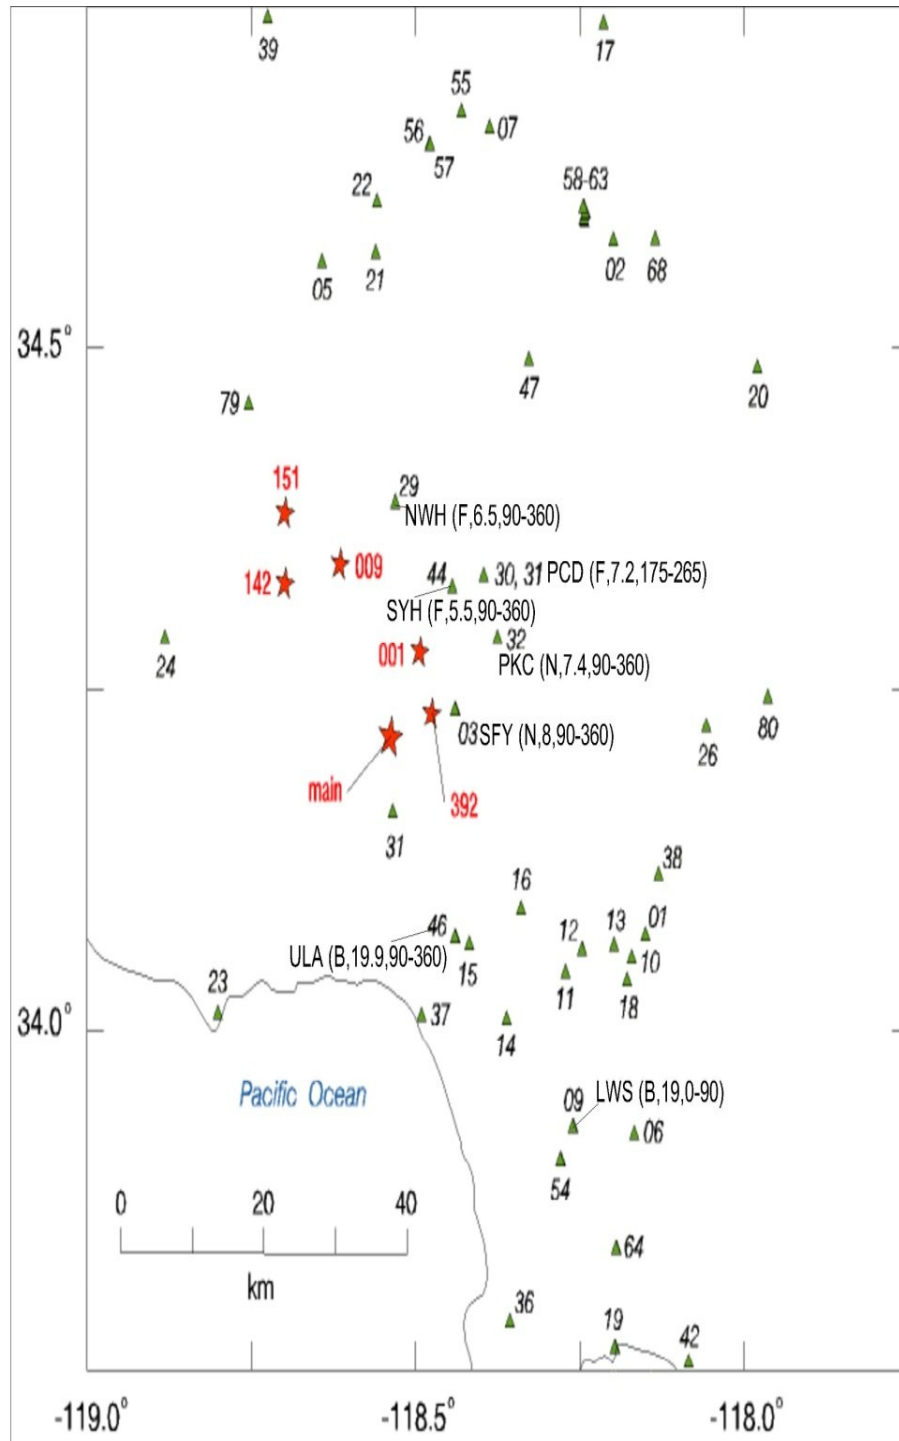
Figure 5.30 Stations DWP sensed the Northridge earthquake.
