Photographic Record

Former 12th Primary School

Vas.Georgiou 27 & Mpizaniou St.

M.Xofi - 2011

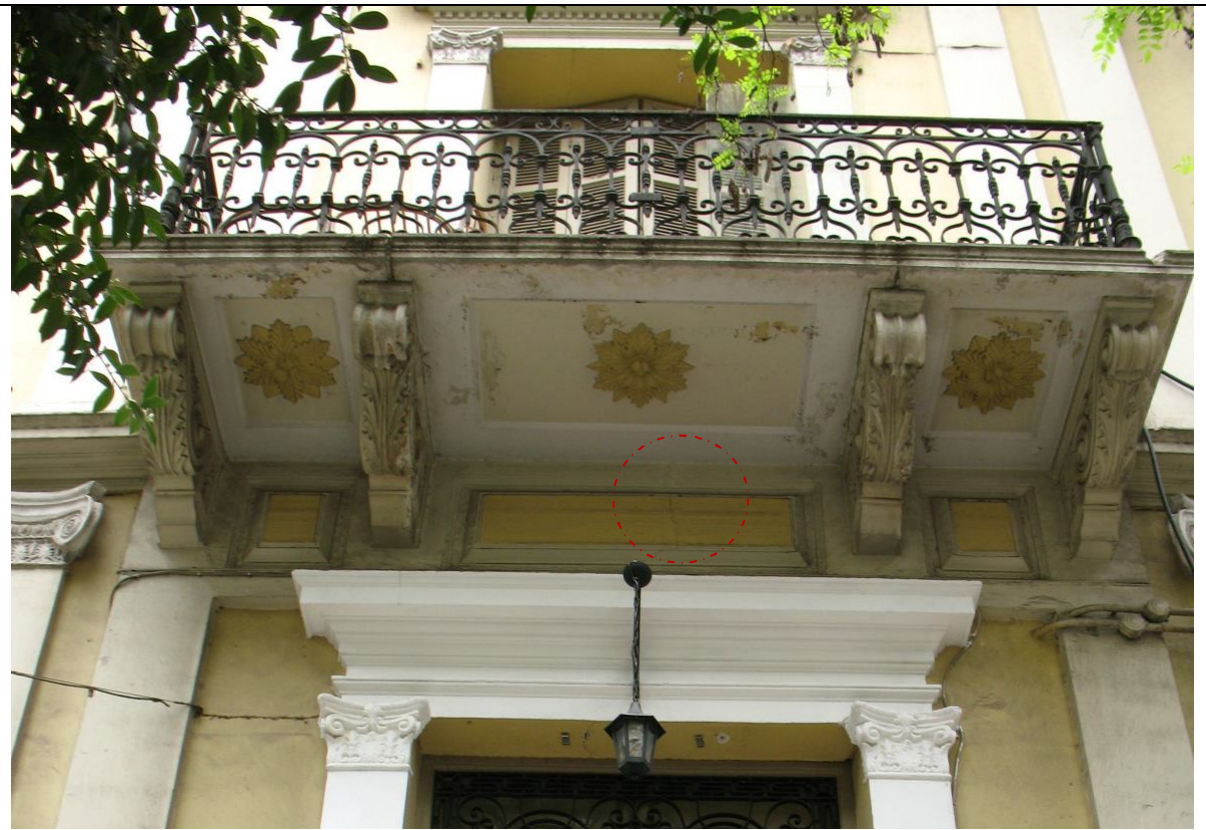
Description: Ph.7- Better detail of Ph.6

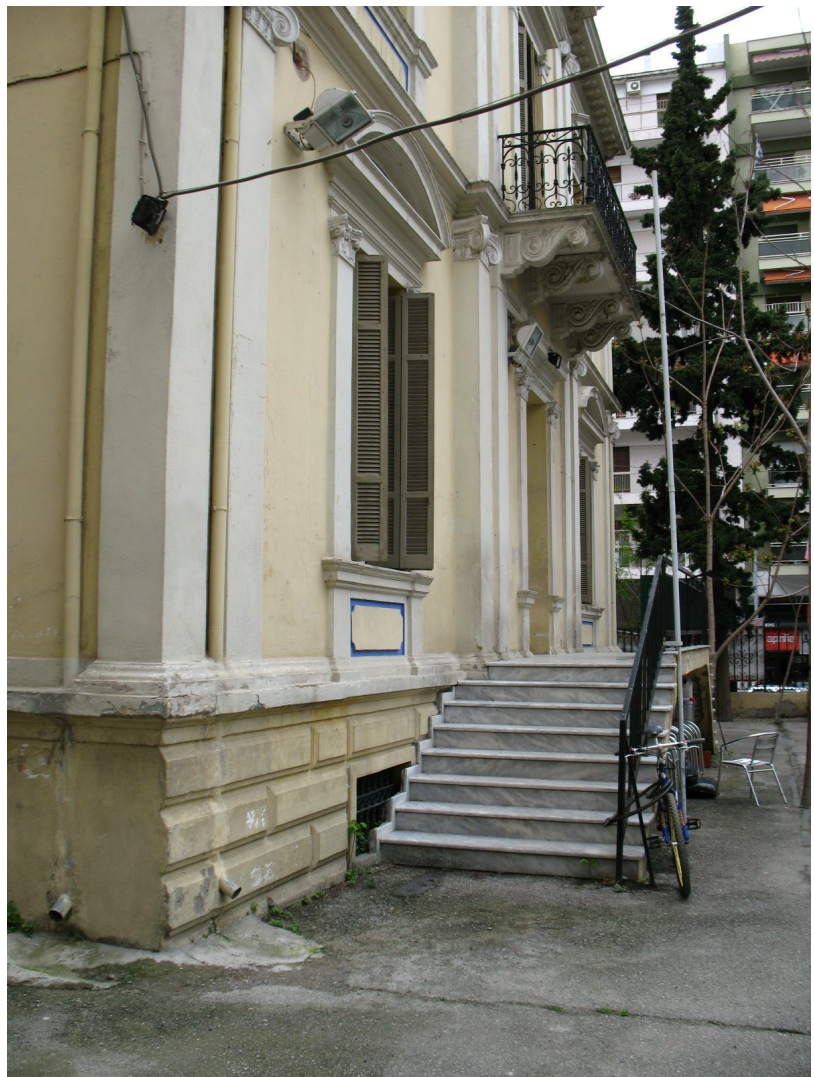
Ph.8 – NW corner with the added part of the courtyard staircase to the upper ground level.

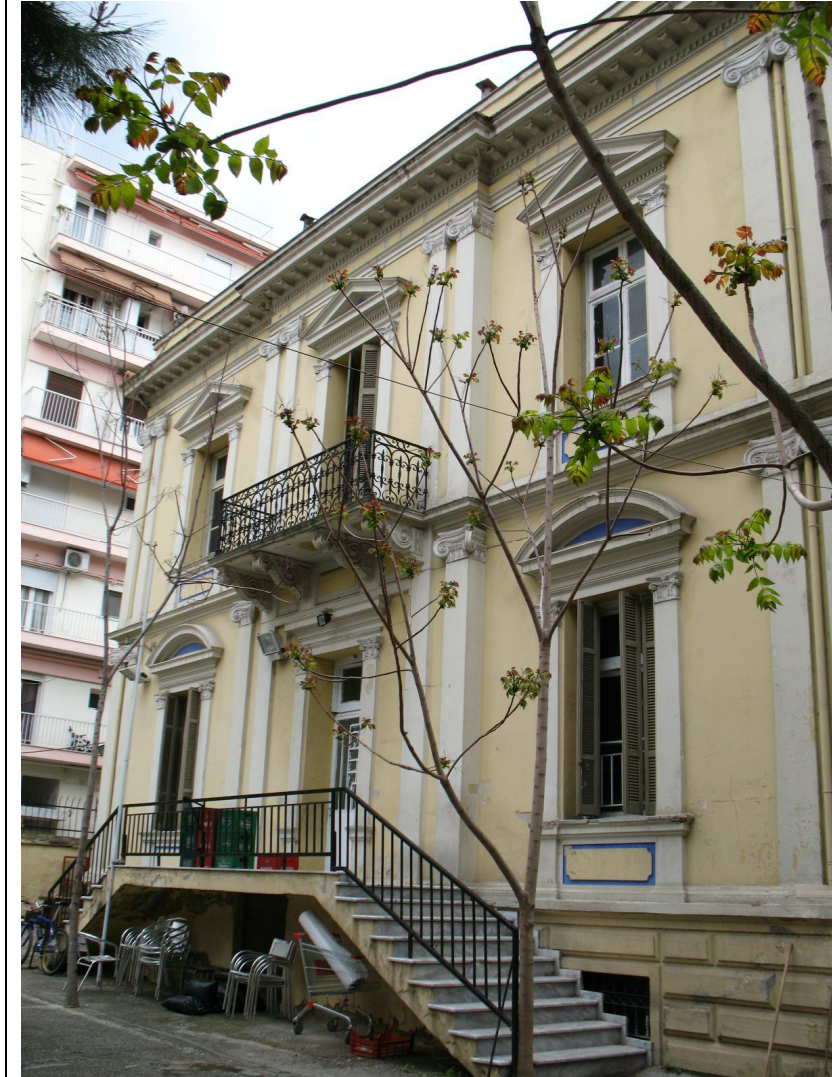
Ph.9- Opposite side at SW corner.

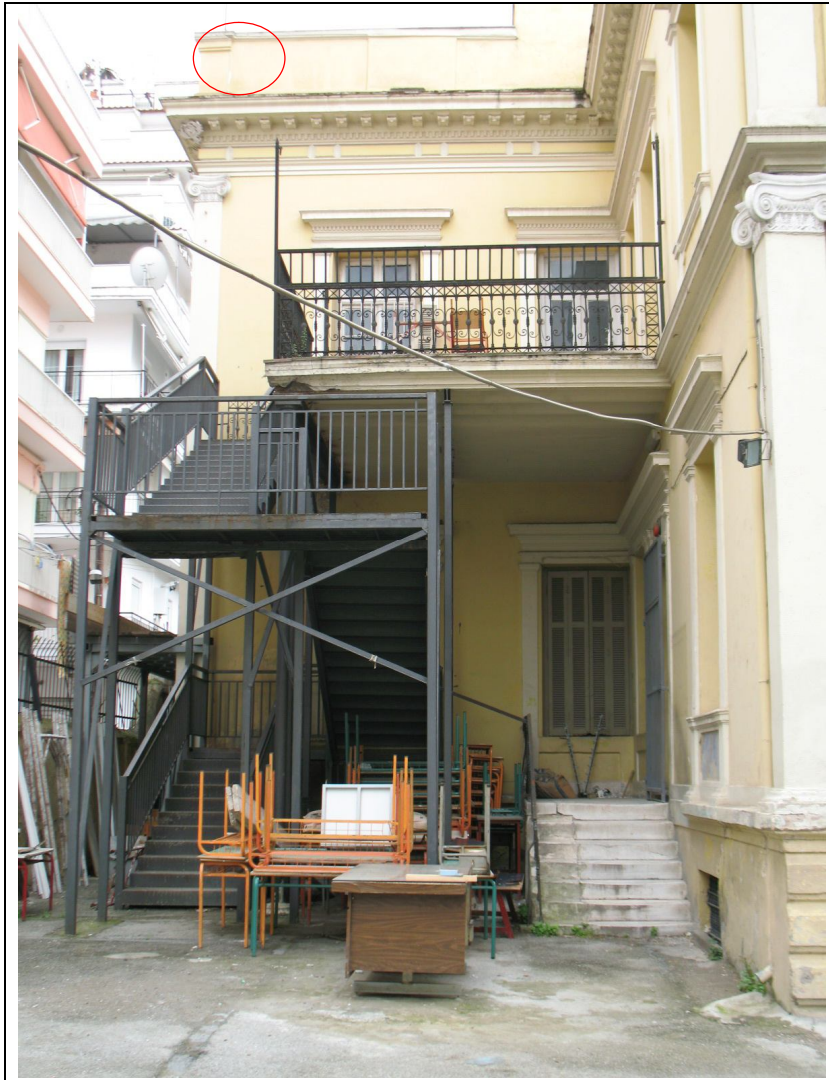
Ph.12- View of the terrace at the rear north side of the building with the recent metal staircase for access to the upper floor.

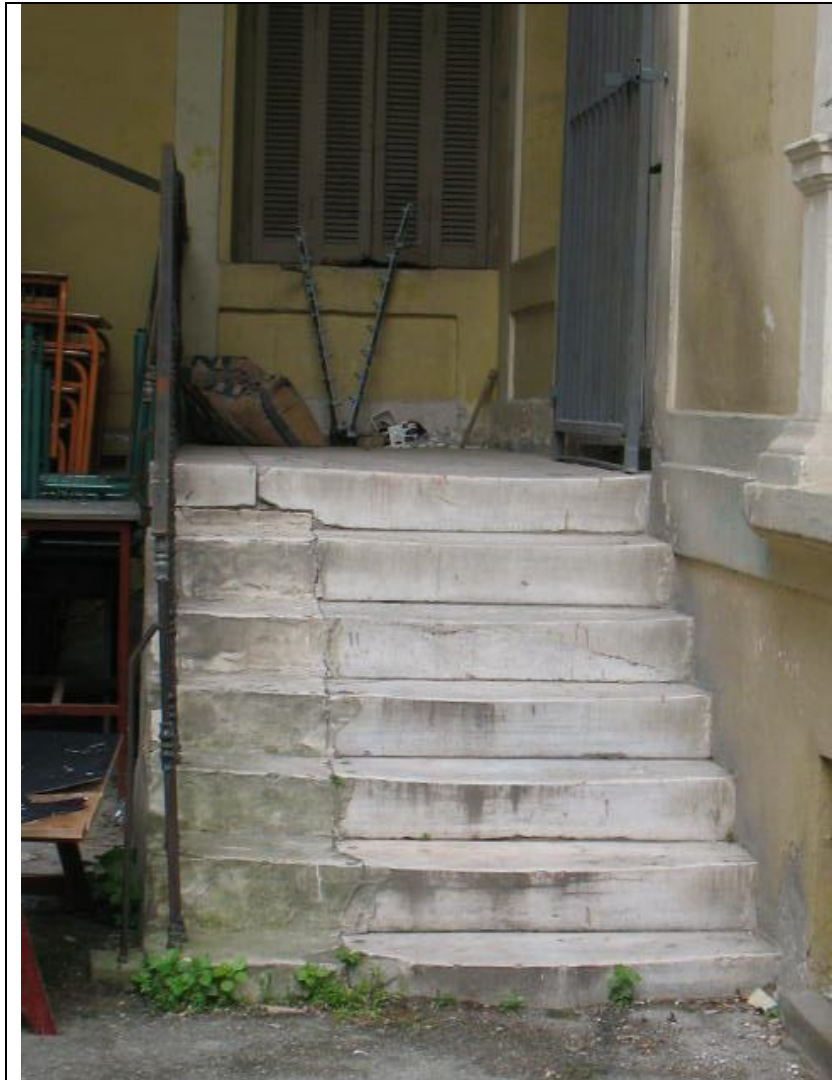
Ph.13- Detail of ph.12 showing the secondary original staircase from the rear north side. The widening of the stairs at a later stage becomes apparent.

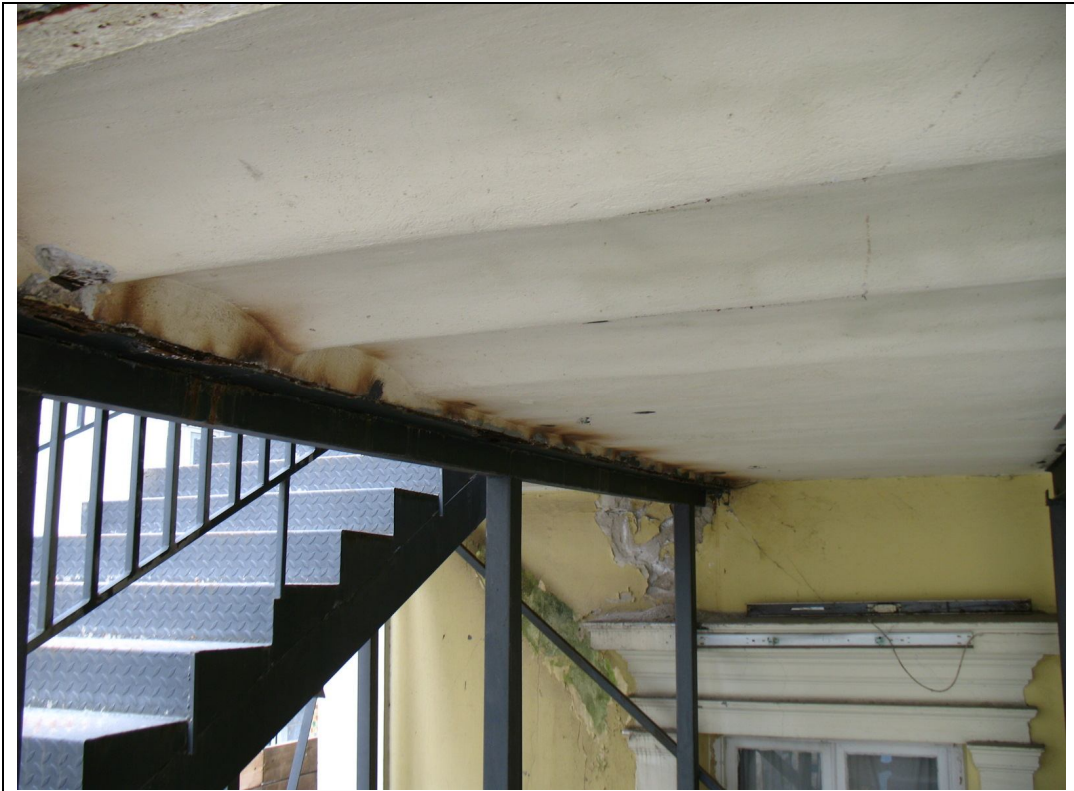
Ph.16- View of the terrace from underneath showing the arched floor between steel beams.

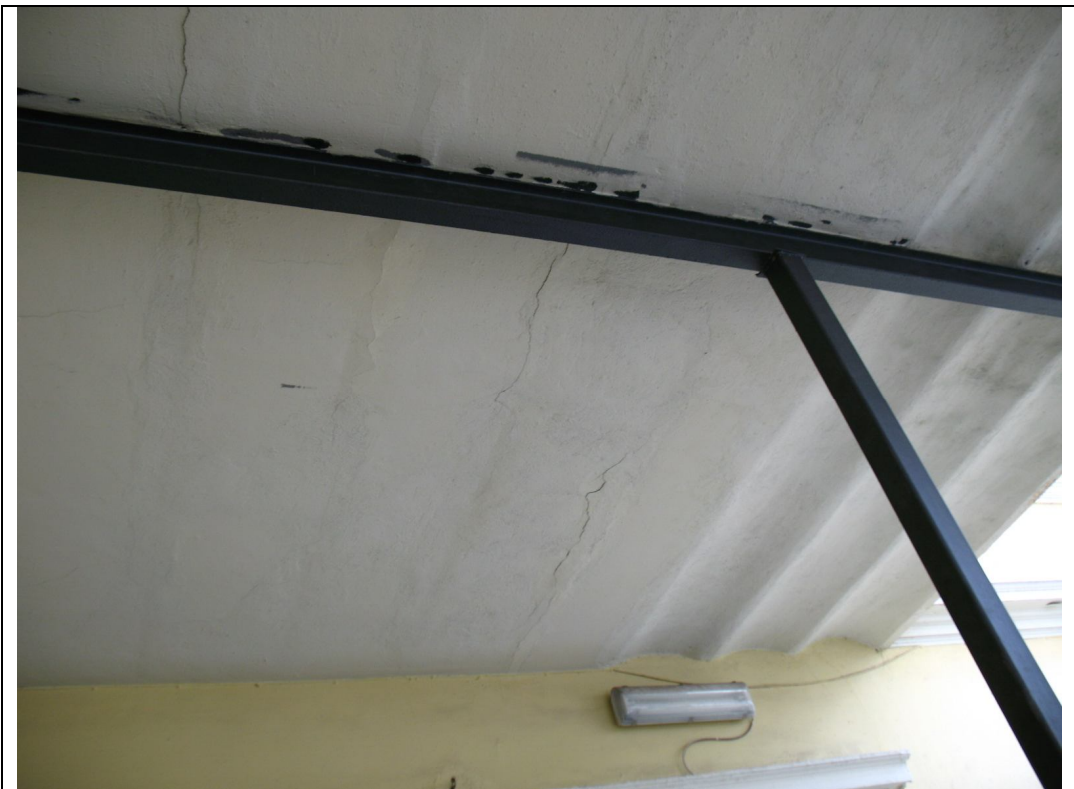
Ph.17- Intermediate support of the terrace at its mid span.

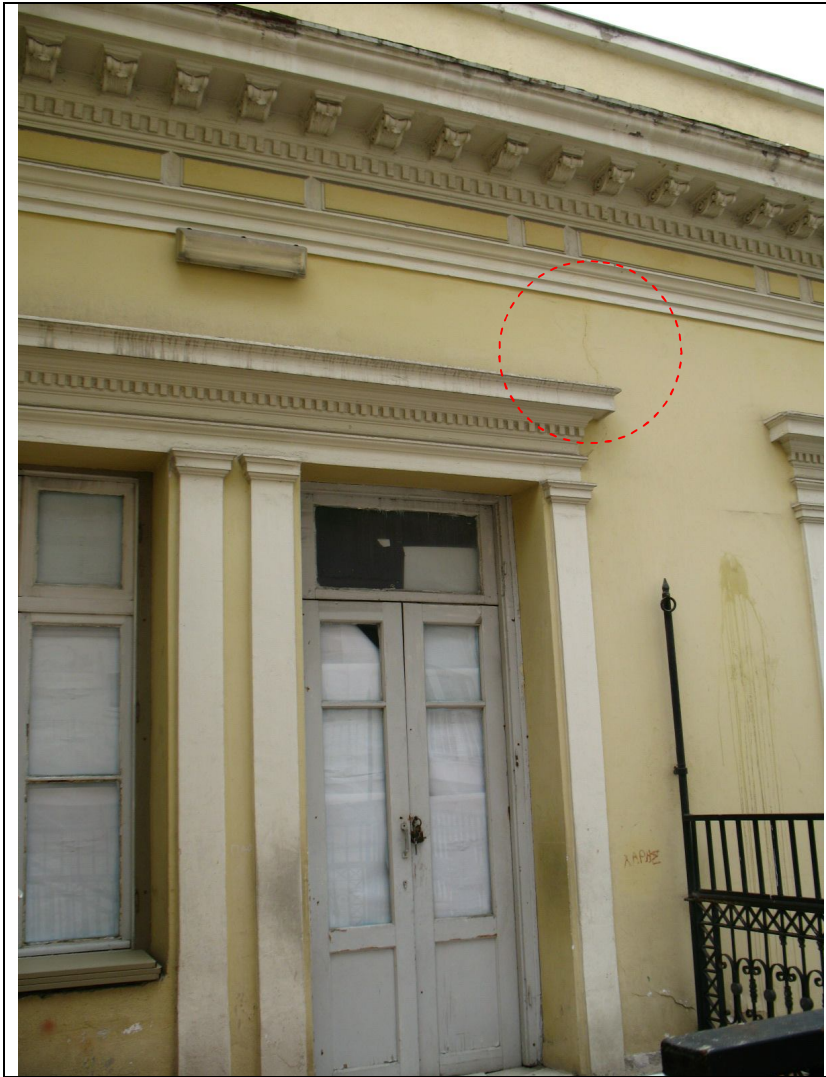
Ph.18— North view at upper – 1st floor from the terrace (outside of room O1).

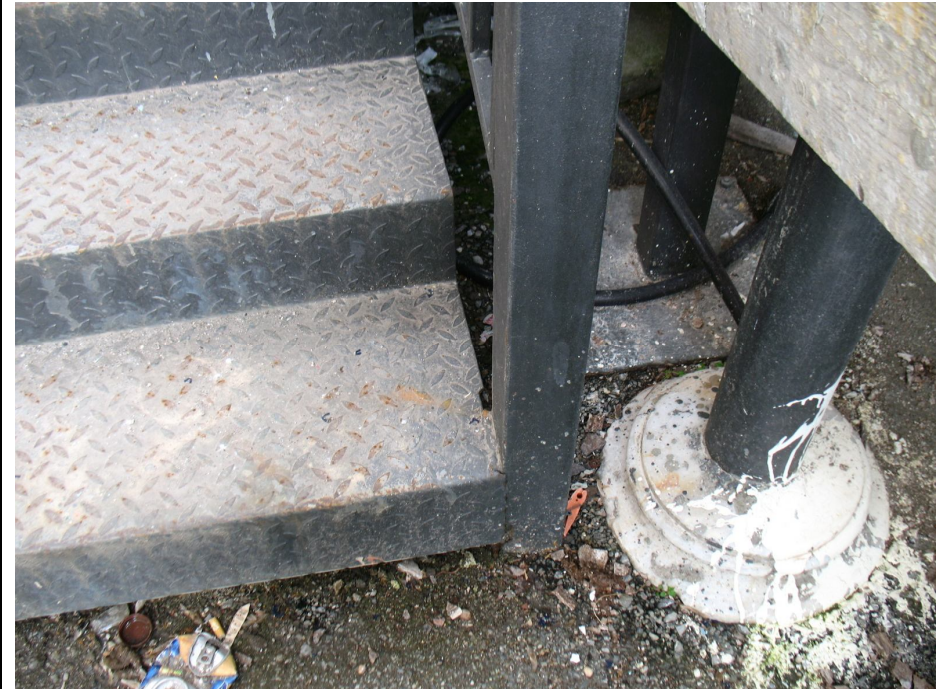
Ph.19- Base support of original circular post Ø120 of the terrace next to the recent SHS post of the steel staircase.

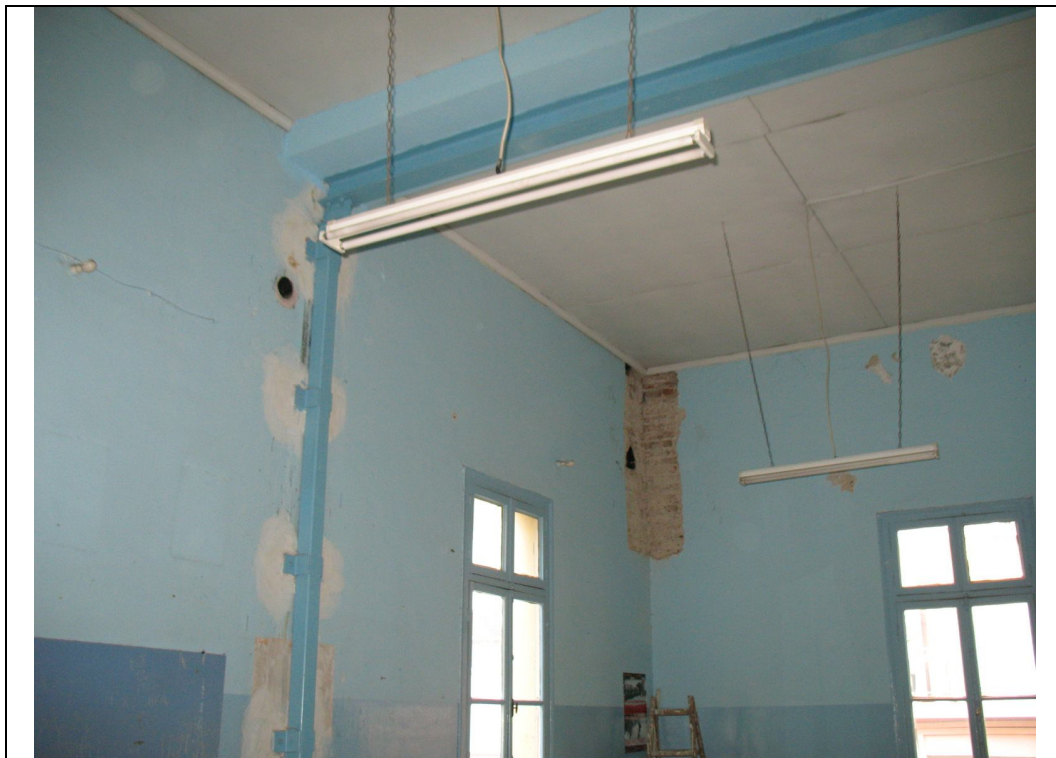
Ph.24- View of room O3-O4 at N-W corner showing the built in chimney at the perimeter walls and the recent intervention on the side walls with the steel goal post arrangement.

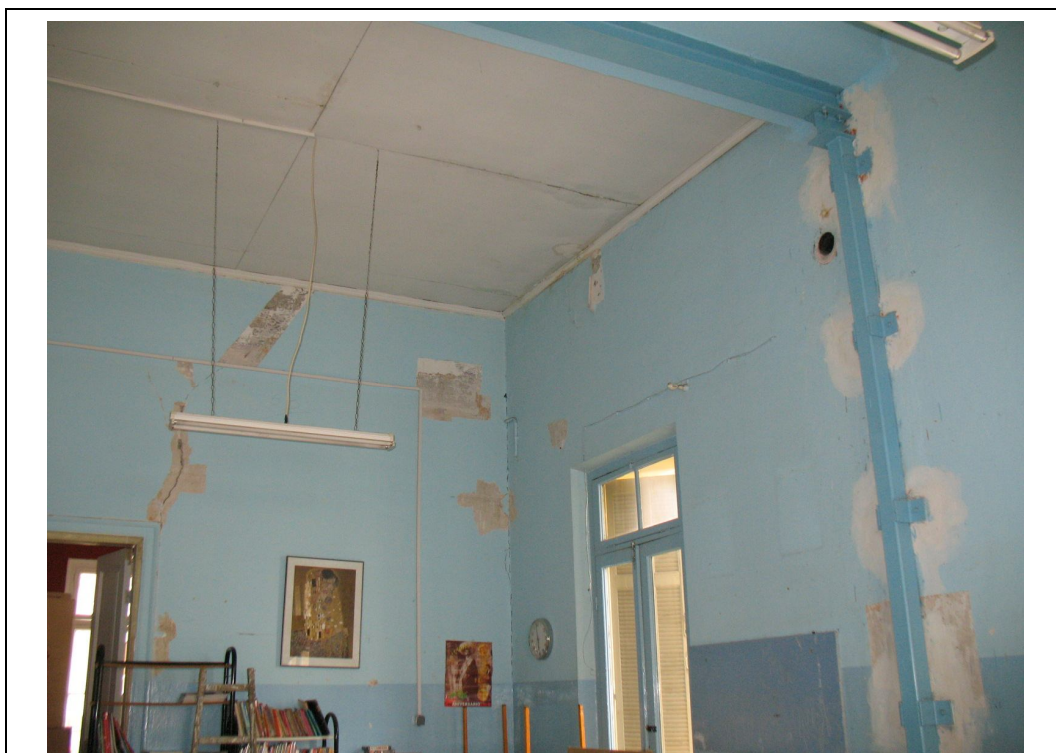
Ph.25- View of the SW corner of the joined rooms O3-O4 showing the steel goal post arrangement below the original pair of steel beams which were placed after the wall demolition.

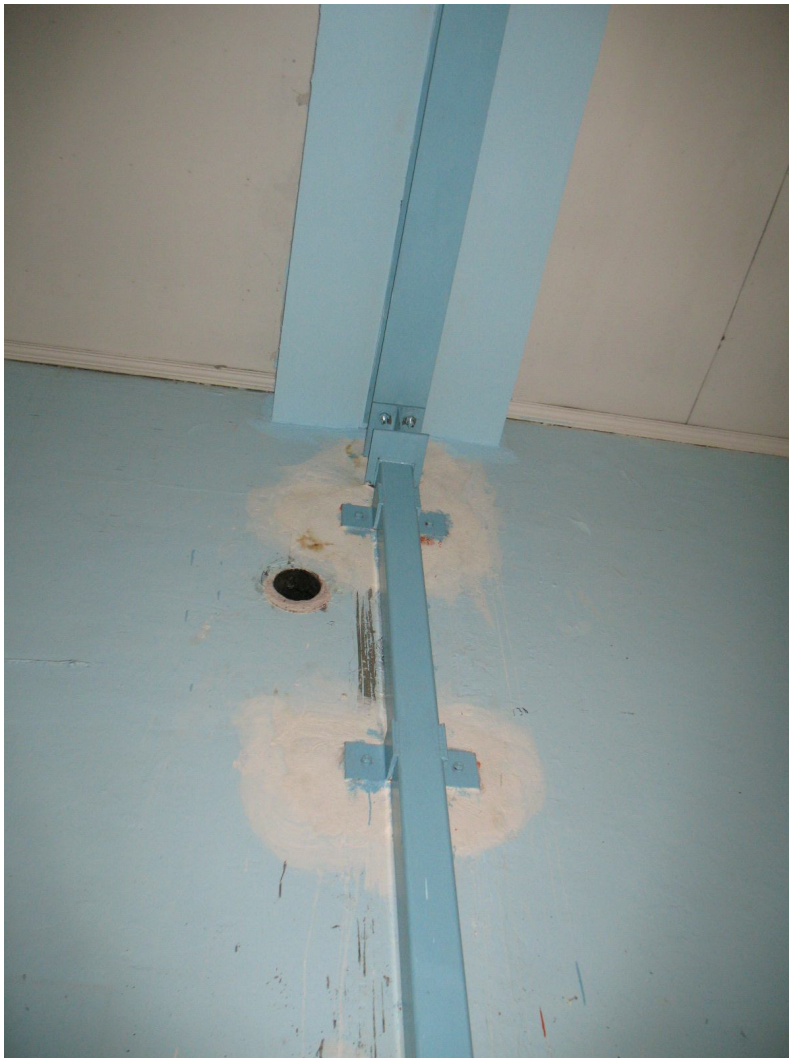
Description: Ph.25a- Detail of ph.24.

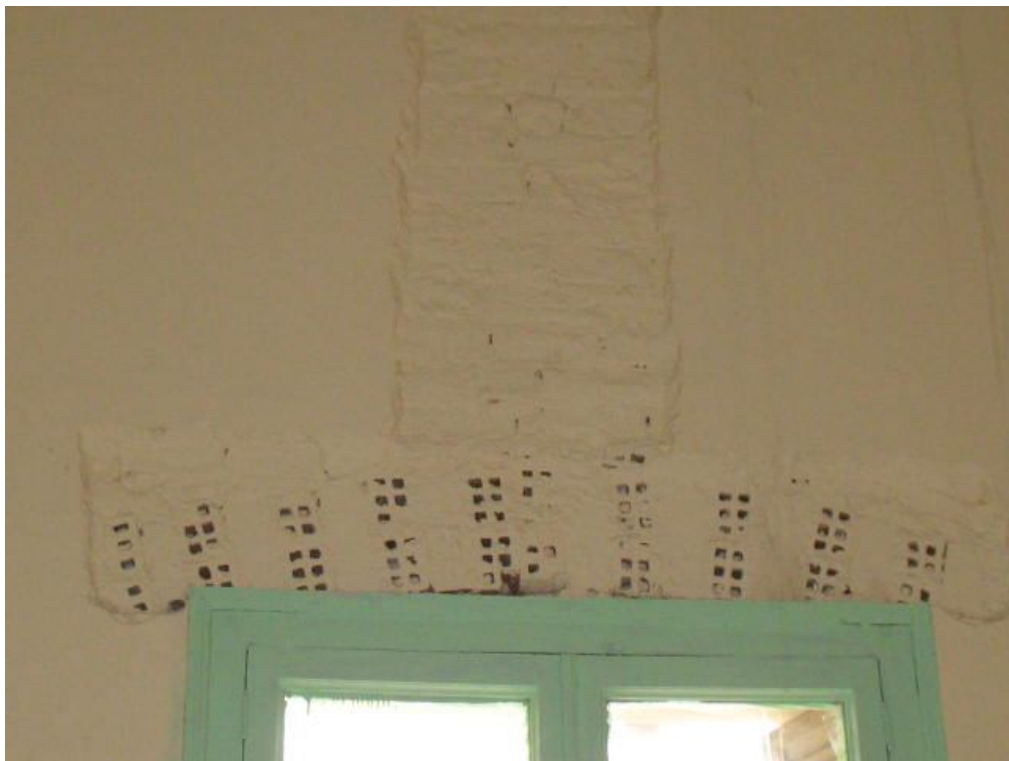
Ph.27 – Section above the window at room O7 showing the two layers of hole bricks creating an arch shape lintel.

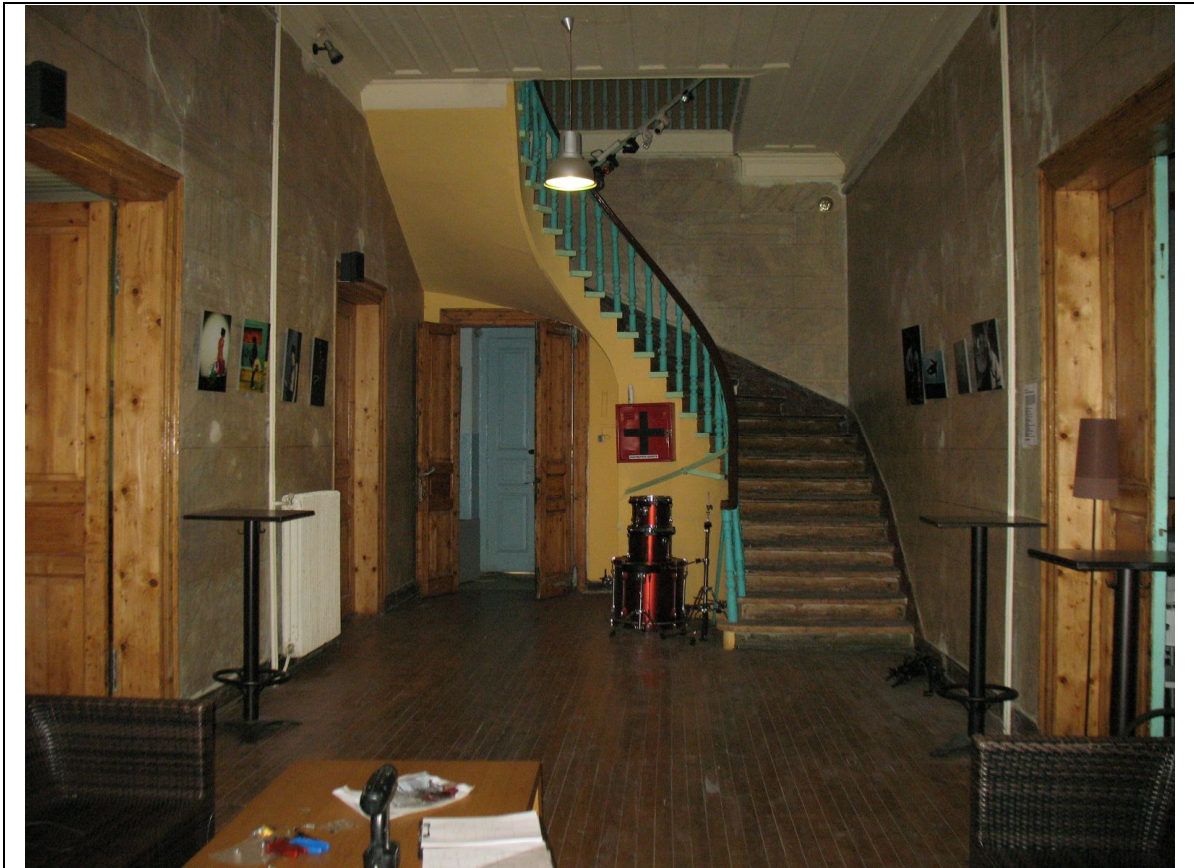
Ph.32- Overall view of the main communal room 11 from south to north showing the main timber staircase at ground level going up at 1st floor.

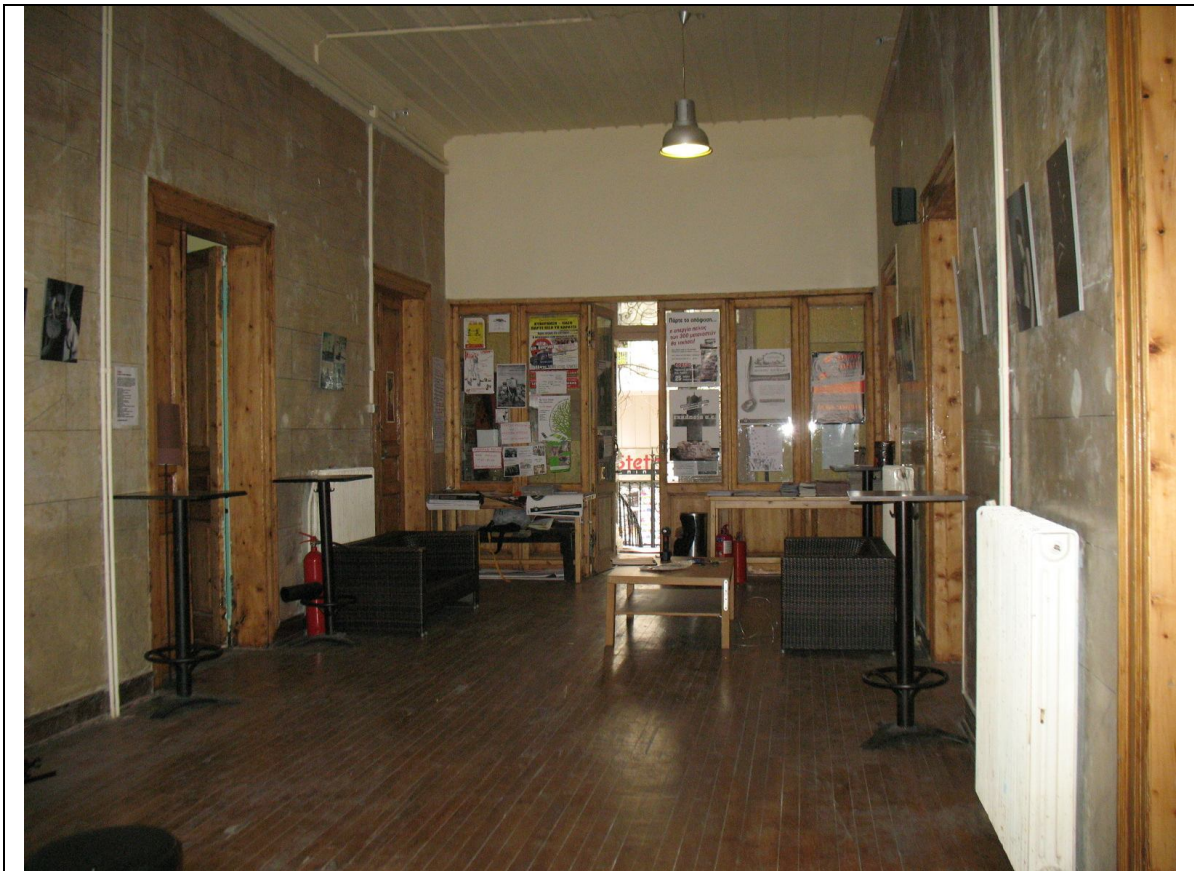
Ph.33- Overall view of the main central communal room 11 at ground floor taken from north to south side.

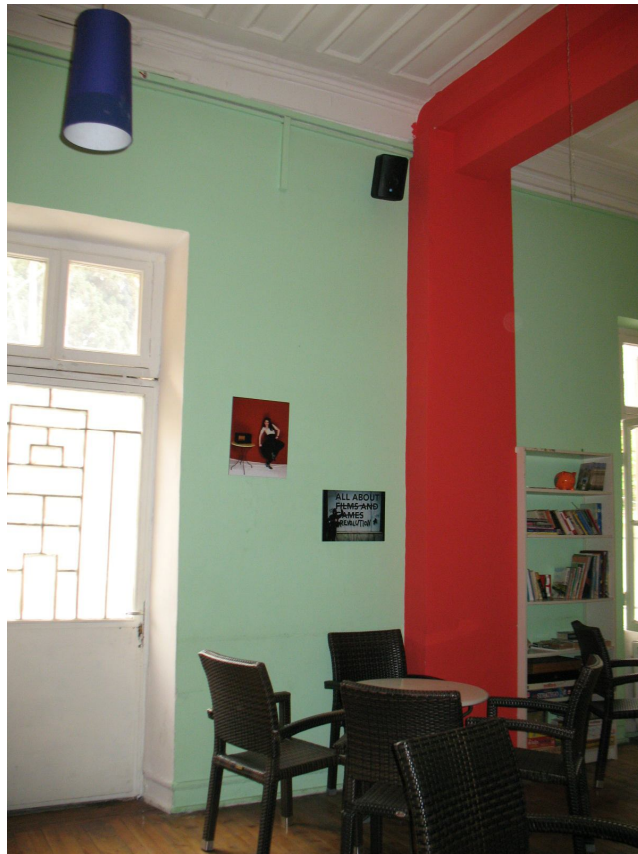
Ph.34– View of the today’s joined rooms I3-I4 at ground. The exit door leads to the west side staircase of the courtyard.

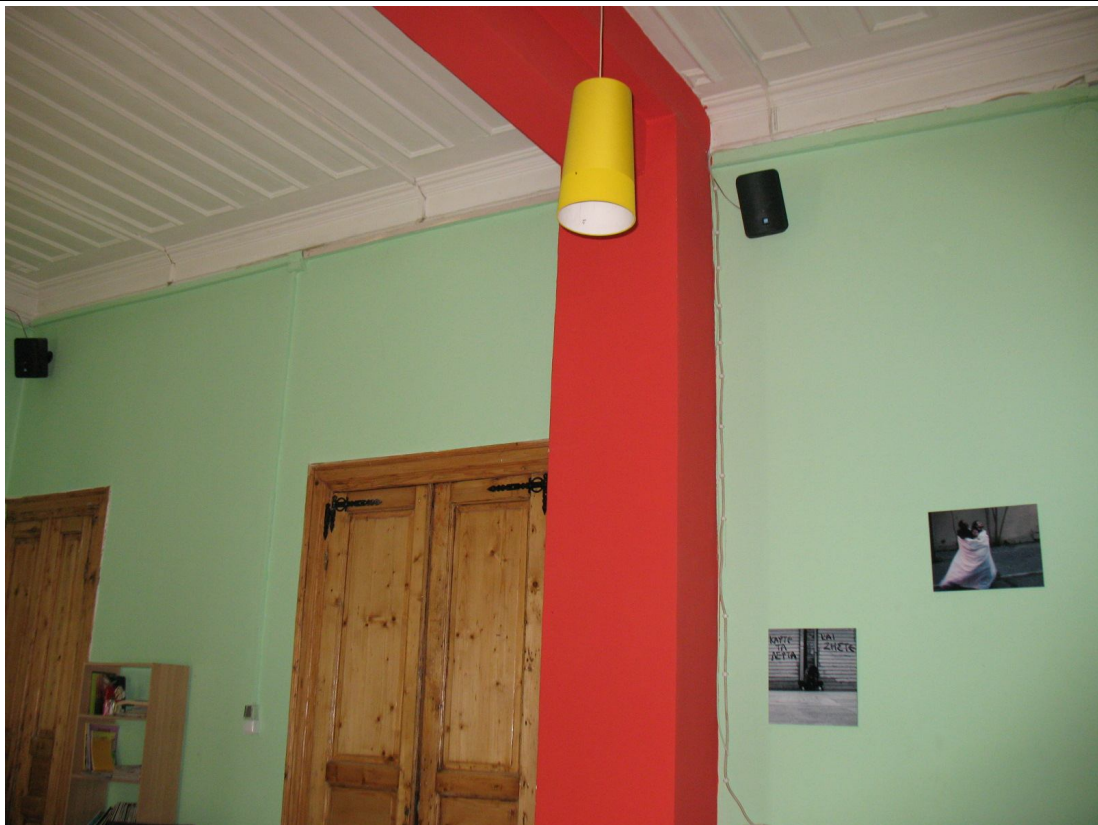
Ph.35– Opposite side with the boxed out section of previous interventions (as shown on room above at O3-O4).

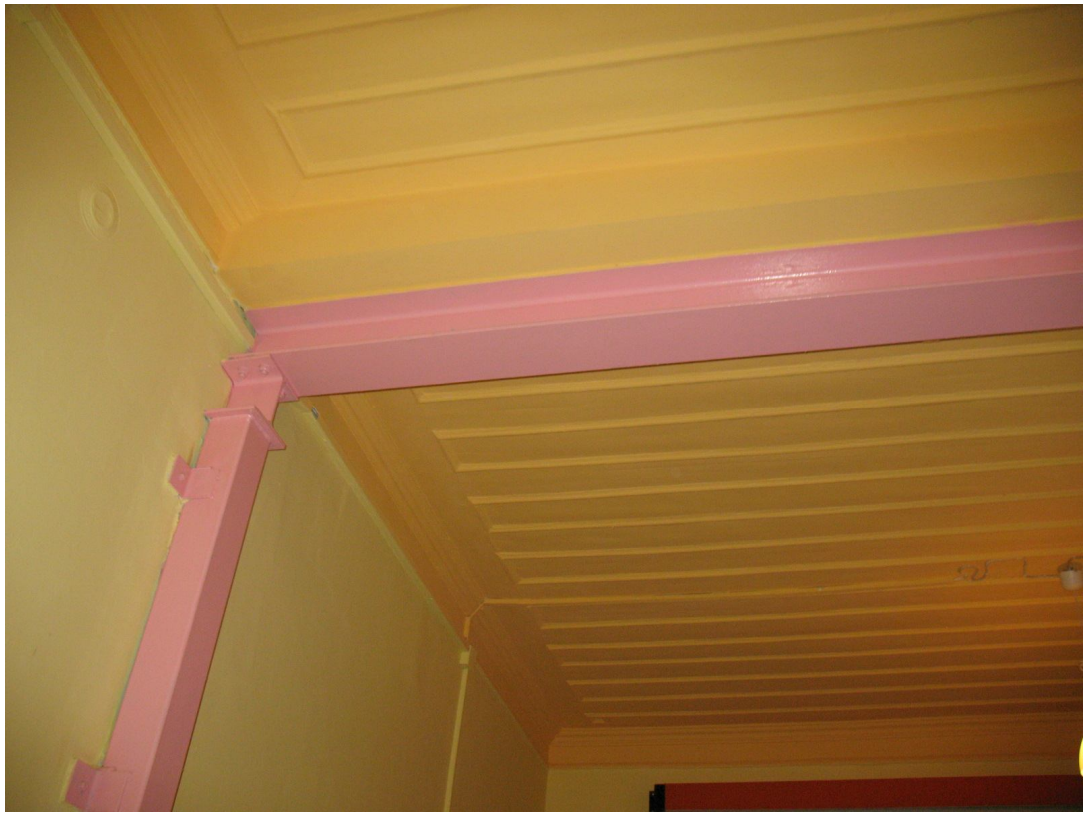
Ph.36– Steel goal post arrangement at the joined room I6-17 at ground.

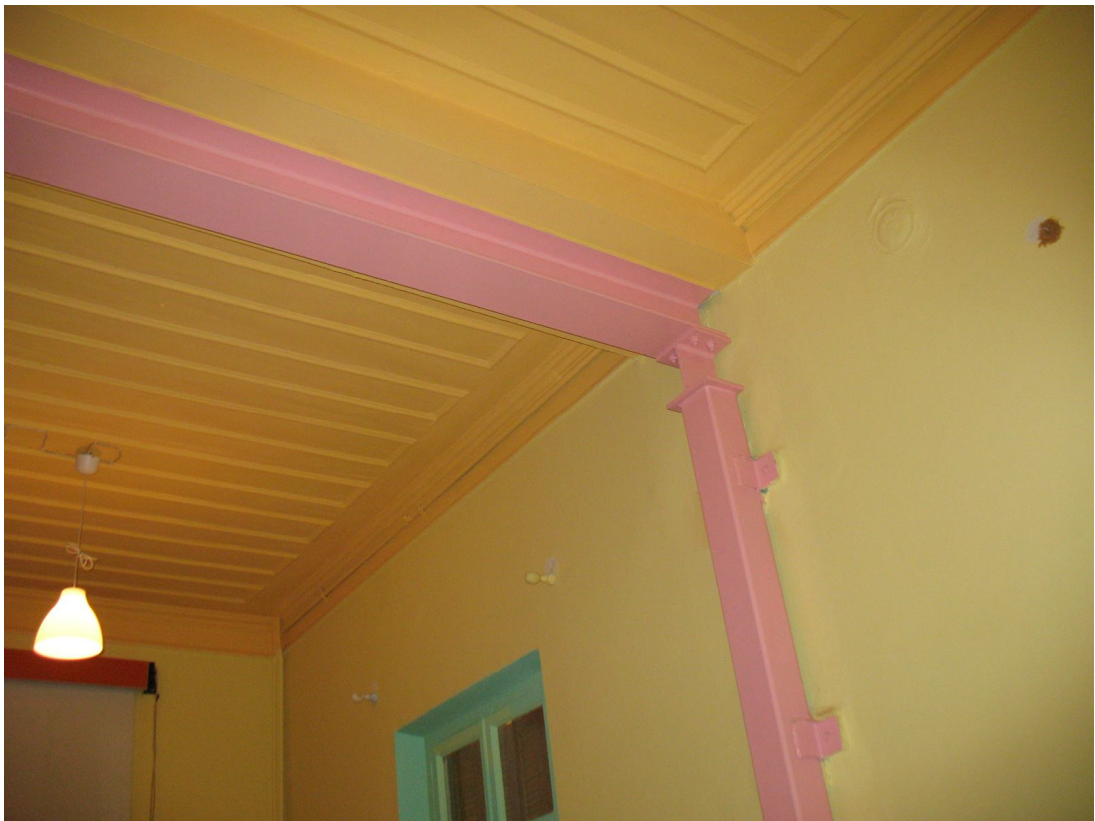
Ph.37- Opposite side of the same room I6-17 at ground floor.

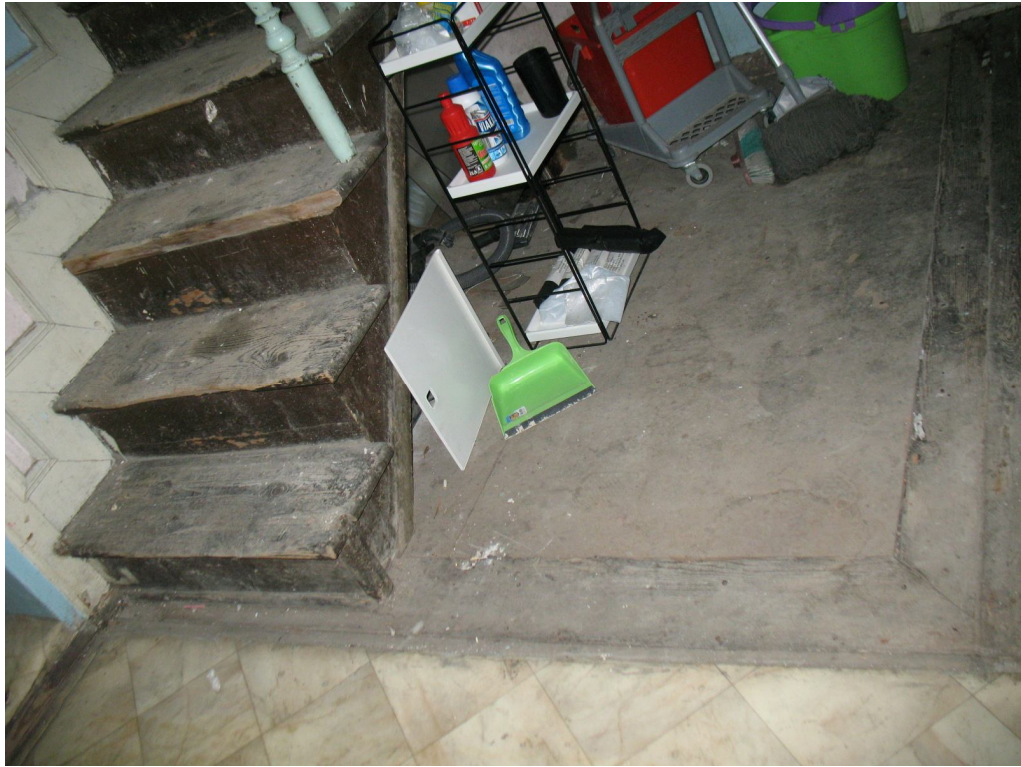
Ph.38– View of the secondary staircase at ground floor level. The previous opening of the floor for access to the basement is closed by plywood sheets.

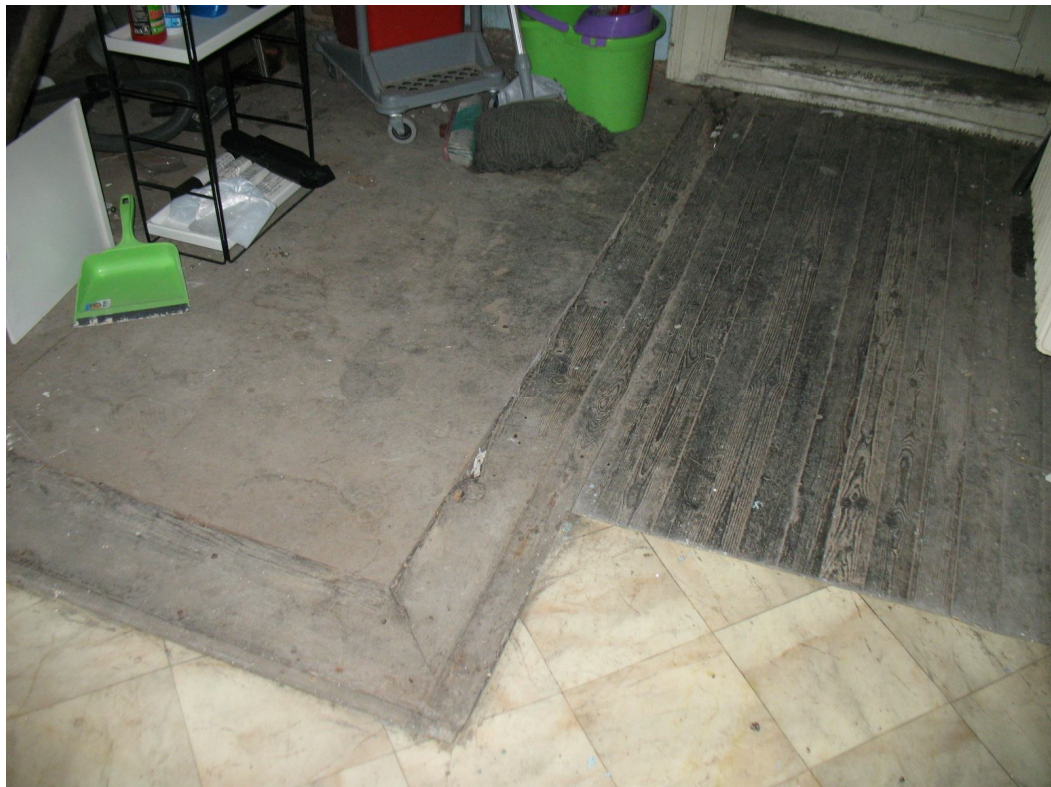
Ph.39– Detail of the floor closure next to the original floor boarding.

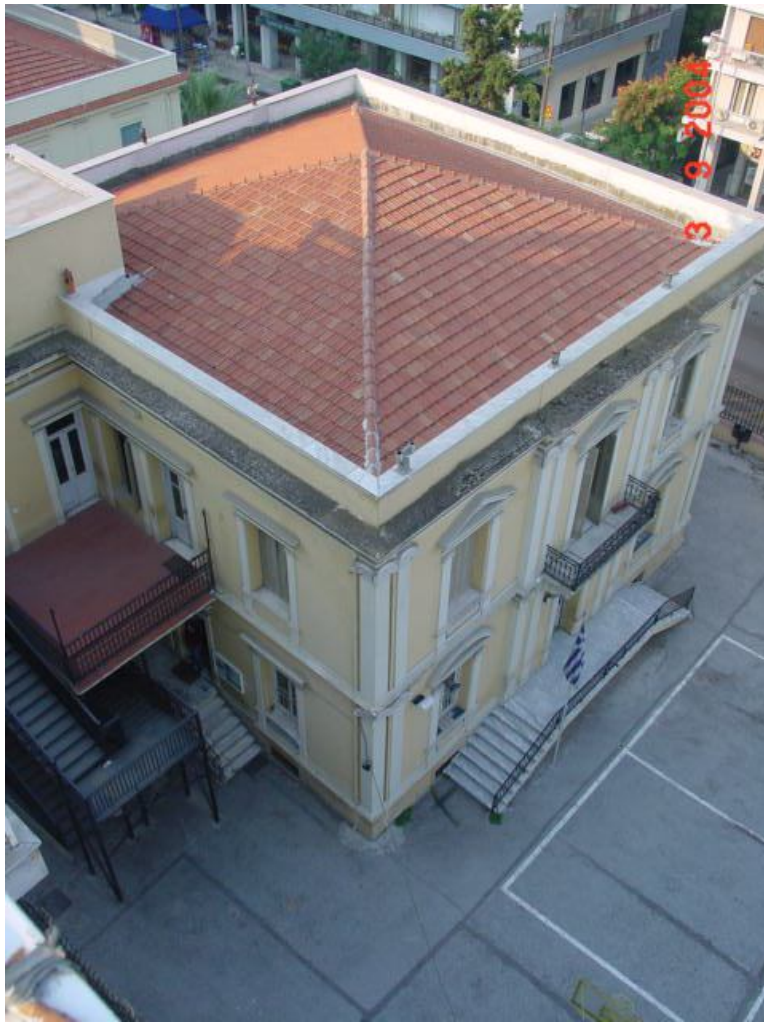
Ph.40- Panoramic view of the NW corner of the building and the roof plan.

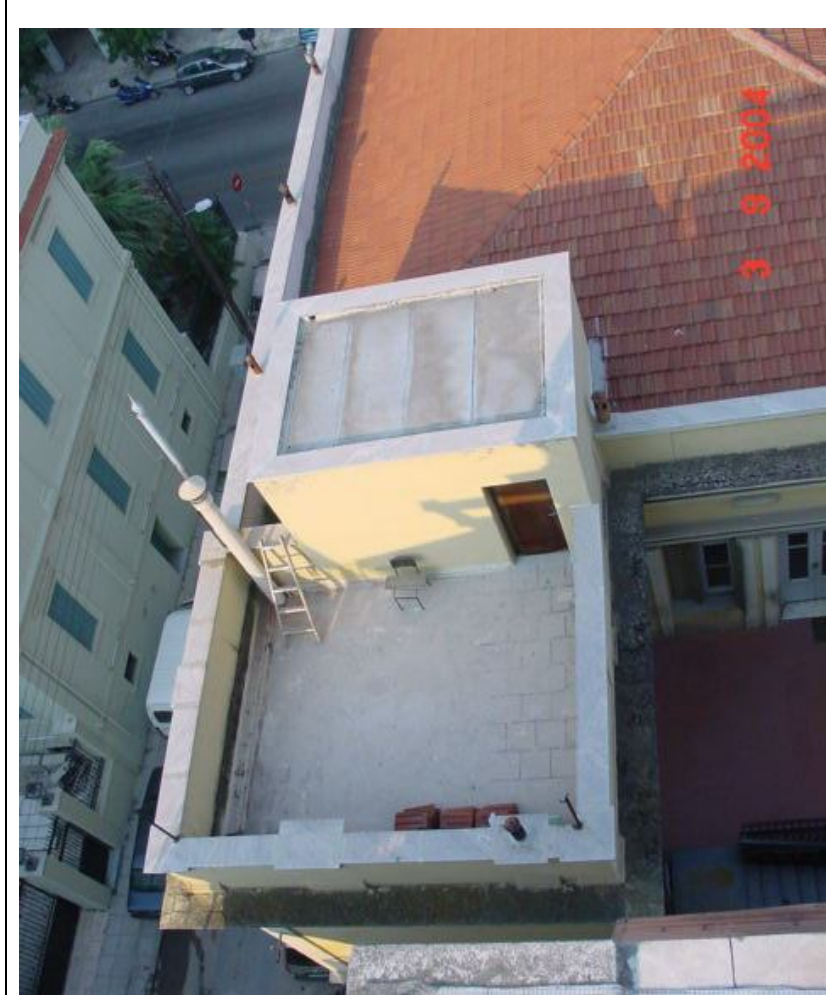
Ph.41- Top view of the terrace above room O10 with the secondary timber staircase access from 1st floor.

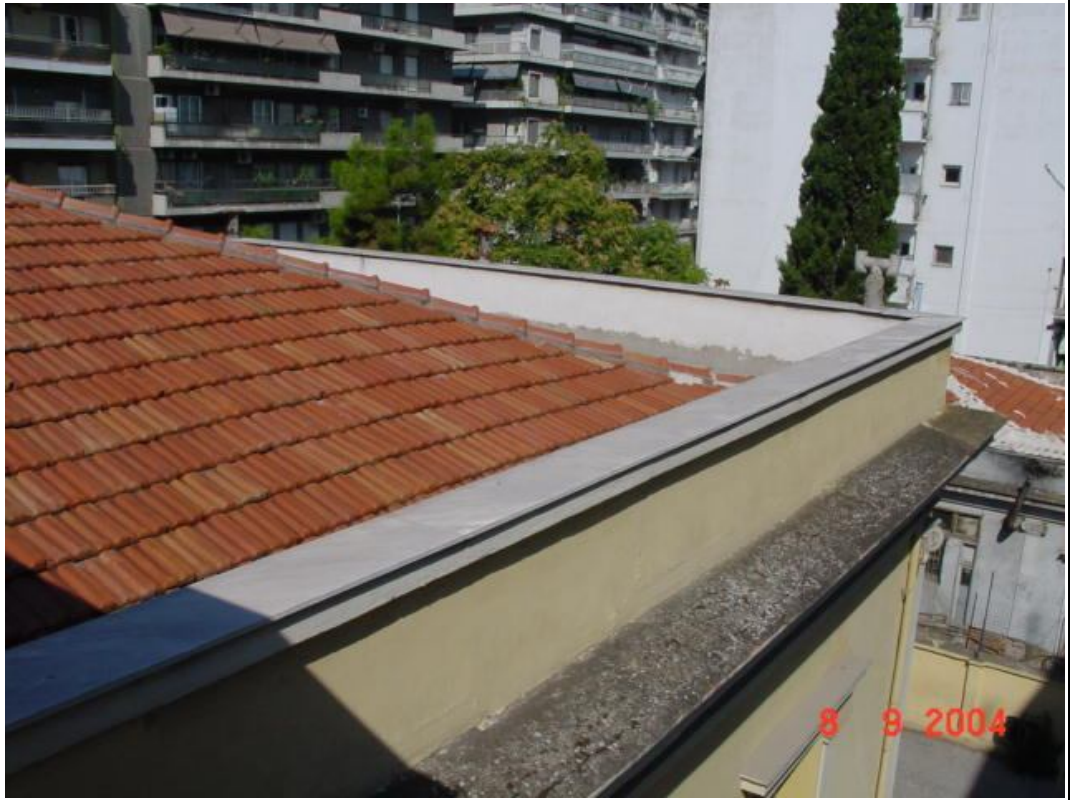
Ph.44- Parapet side view at the NW corner of the building.

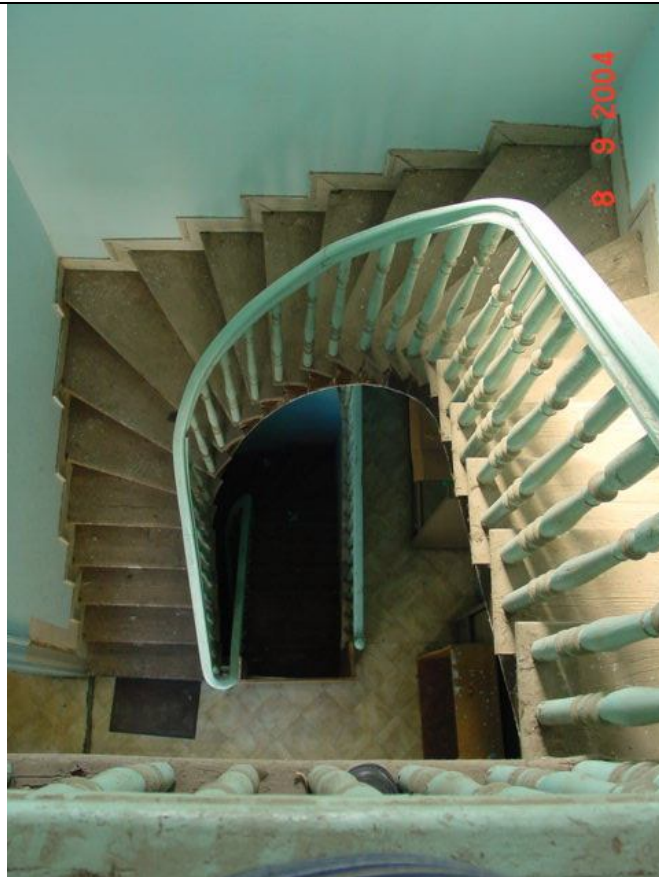
Ph.45- Top view of the secondary timber staircase from terrace roof level towards first floor at room O8.

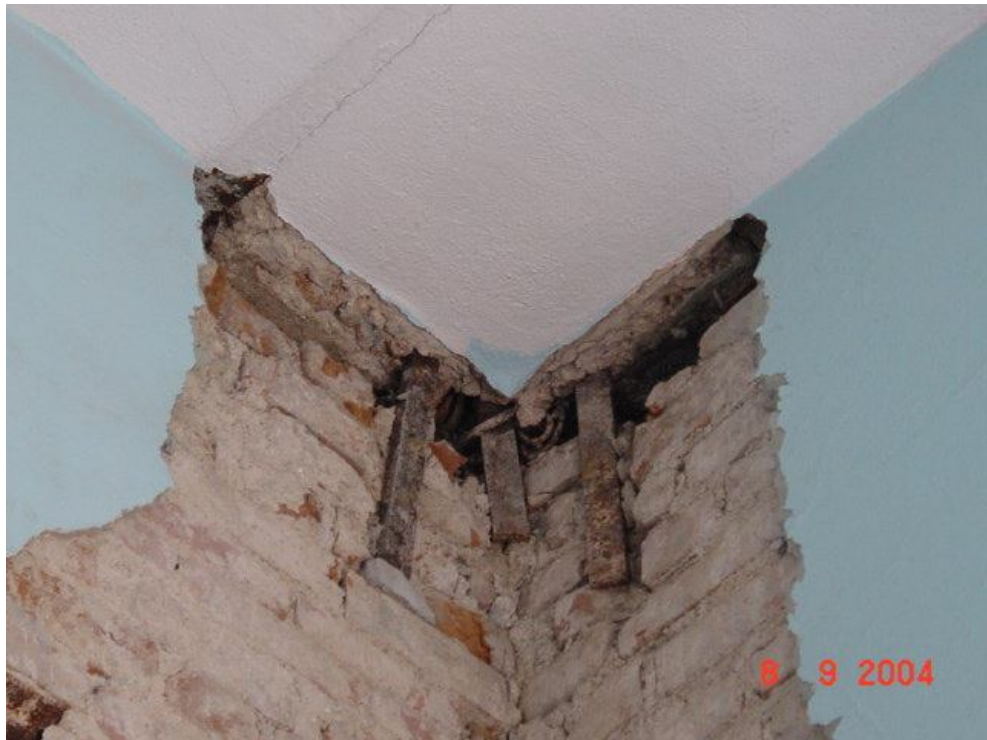
Ph.52- Detail of ph.51 showing the discontinuous built of the fireplace infill by bricks.

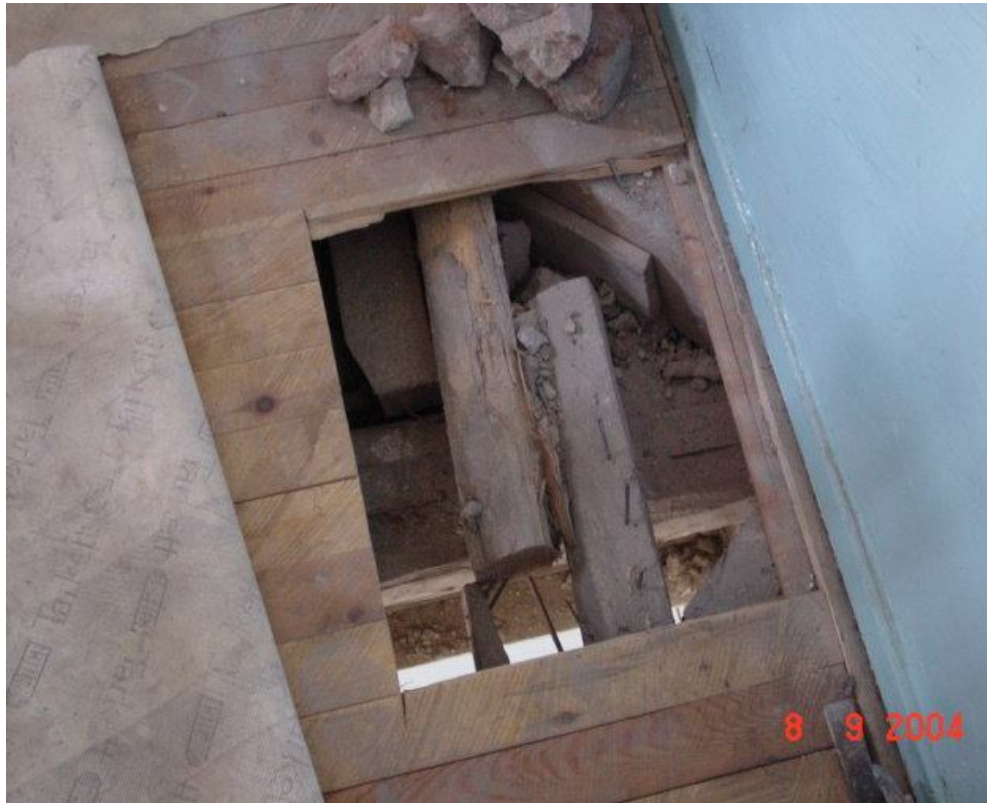
| Description: | Ph.55- Timber floor section at room O7 with the transverse timber beams being supported on the wall between rooms O7 – O8. |
