Photographic Record

Former 12th Primary School

Vas.Georgiou 27 & Mpizaniou St.

M.Xofi - 2011

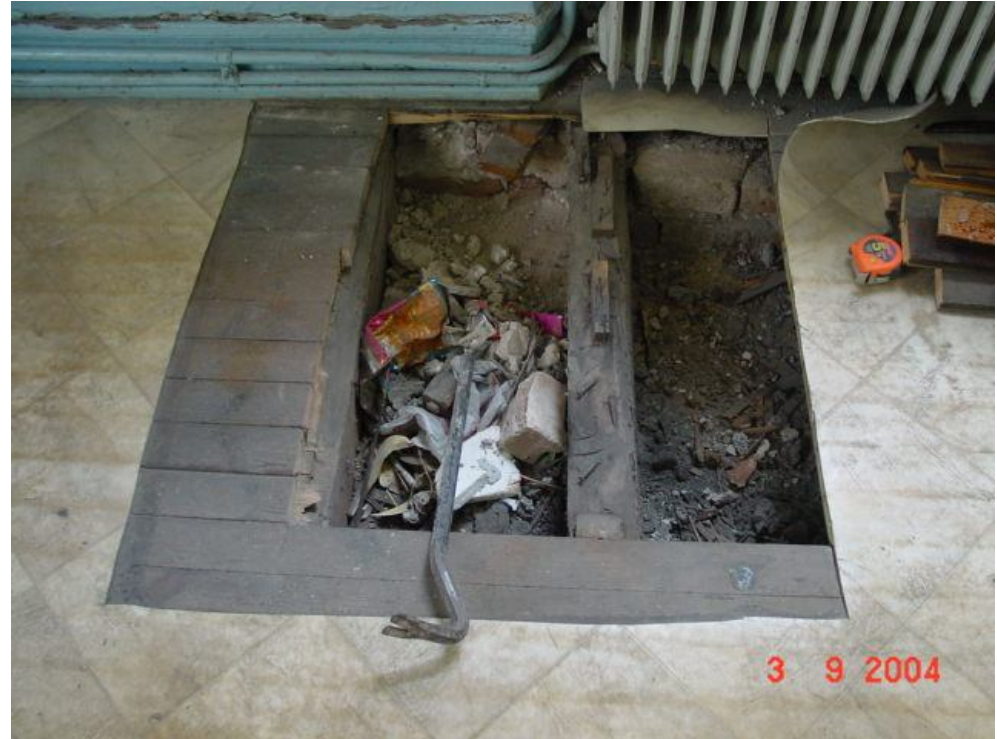
Ph.63- View of the room I4 at NW corner revealing the timber beams at floor (ph.62).

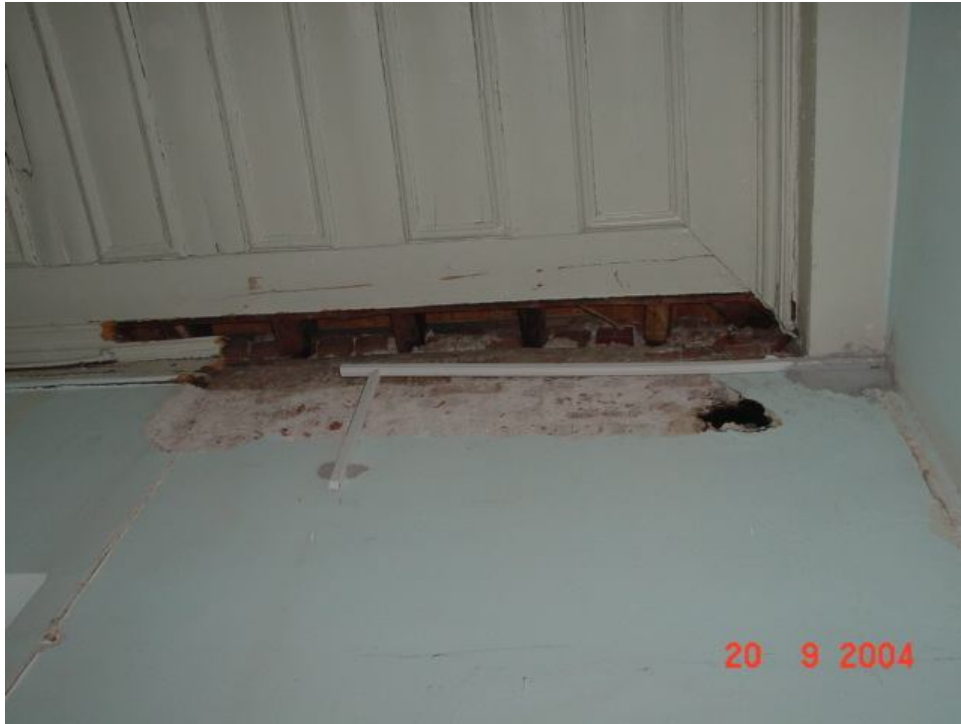
Ph.63a- Detail of Ph.63. showing the timber ground floor beams at room I4 to be supported directly at the head of the basement wall without a tie beam.

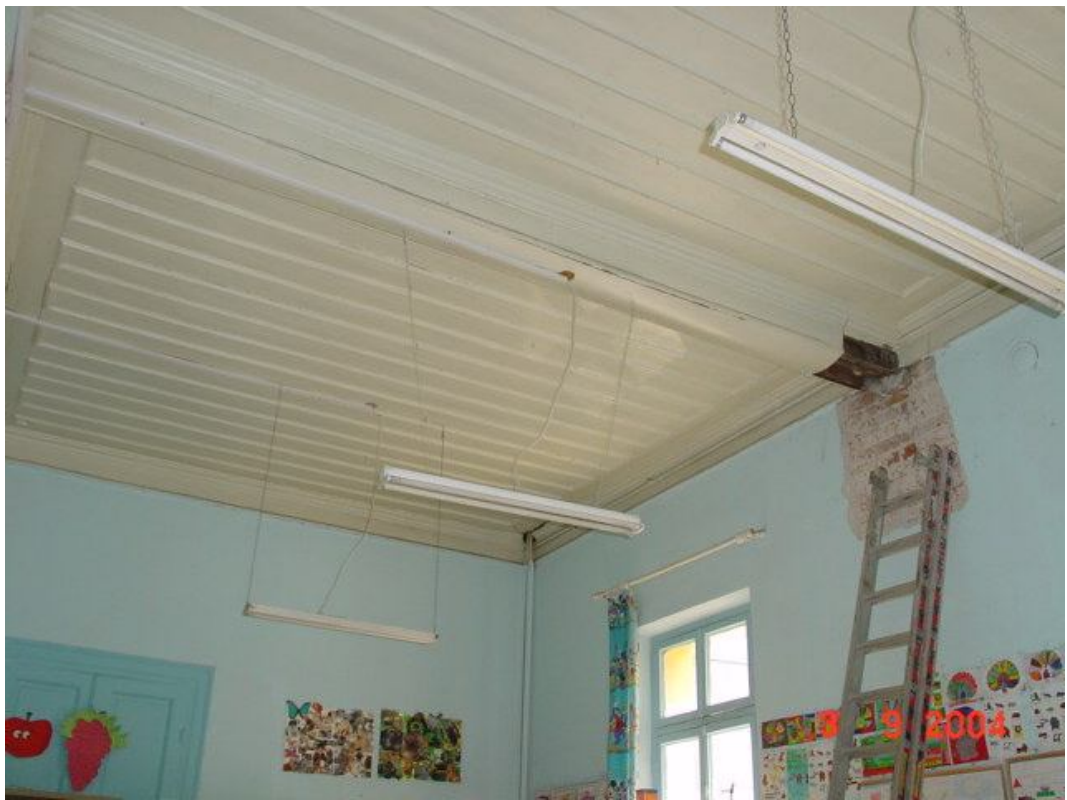
Ph.64- Section cut at ground ceiling level above the west door exit room 13 showing no sign of the marbled cantilever supports of the balconies reaching the inner leaf of masonry.

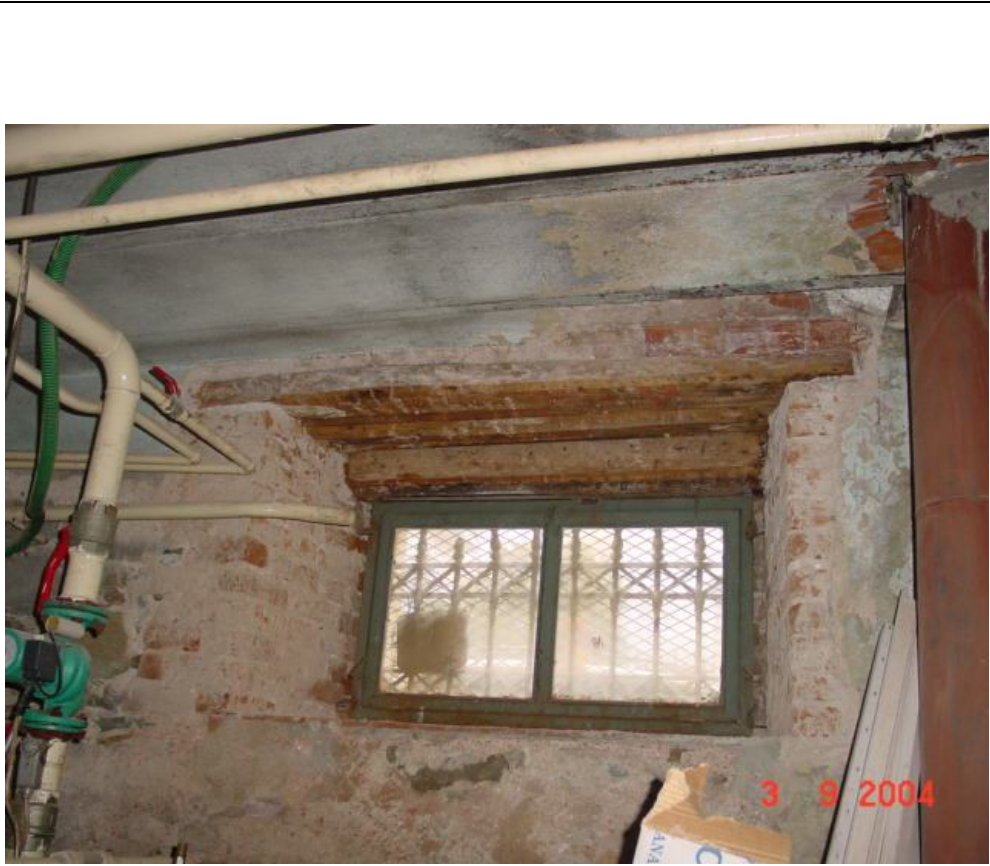
| Description: | Ph.74 – North side view of room Y10 at basement showing the rubble stone masonry and the arched floor between steel beams. |
